Jeffrey C. May

May Indoor Air Investigations LLC
Tyngsborough, MA

Moisture and Leak
Investigations

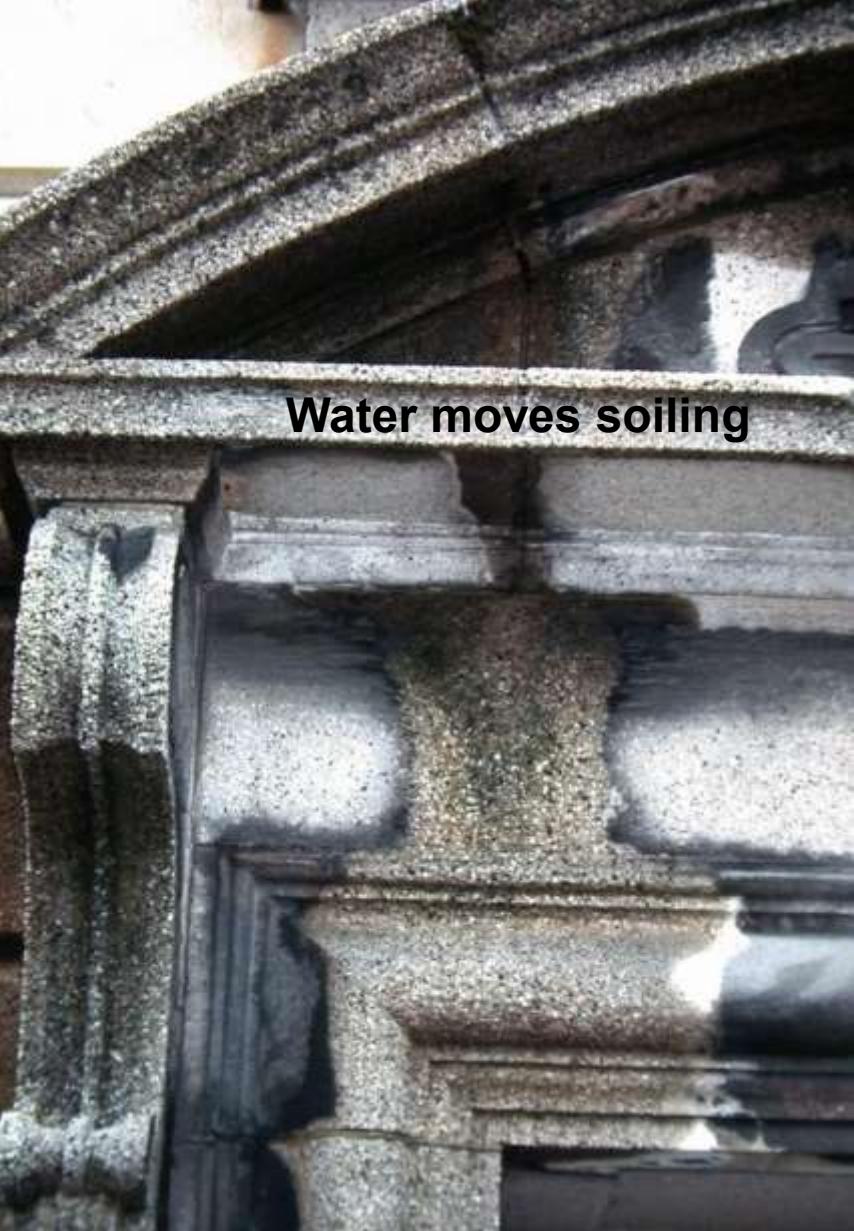
Water moves soiling

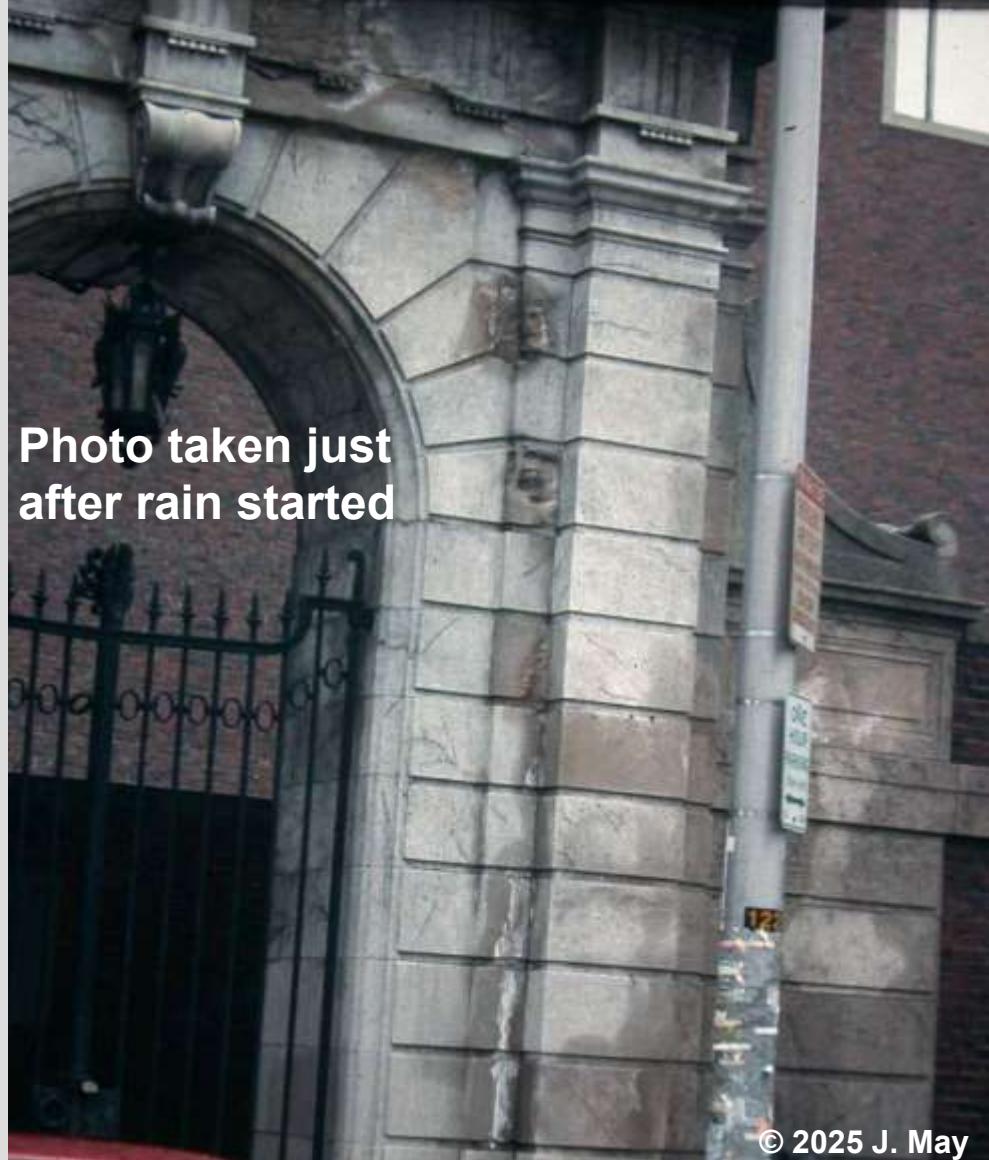
Photo taken just
after rain started

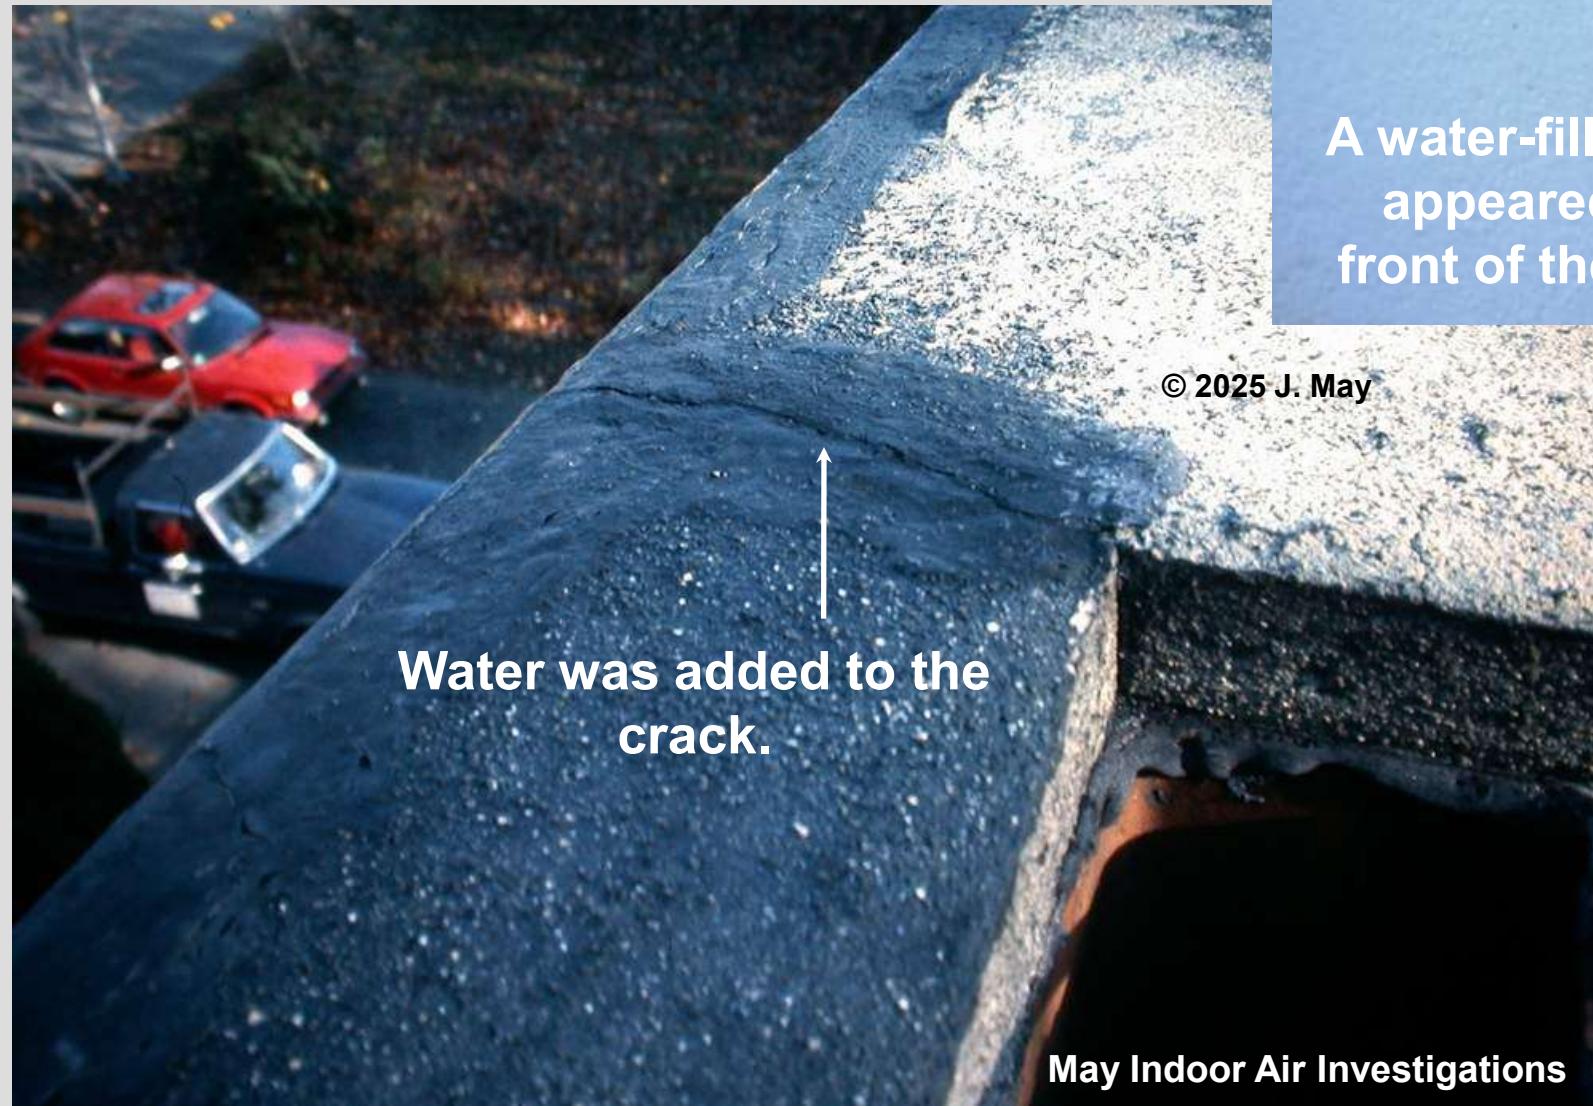
A water-filled blister appeared in the front of the stucco.

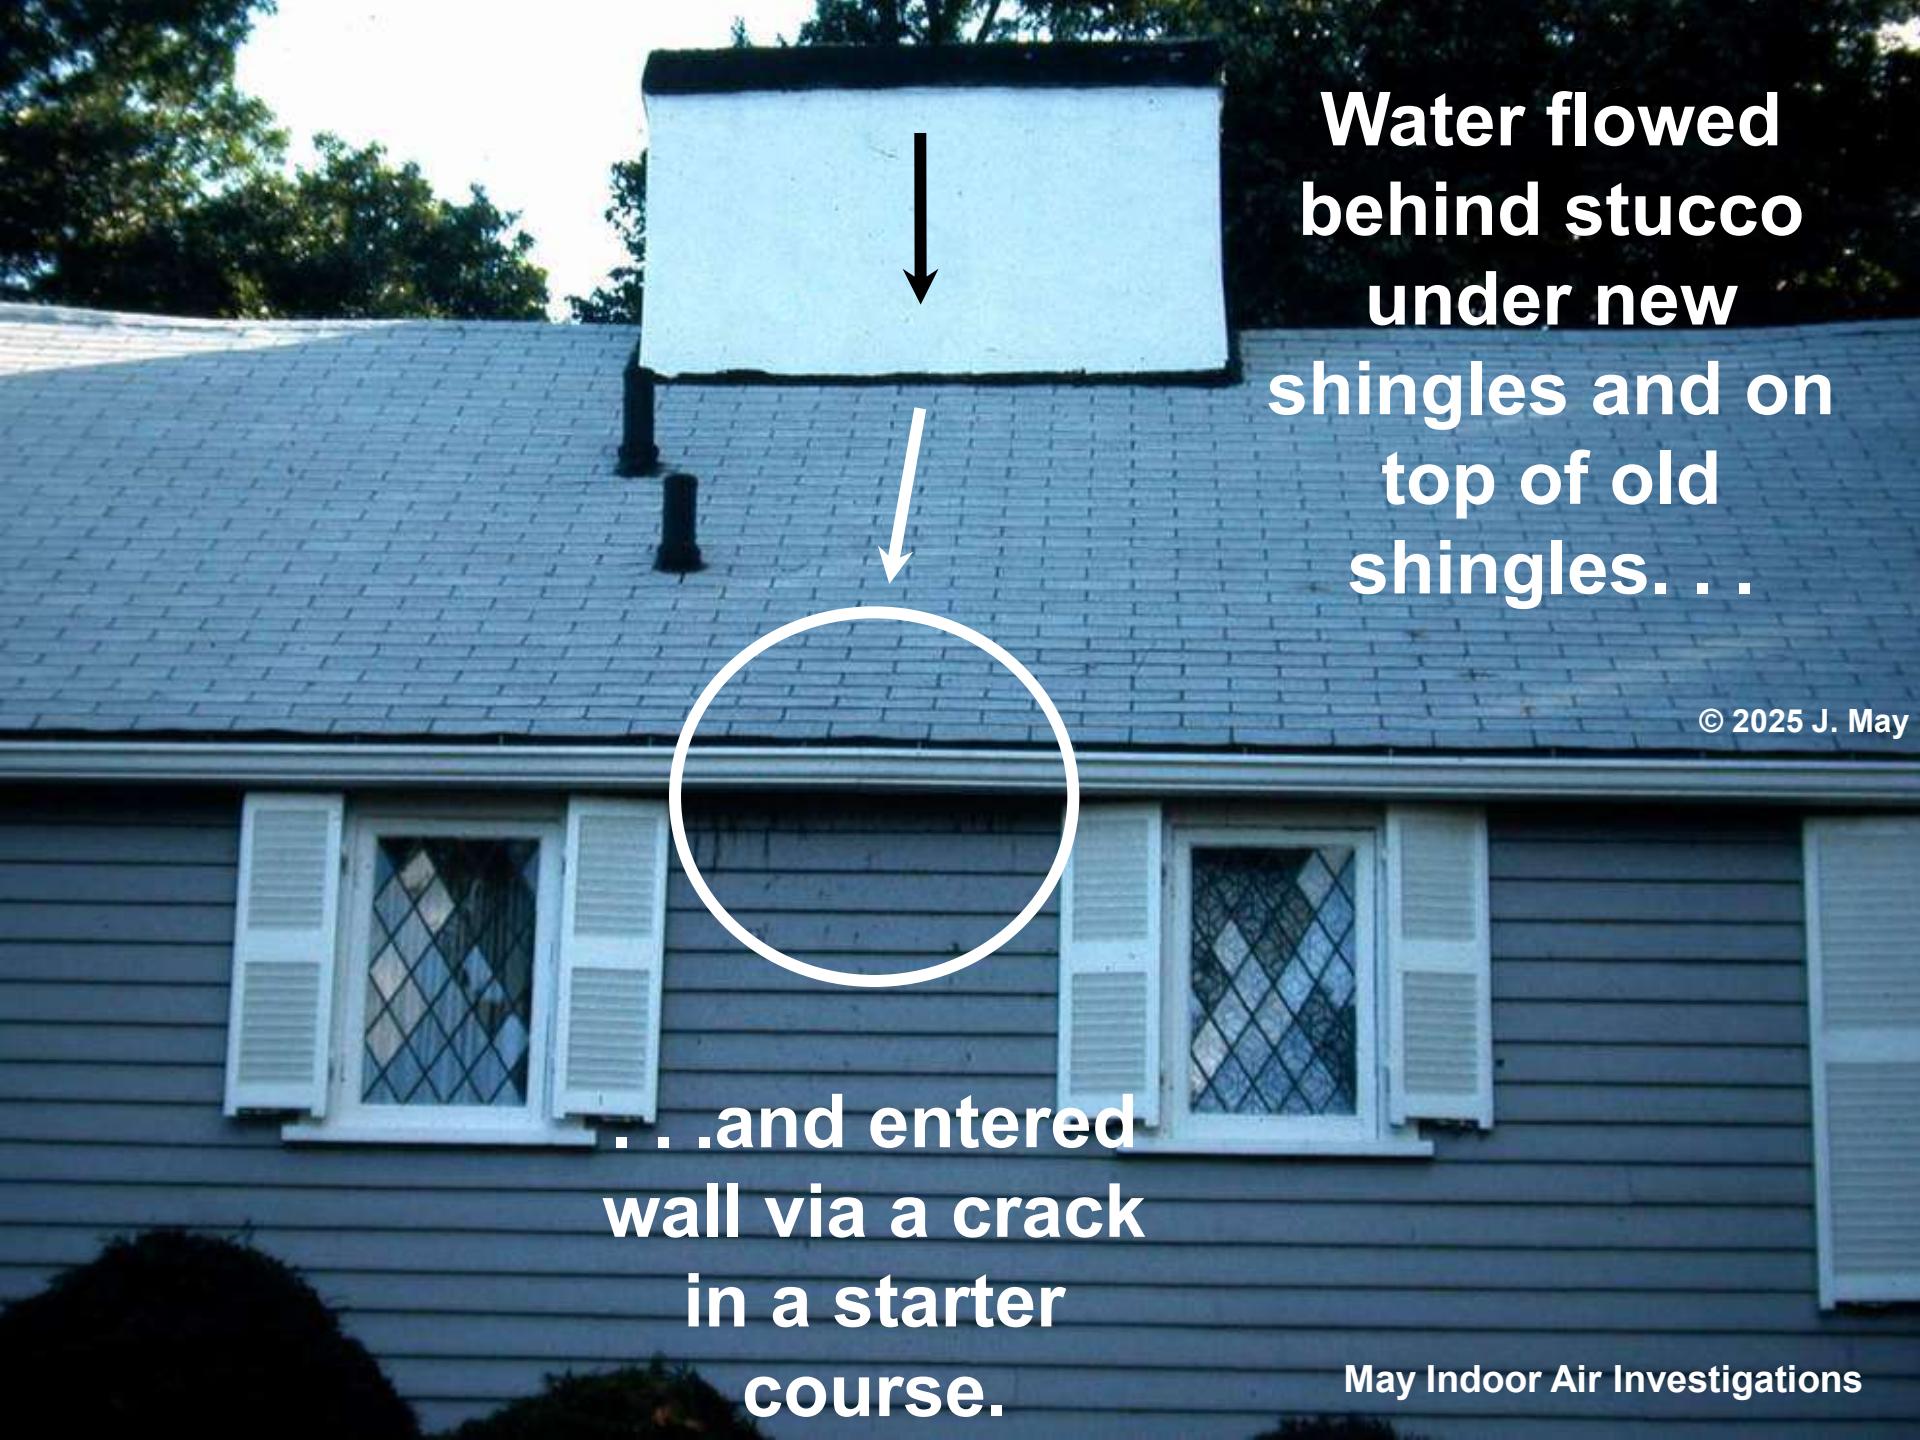
Back of house with first-time water entry

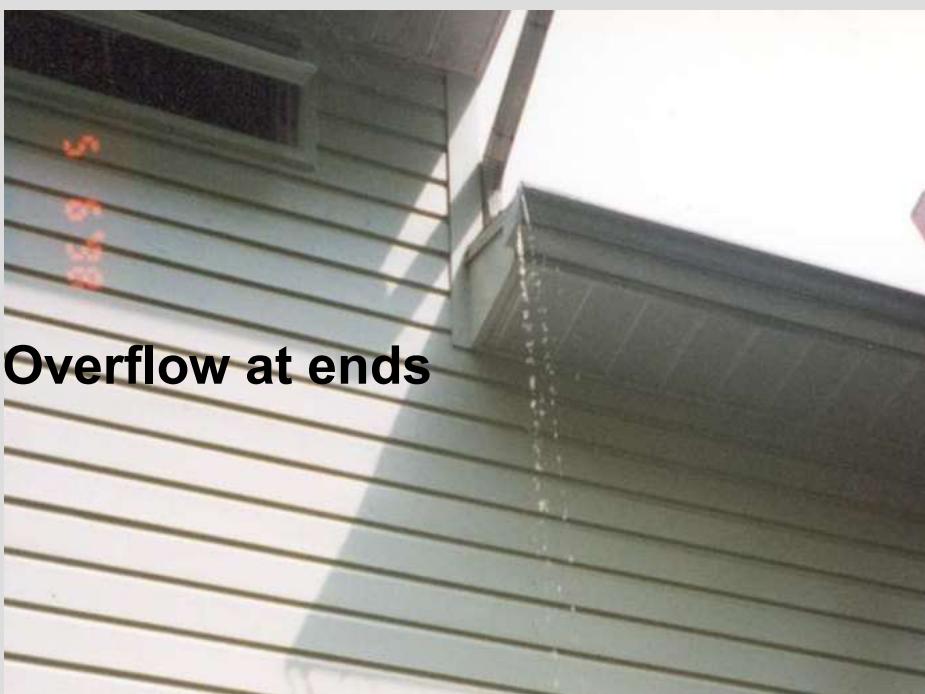
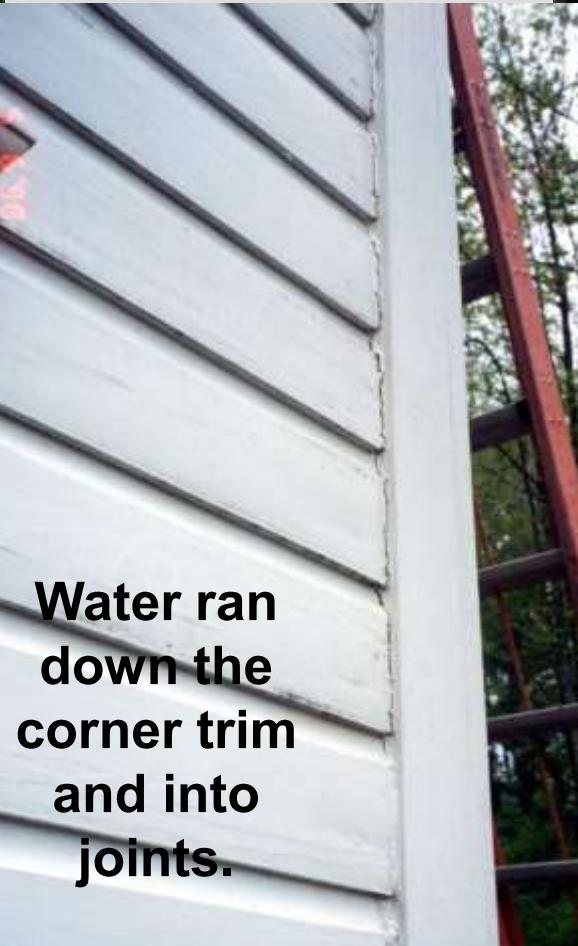
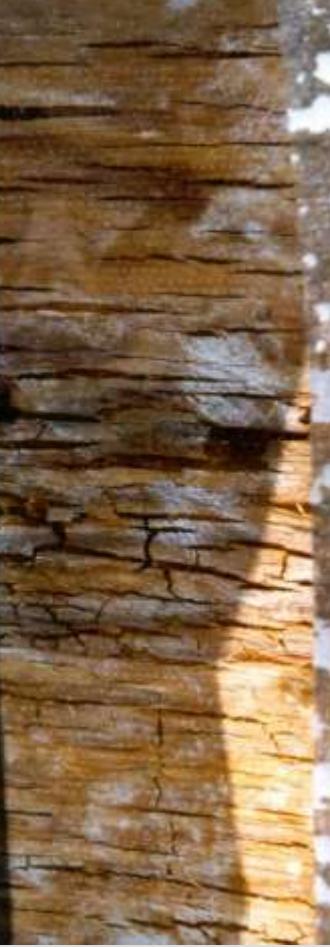
**Above:
the
decayed
sheathing
was under
the
siding.**

**Remind your clients to
keep their gutters and
downspouts clean.**

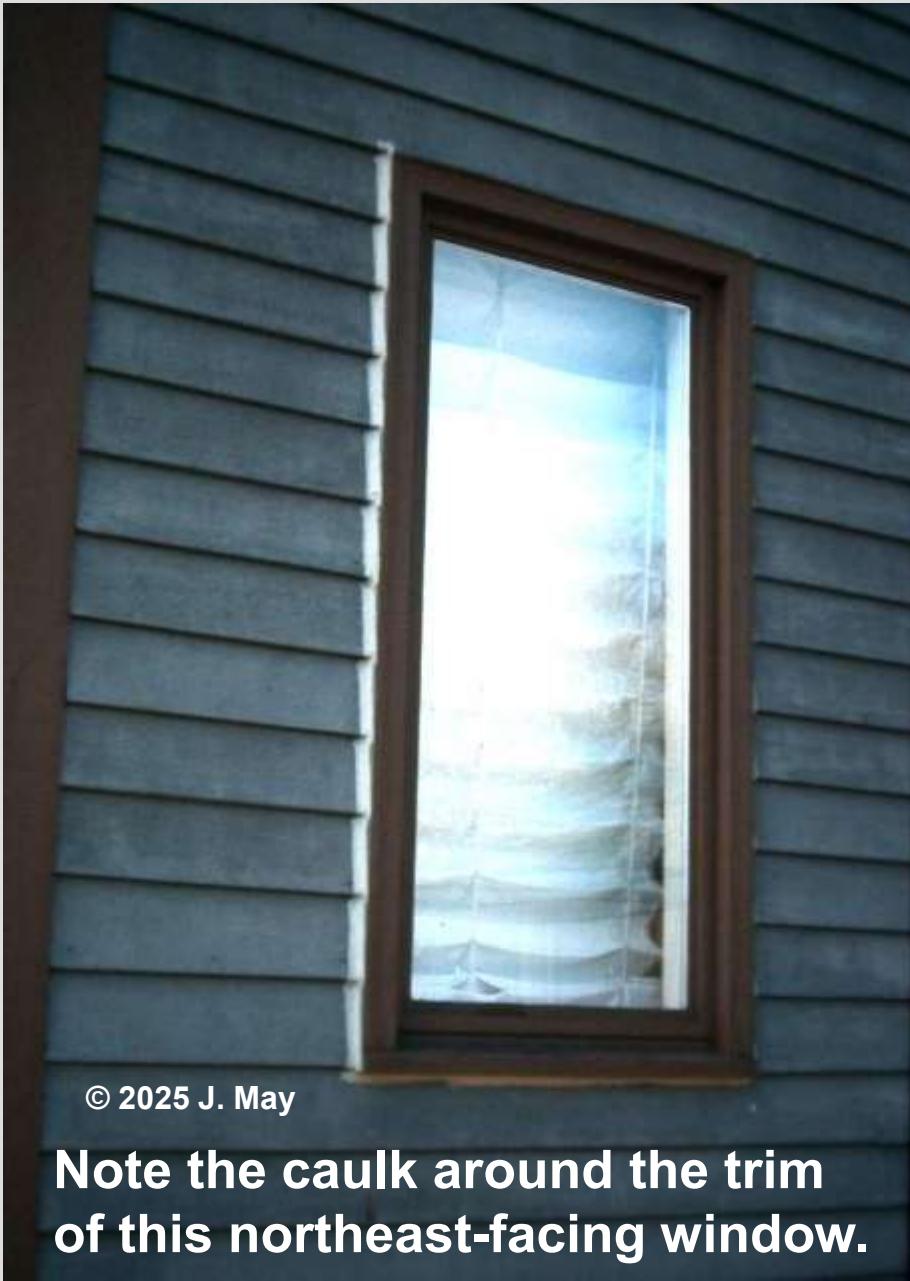
Note the caulk around the trim
of this northeast-facing window.

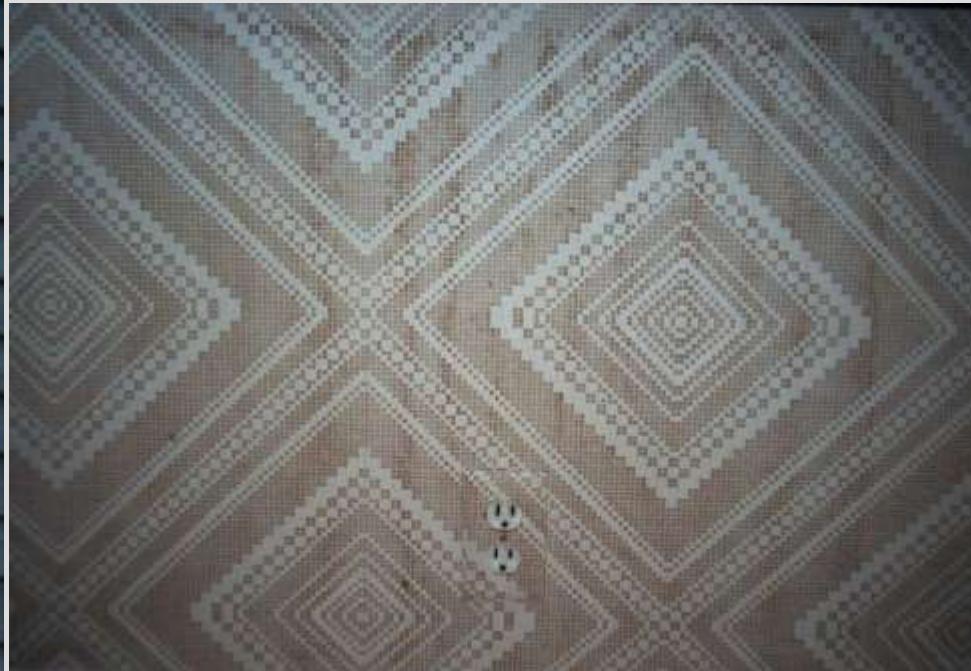
Inside, the wallpaper under the window was all stained from the leaks.

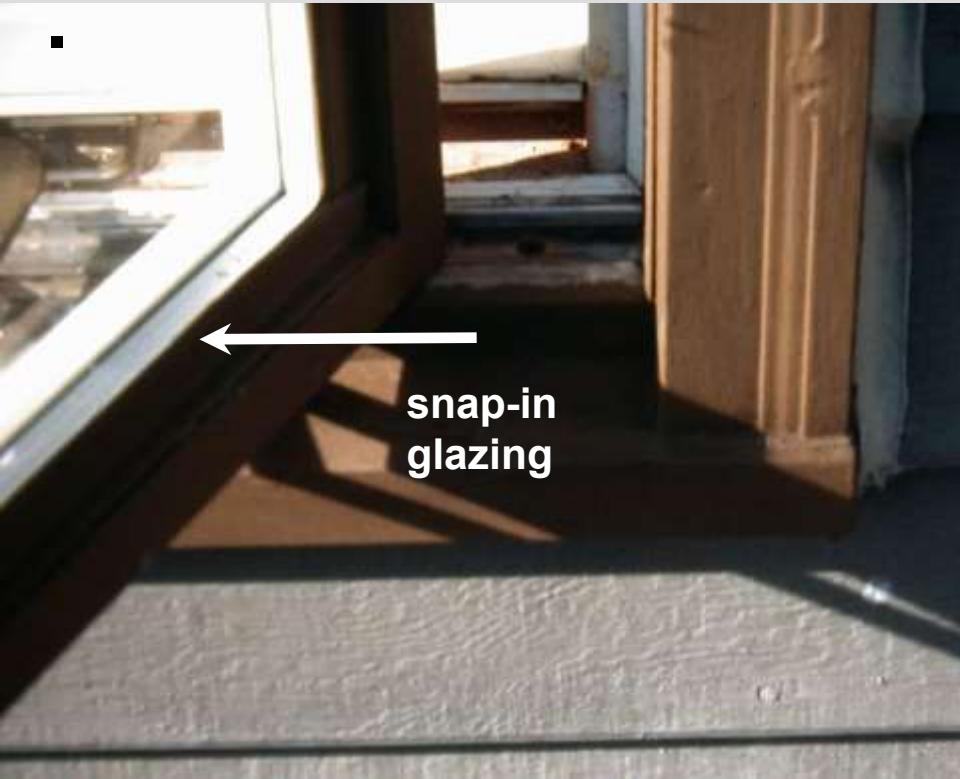
Wind-blown rain flowed down the window. .

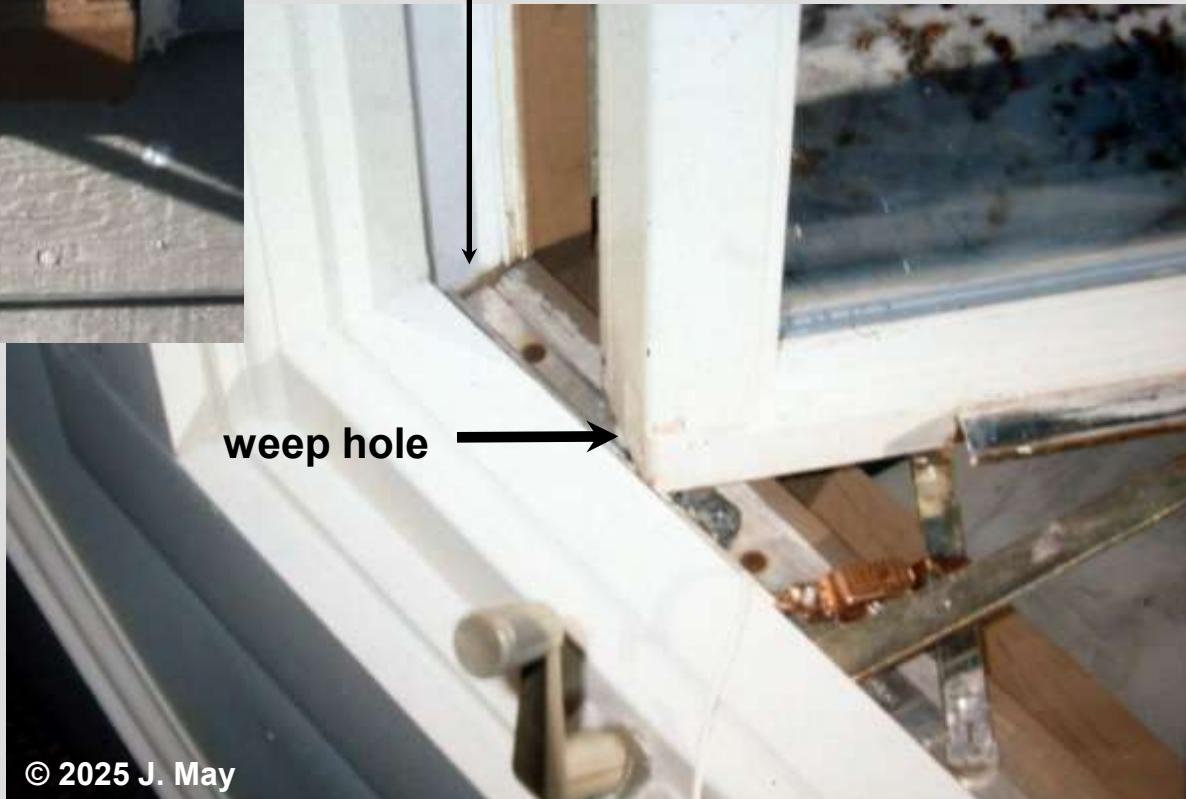
Water entry at leaky joint

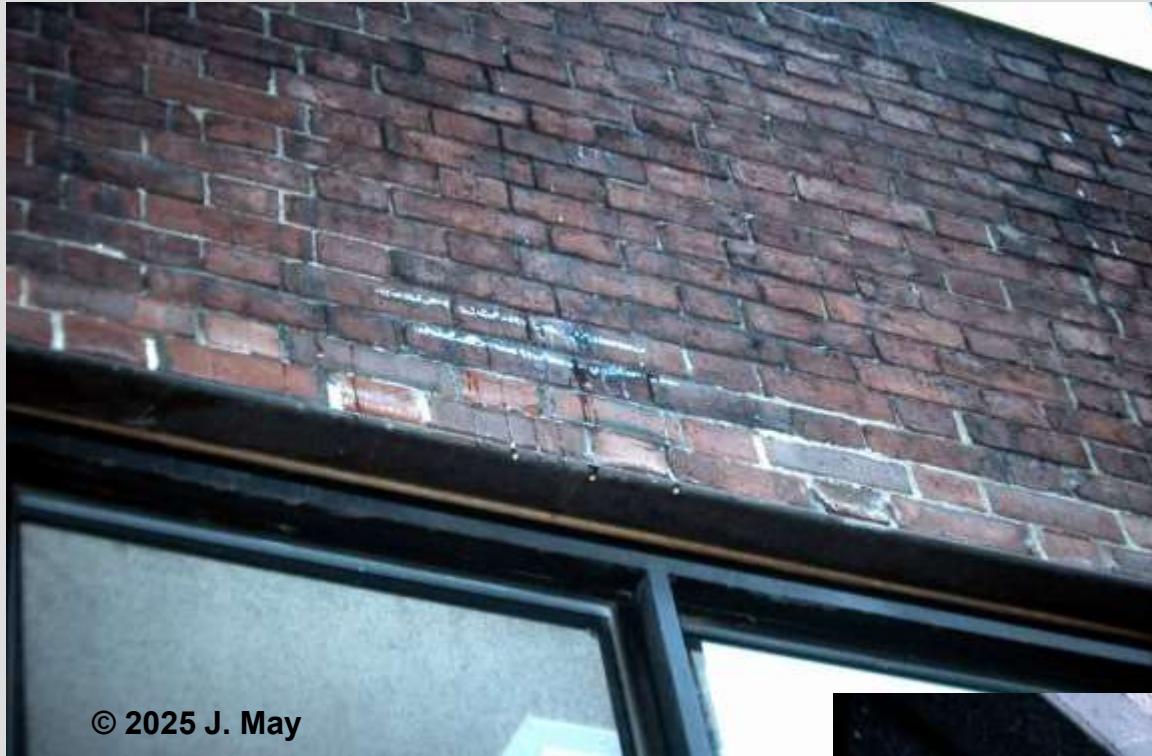
At the home above, pests and both insect and wood decay led to powerful, musty indoor odors. Water entered the wall between the separate window units.

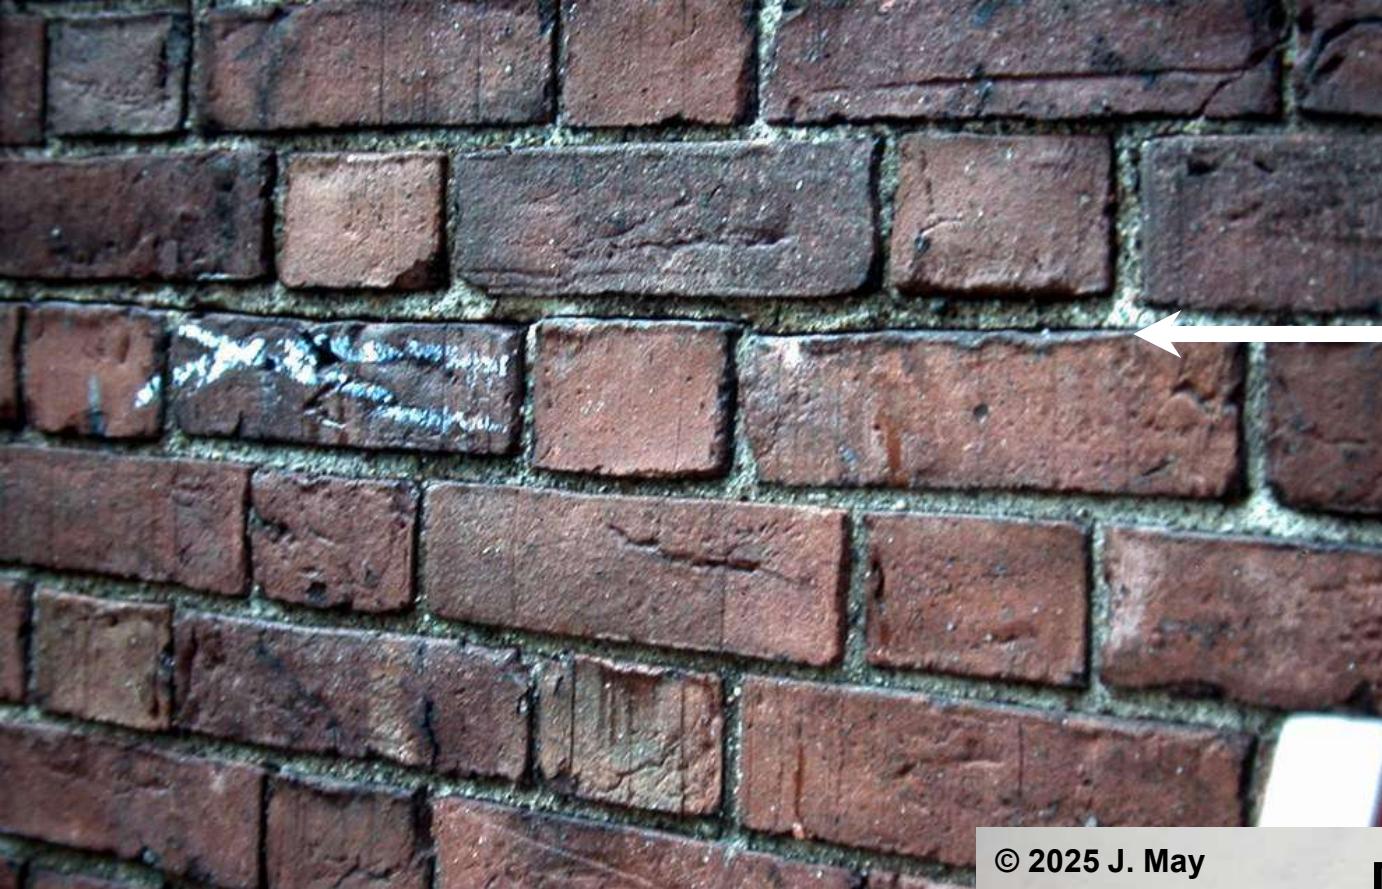
There was a long crack in the mortar joint a few courses above the window.

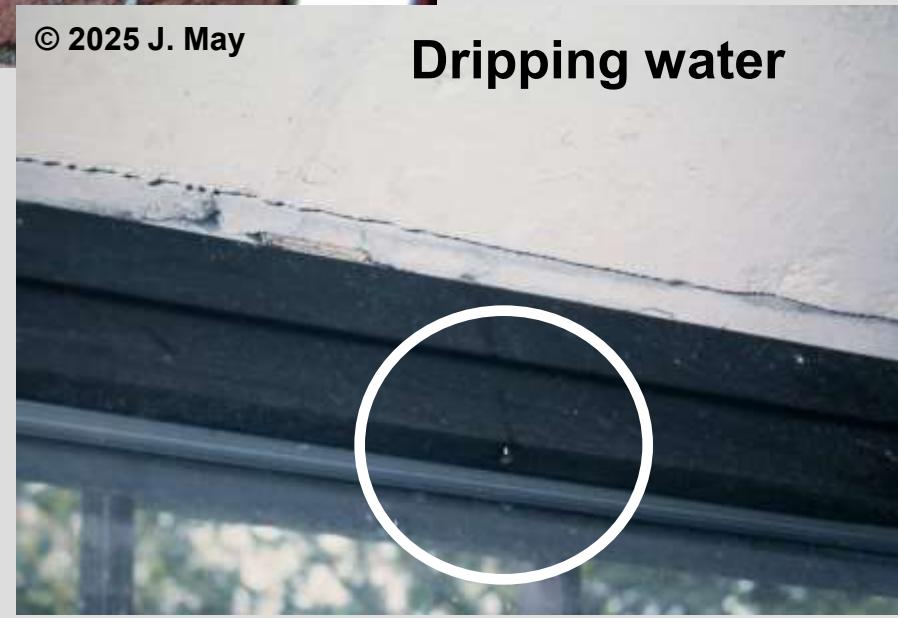
Dripping water

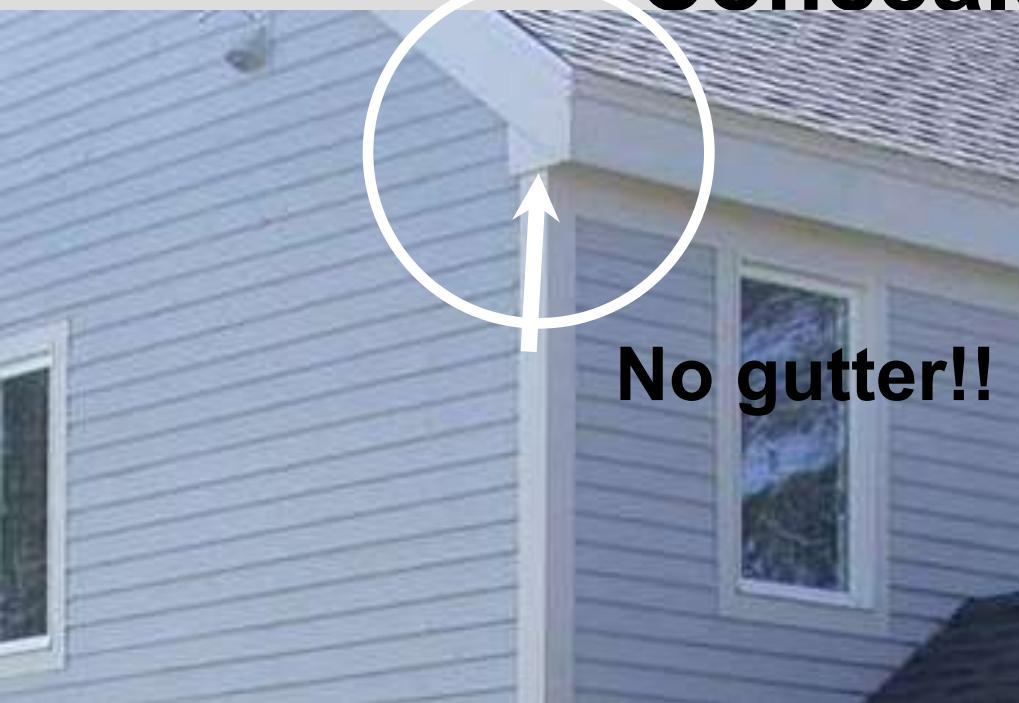
**Return sloped
improperly at
bottom edge**

**Visibly decayed
clapboards**

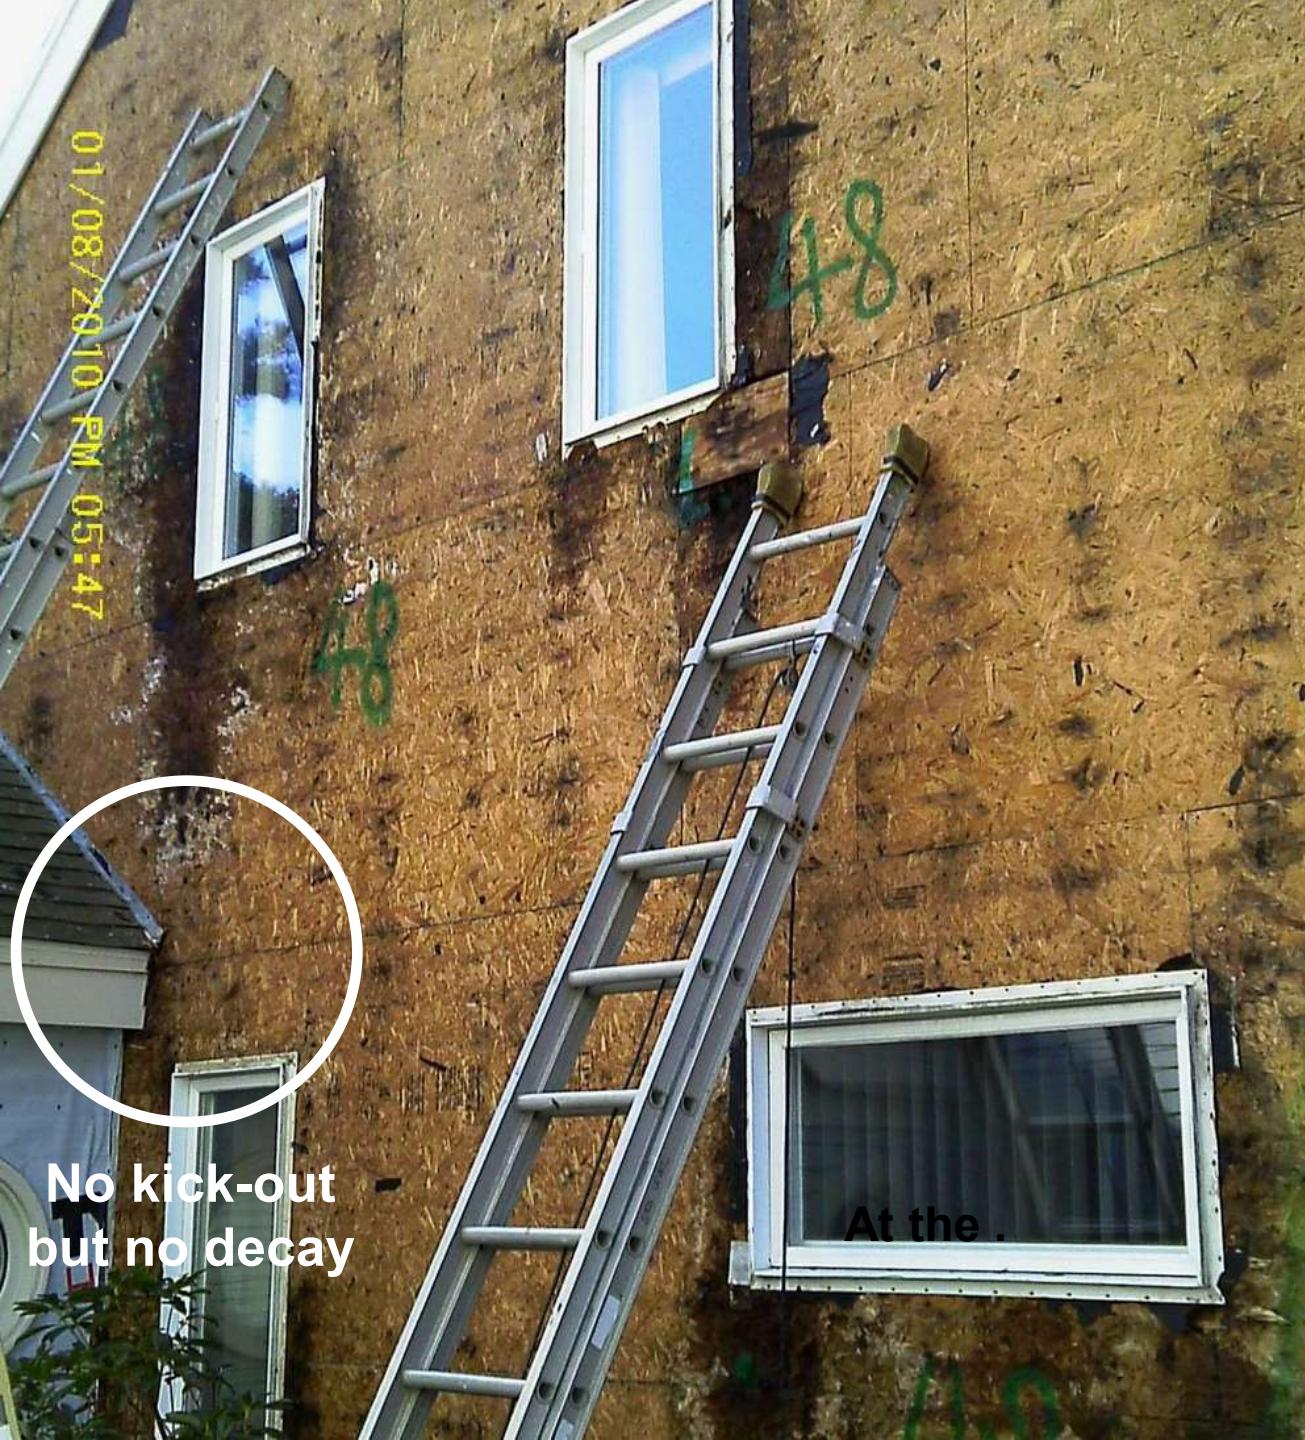
- Window-pitch effect on flow
- Staining at nail penetrations

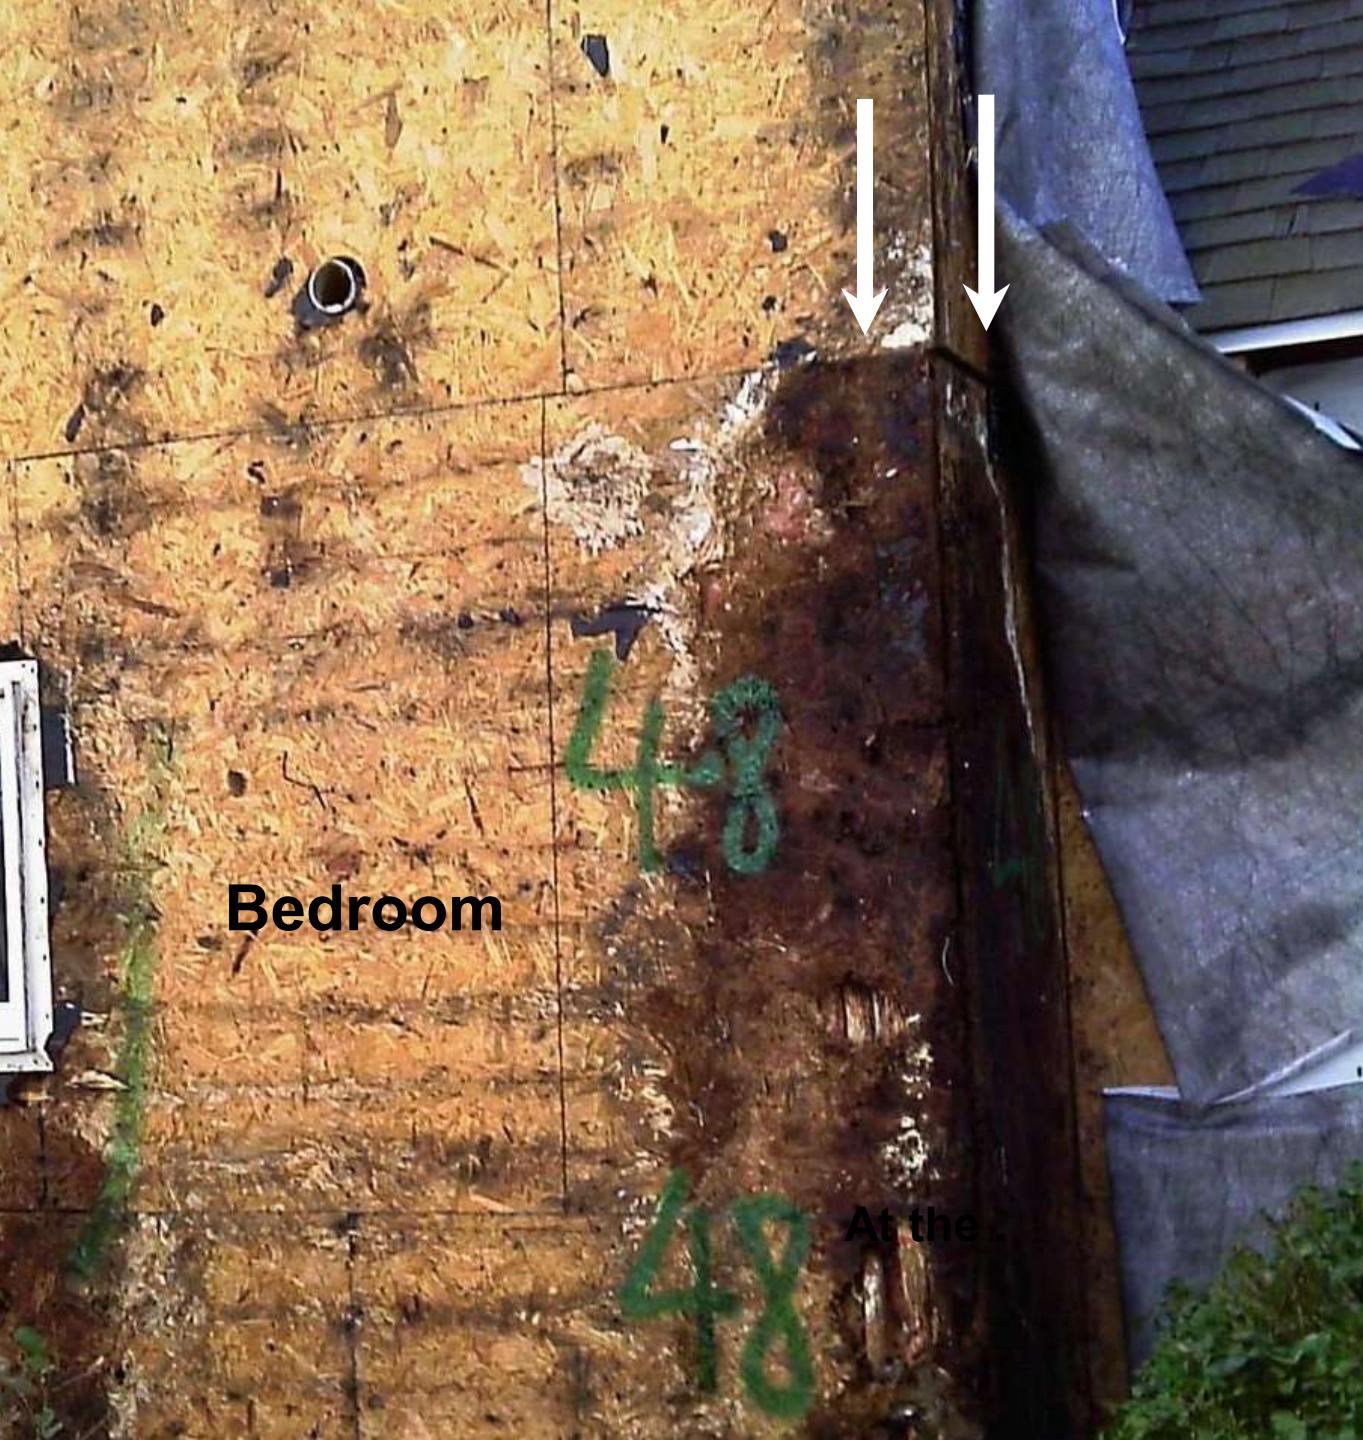
Water flows by capillary action behind OSB at joint.

**White hyphae
delineate flow.**

Build with ample overhangs

Gutters

Kick-out flashings

Don't set nails in too deeply

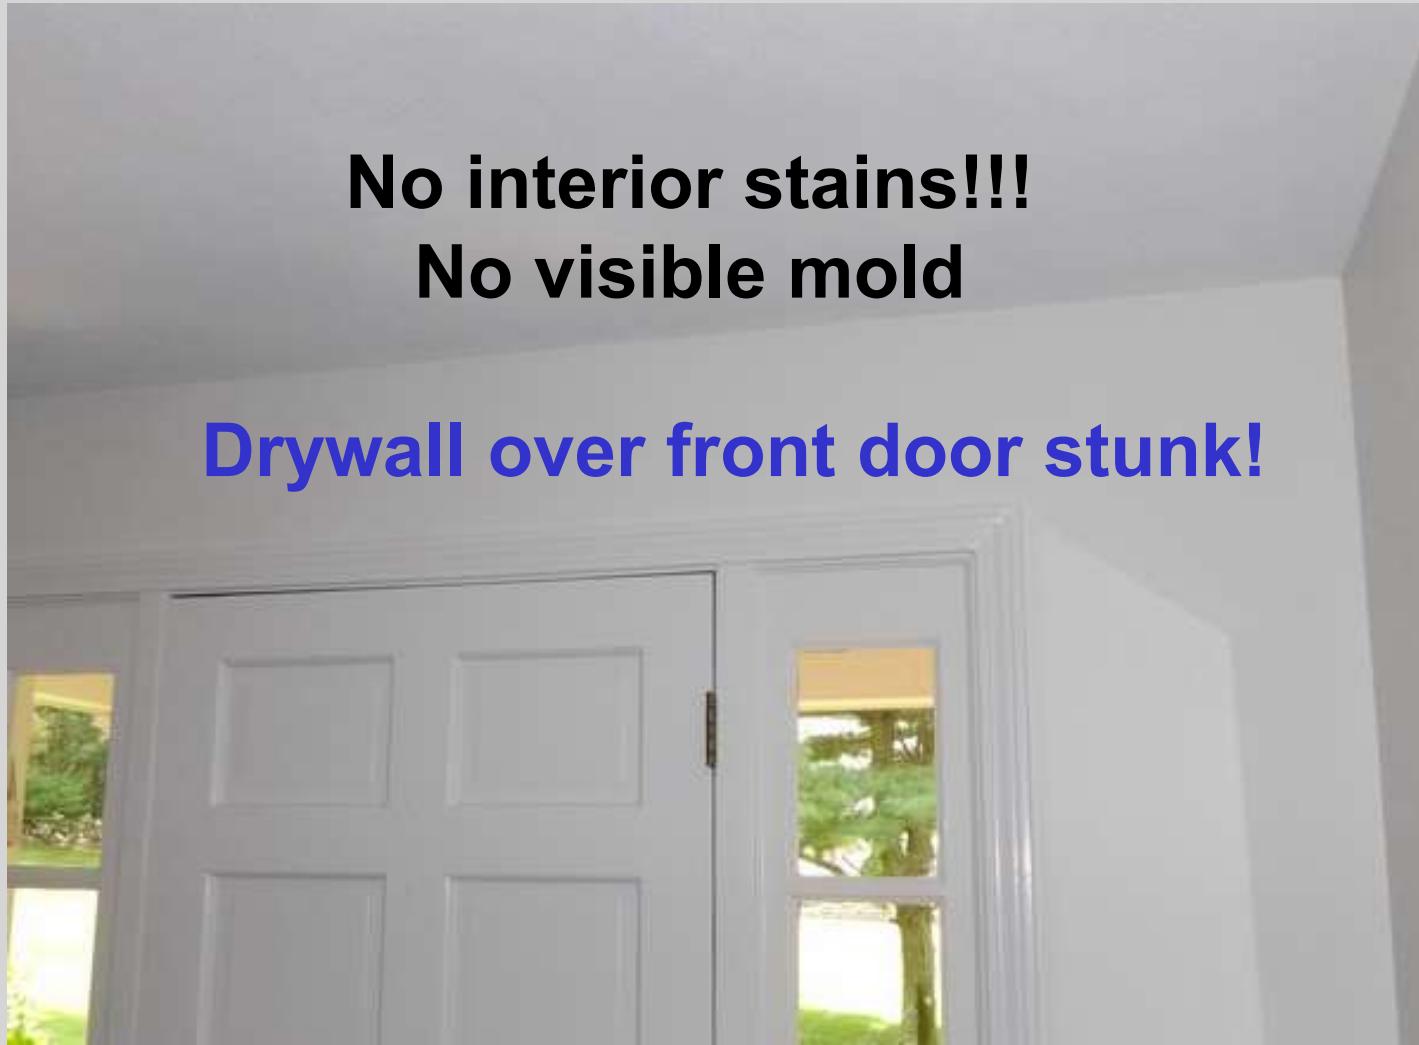
Elevated moisture content in drywall under 2nd floor window over entry

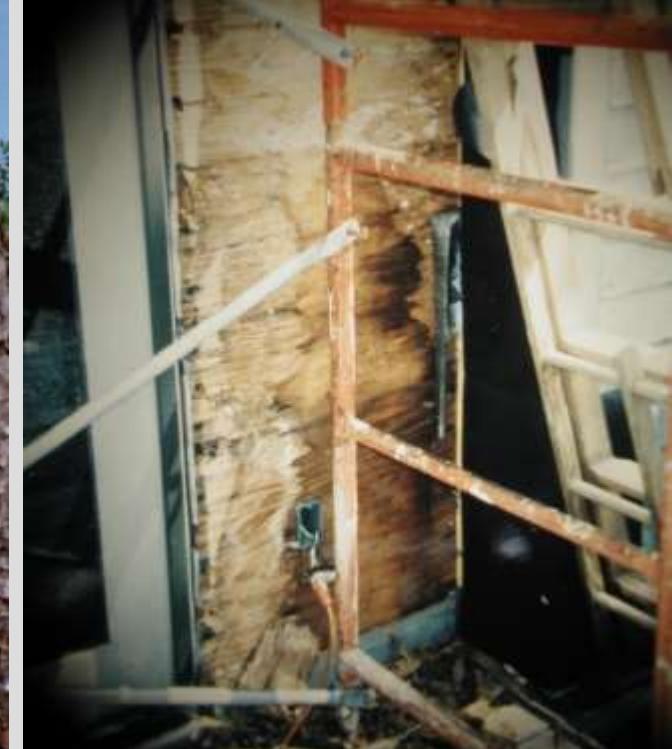
No roof overhang or gutters!

Decayed sheathing

This house must have overhang or gutters!

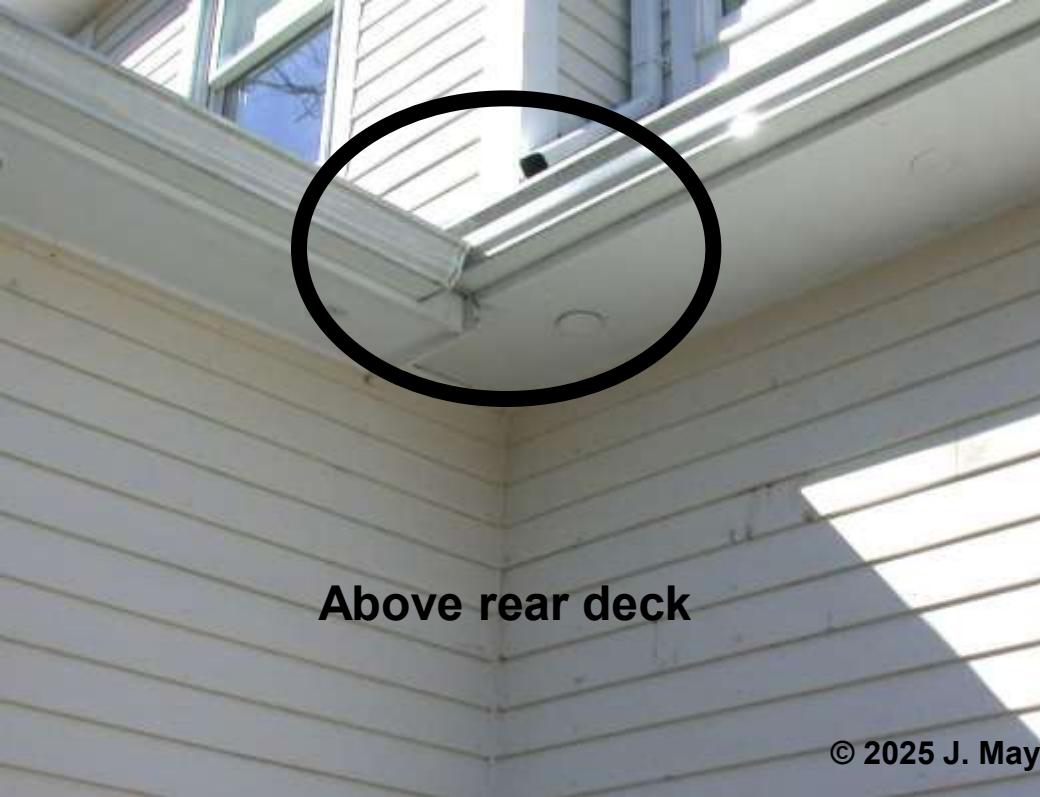
Above rear deck

Discoloration due to cedar extractive stains is characteristic of water entry behind the clapboards.

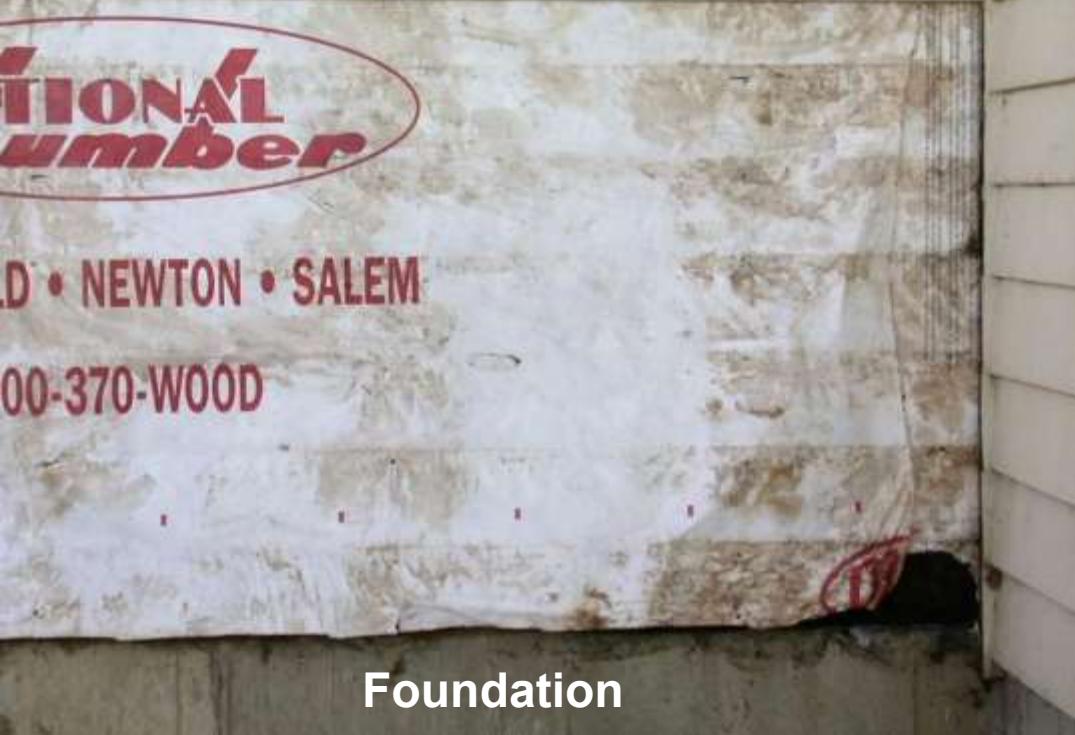
**The OSB sheathing
was rotted by decay
fungi and there was
mold growing on the
housewrap.**
