Jeffrey C. May

May Indoor Air Investigations LLC
Tyngsborough, MA

Moisture and Leak
Investigations

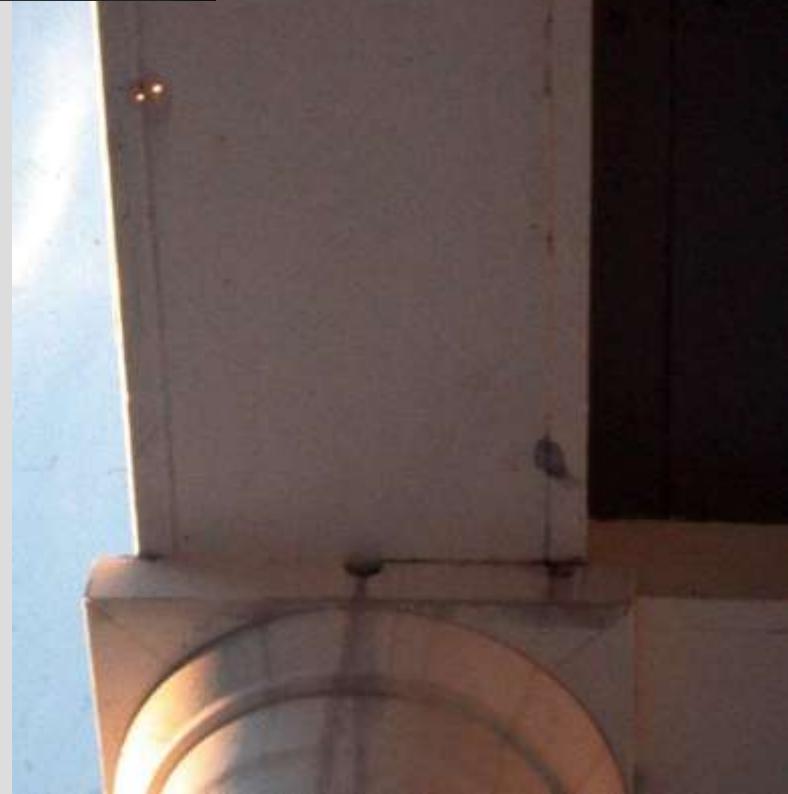
Eight years after construction, all the siding was replaced.

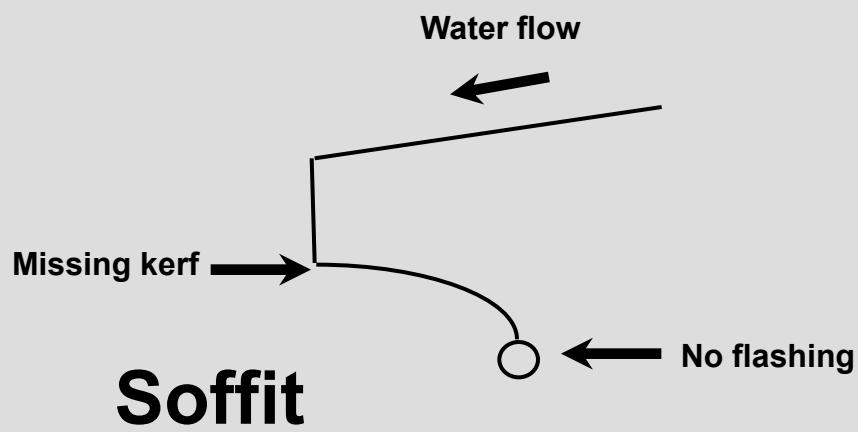
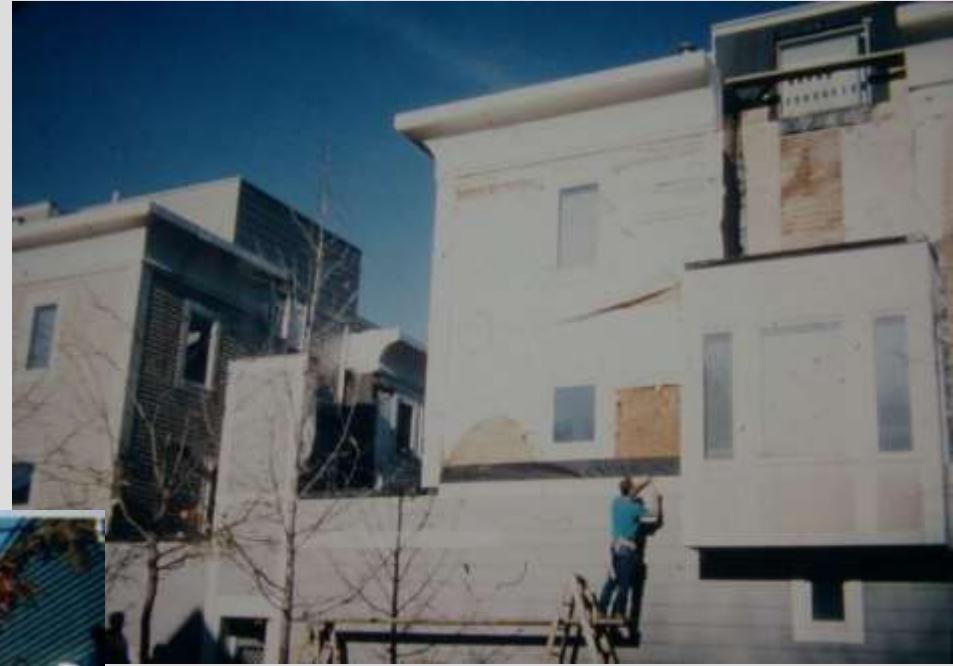
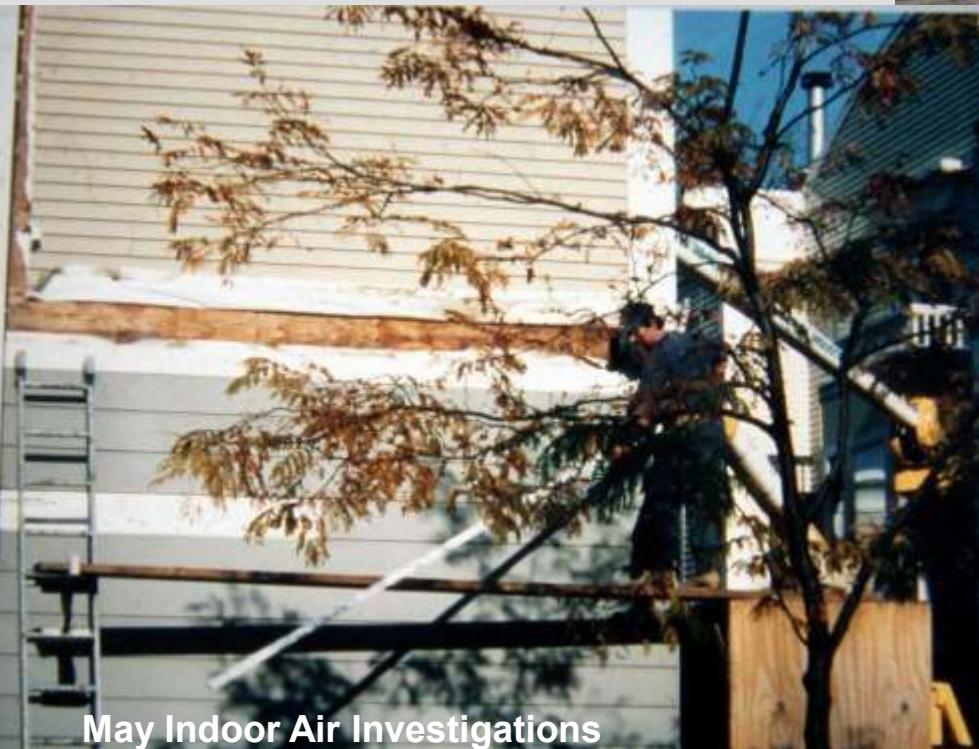
Originally, there was no flashing or caulk at the half-round trim beneath the soffit, which shed roof water down the concave curve and into the wall.

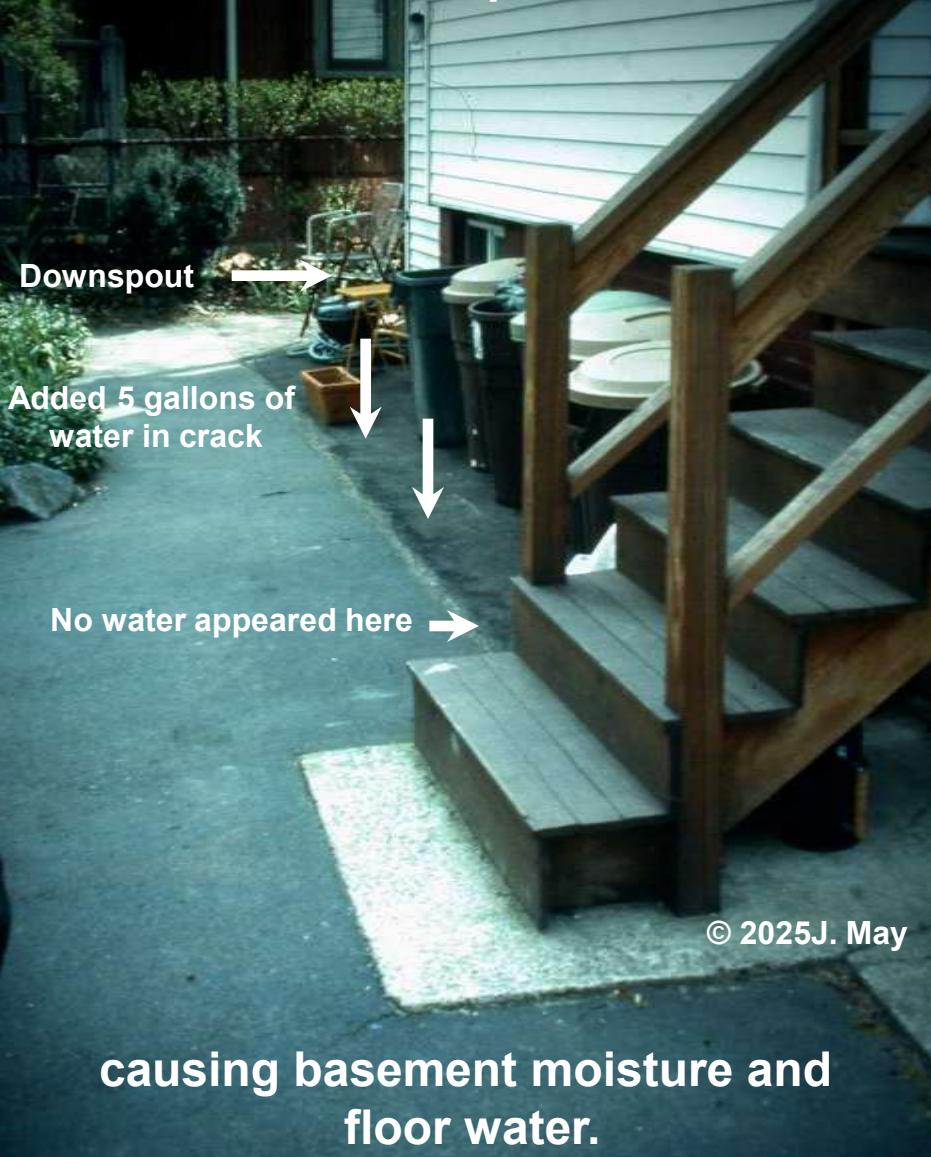
Roof water flowed into the 1/8th inch crack between the asphalt and concrete,

Grade surfaces so that water flows away from the foundation.

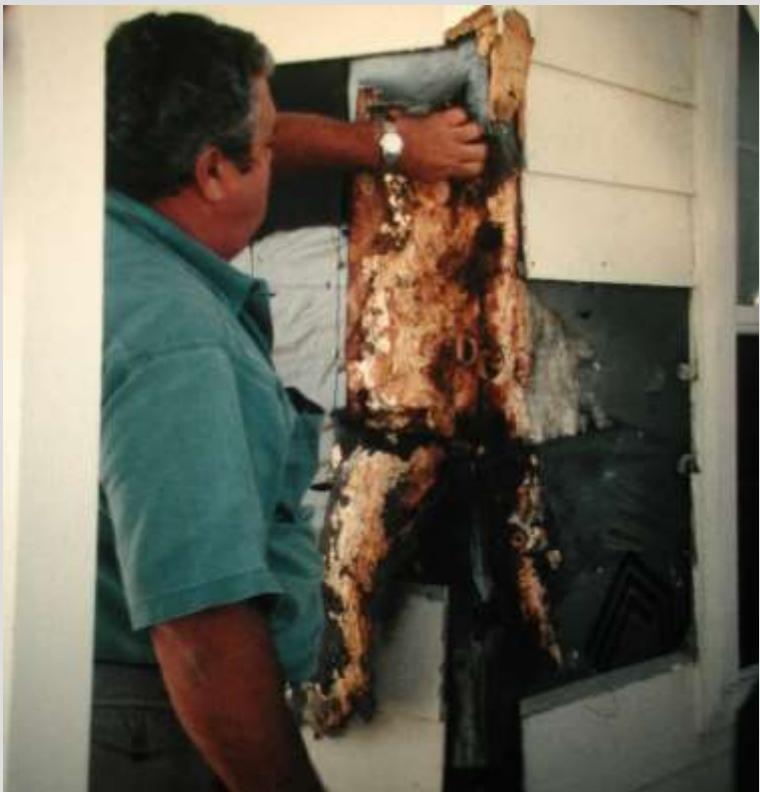
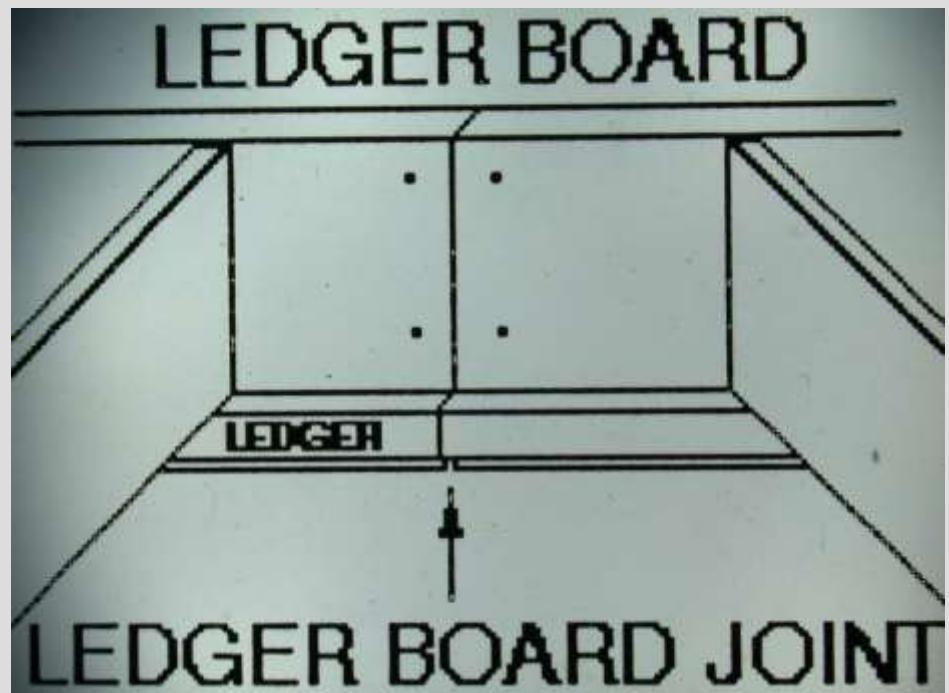
The severe decay at the three year-old building was due to water penetration at a joint and a lack of flashing at the deck ledge.

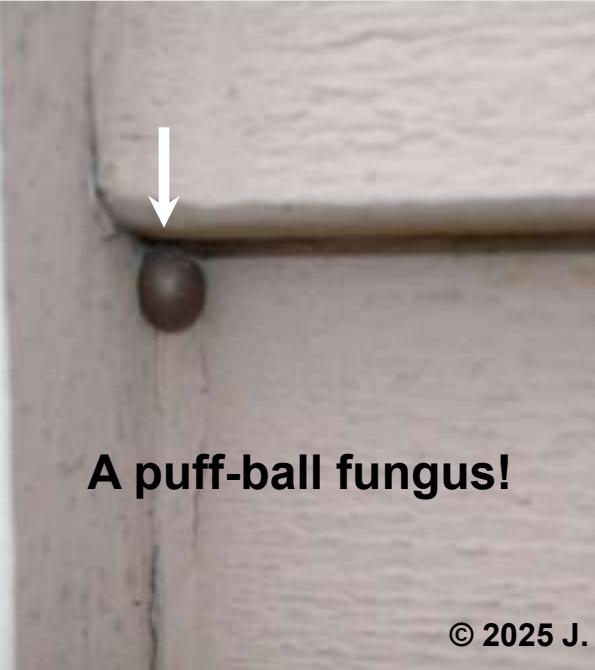
Cedar extractive stains

A puff-ball fungus!

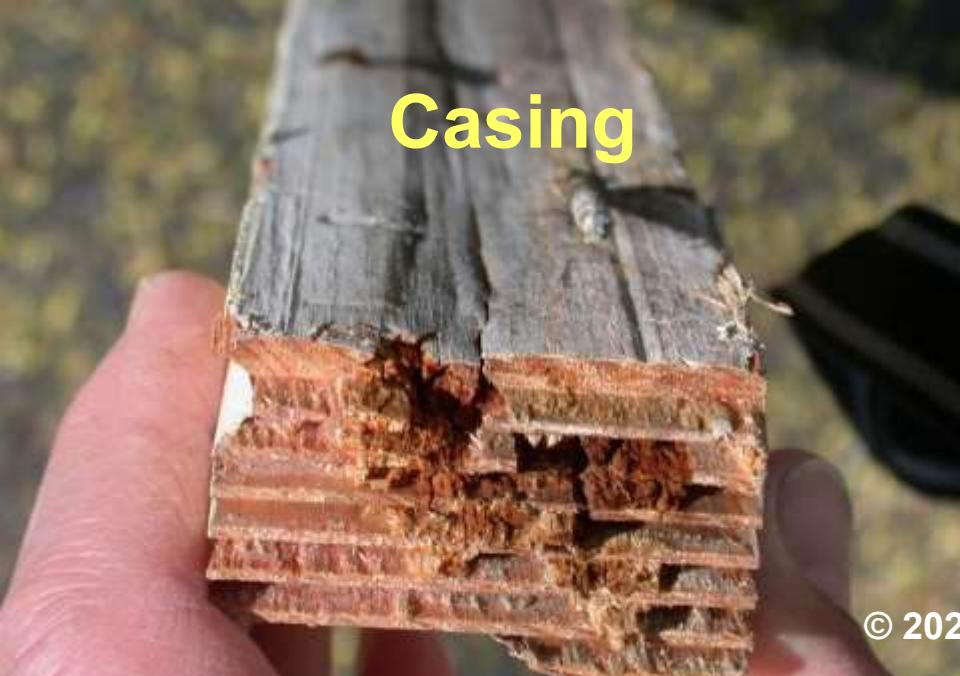
The decayed casing from the left side of the window was removed.

Even the framing lumber at the side of the window was rotted. The rough window opening was never flashed.

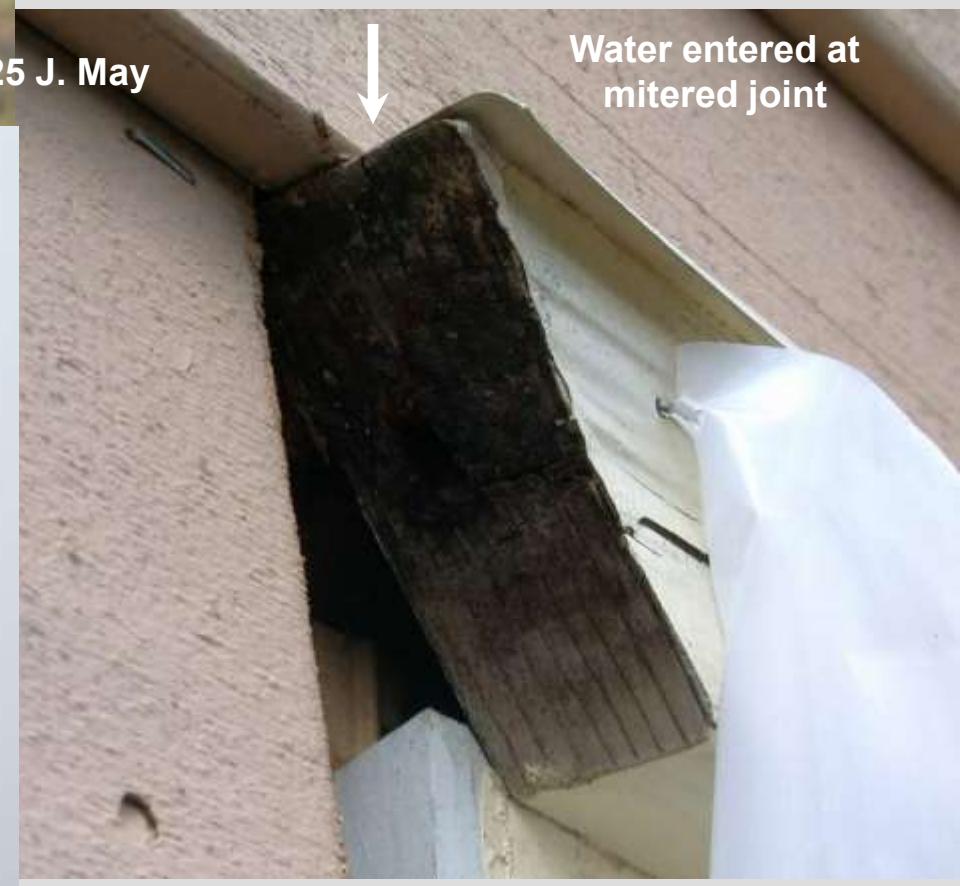
Water entered at mitered joint

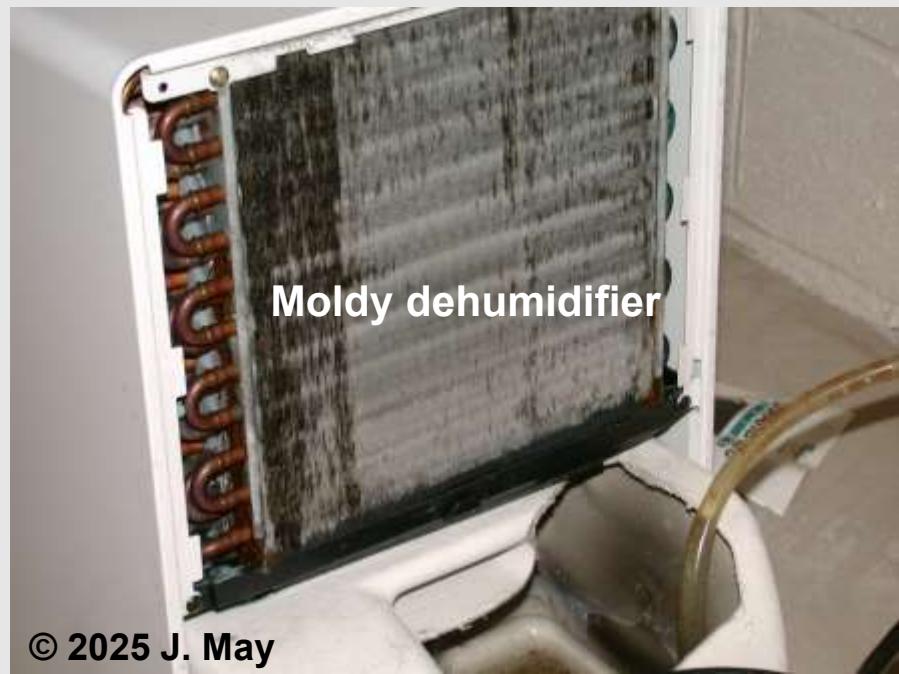
Moldy dehumidifier
