The First Frontier in Home Weatherization: Attics and Cathedral Roof Slopes

By: Henri Fennell, CSI/CDT

© H C Fennell Consulting, LLC 2025

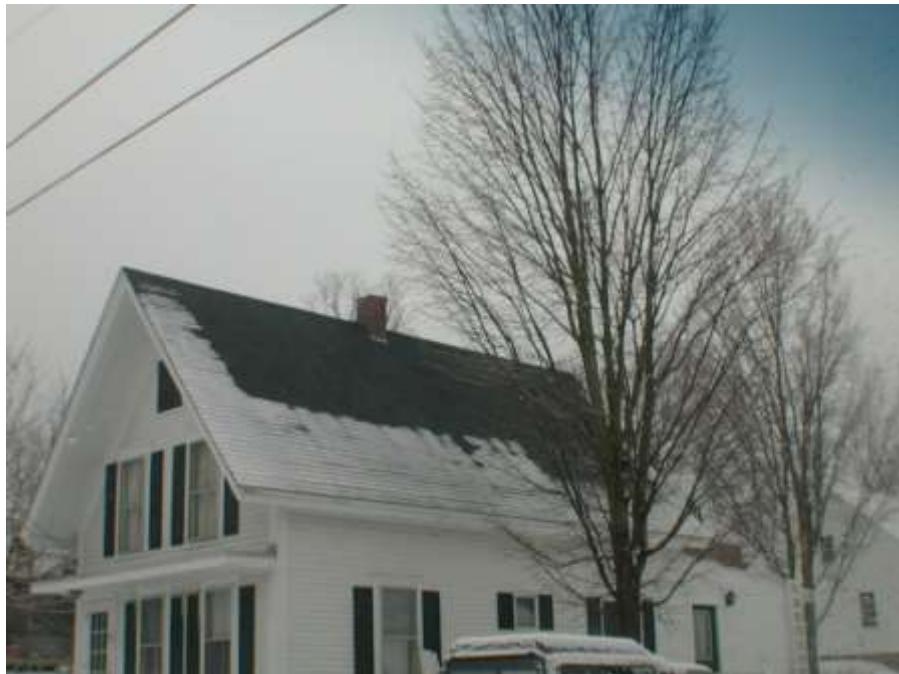
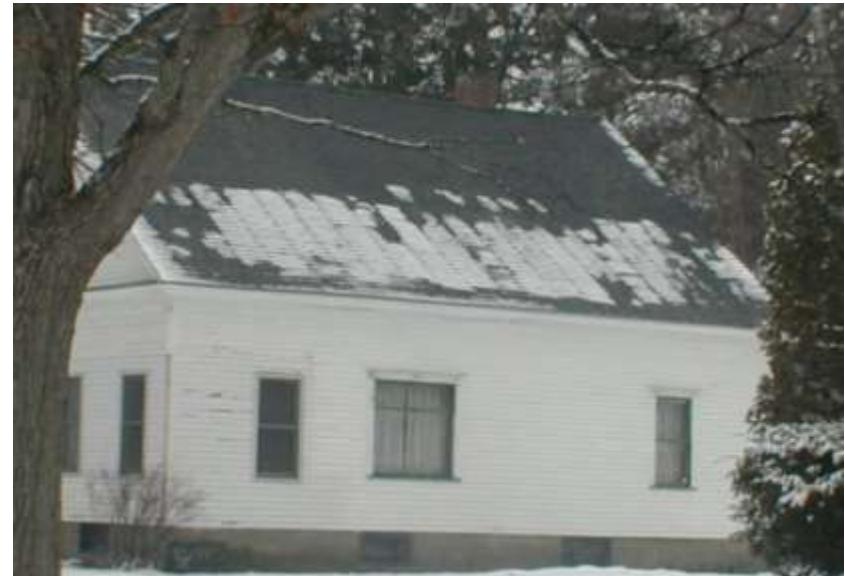
Classic cathedral slope melt pattern below a leaky attic's melt pattern

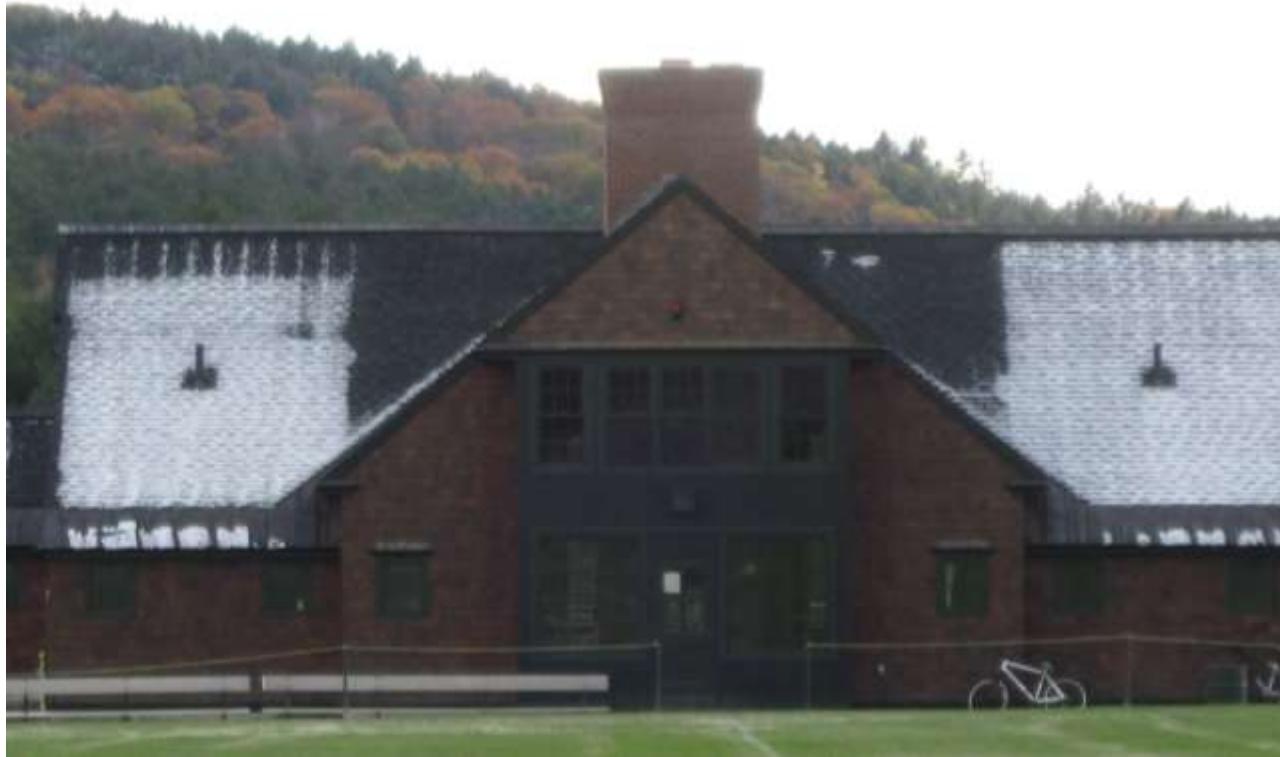
Melt pattern shows insulation and air leakage problems in attics vs. cathedral roof slope performance

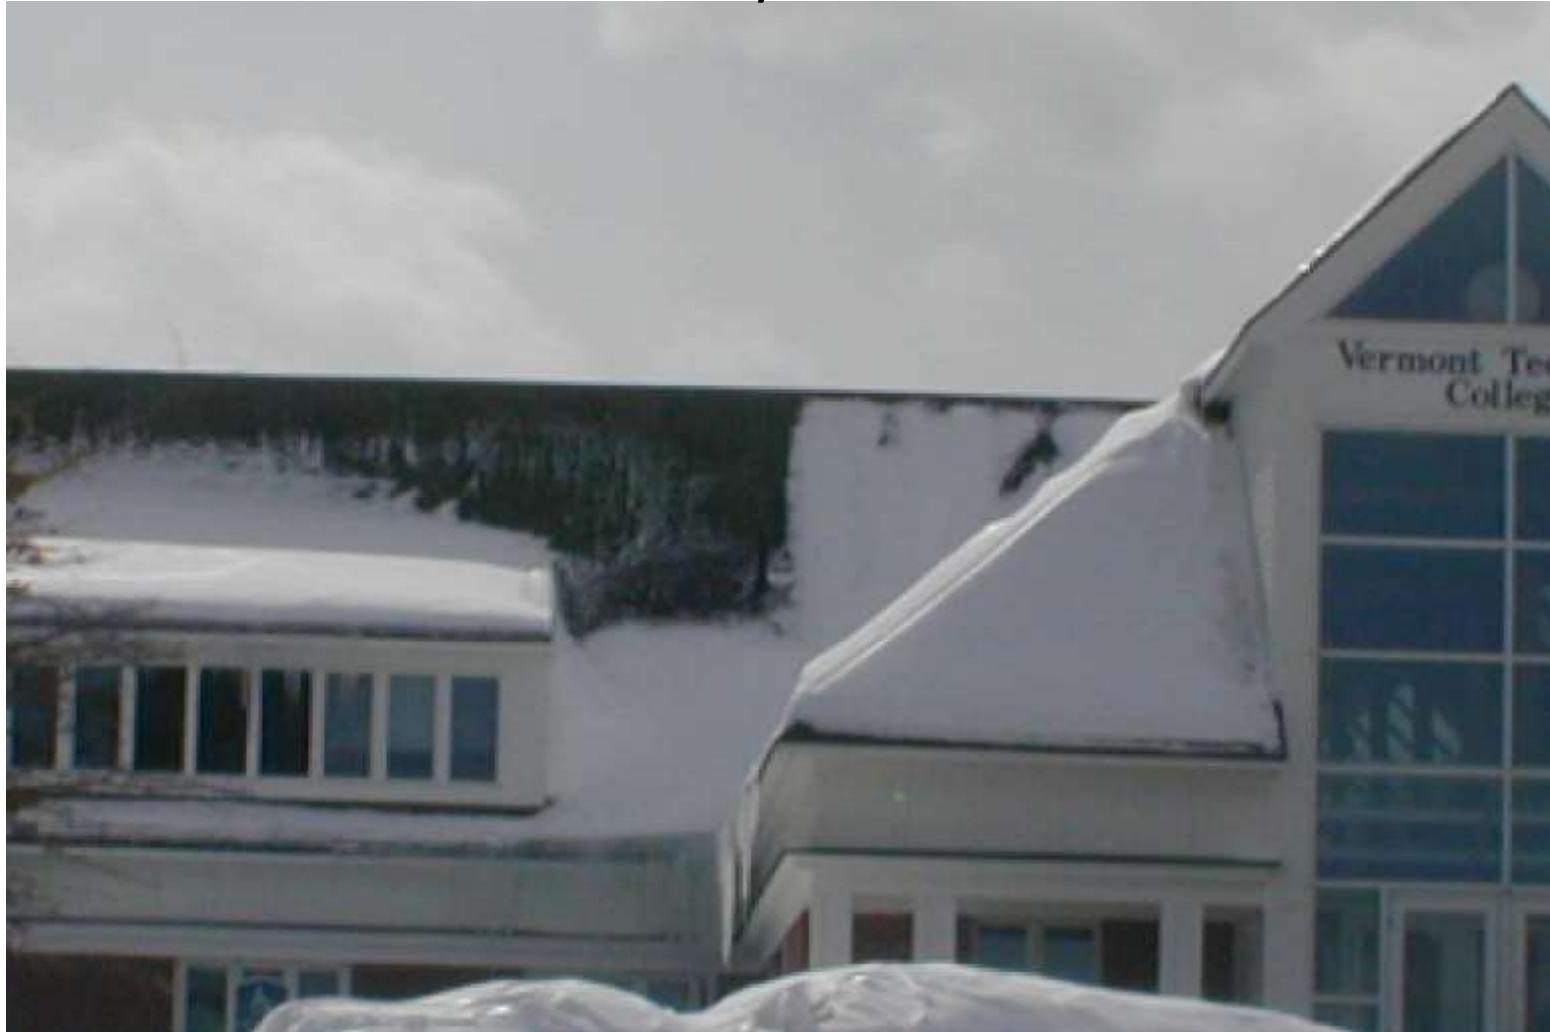
Classic icing at the bottom of cathedral slopes below
leaky attics

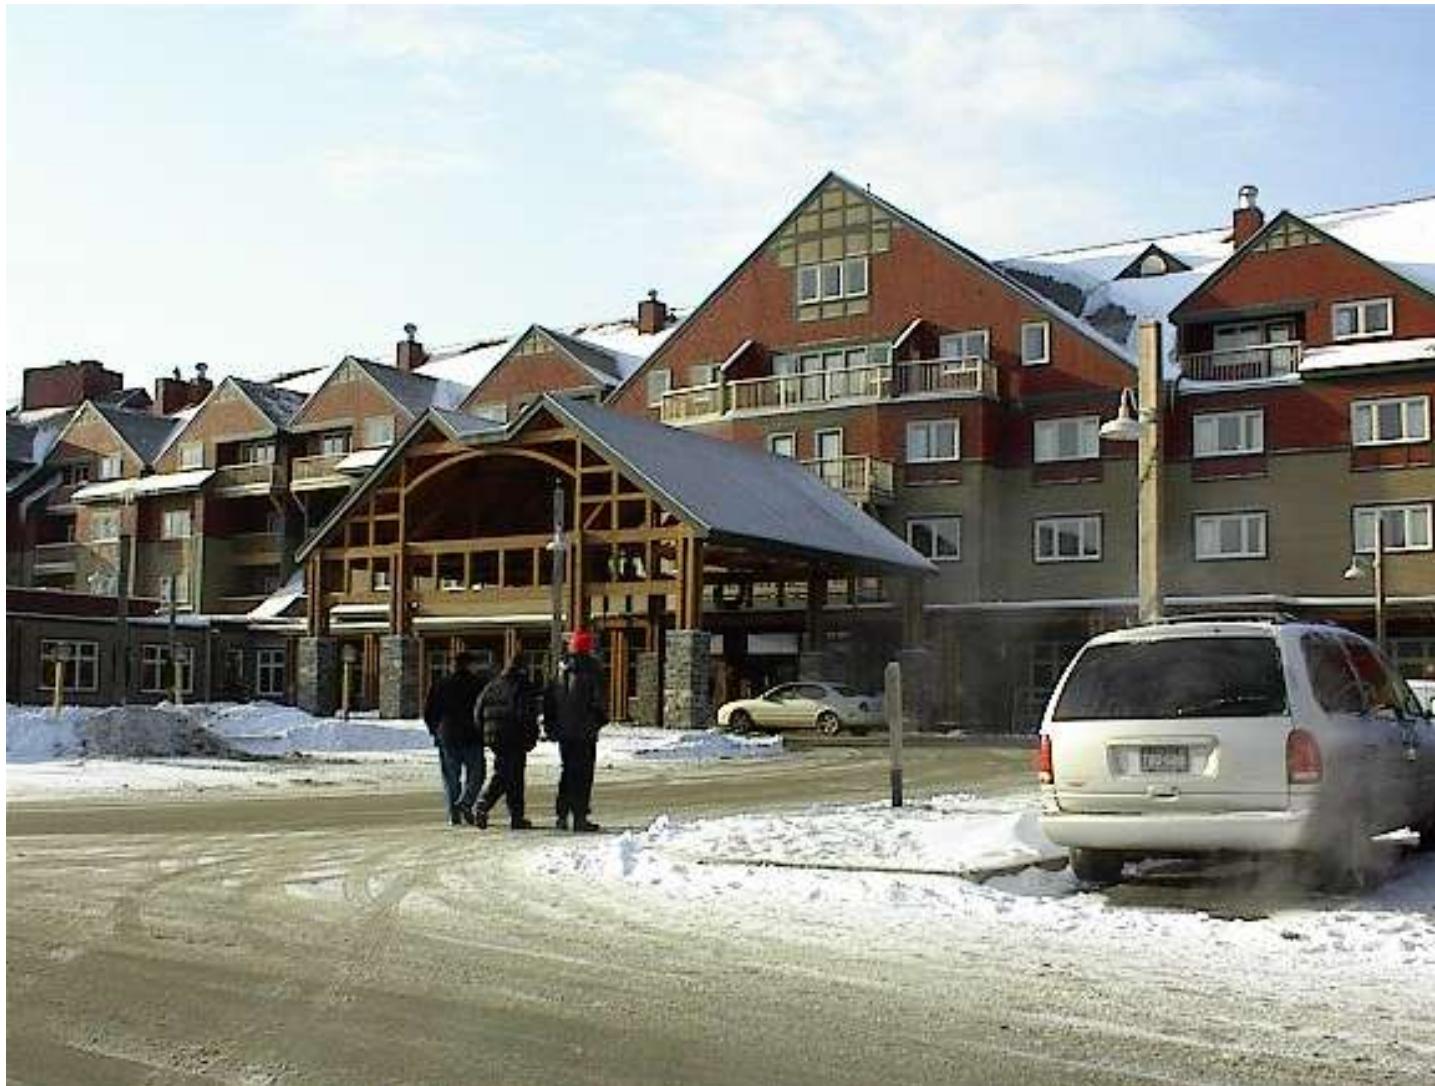
Attic designs that don't account for even distribution of inlets and outlets

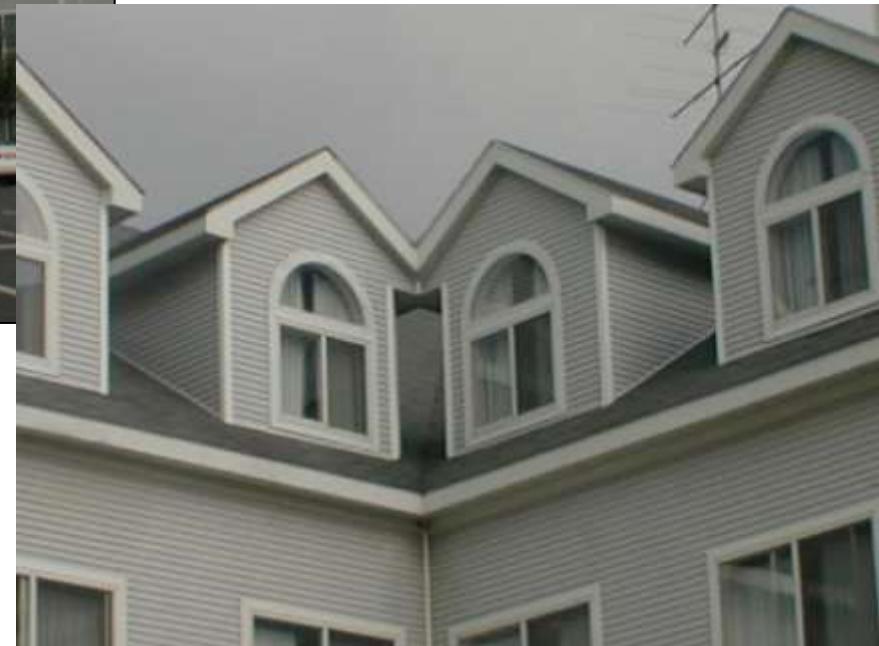
If a vented roof type is chosen - size, balance, and distribute the ventilation system carefully.

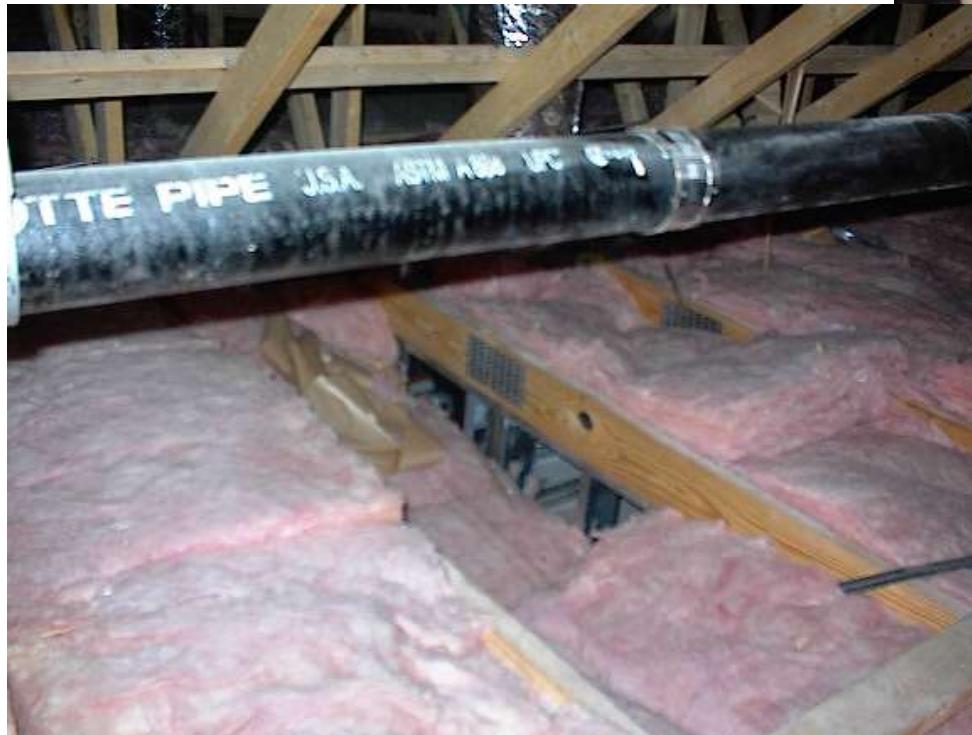
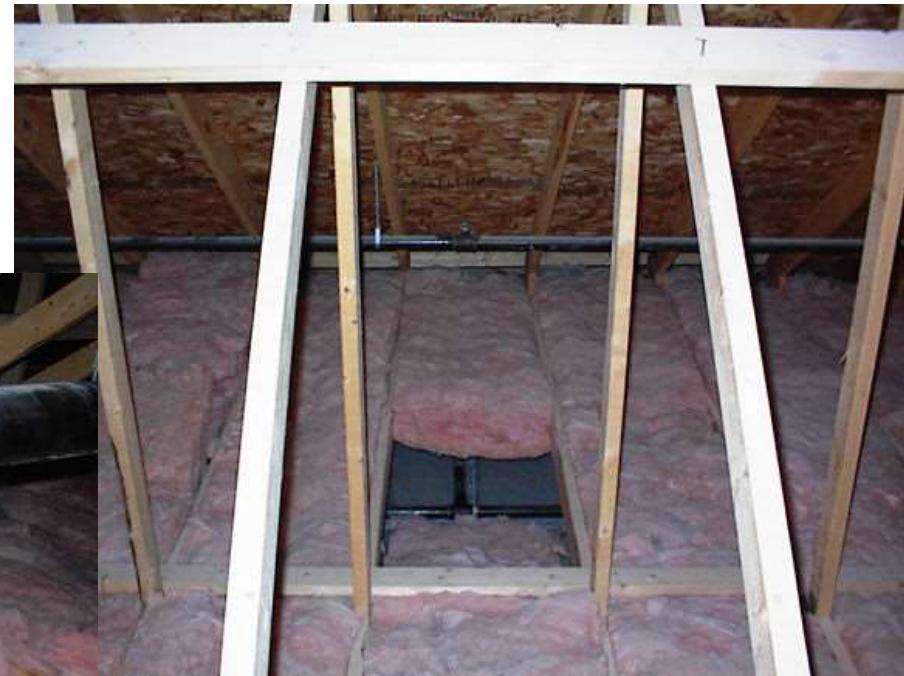
Large plenum spaces under air flow retarders can conceal the location of air leakage sources by distributing the flow over large areas

Openings in air flow retarders appear to be the locations of large air leakage sources with most diagnostic tools

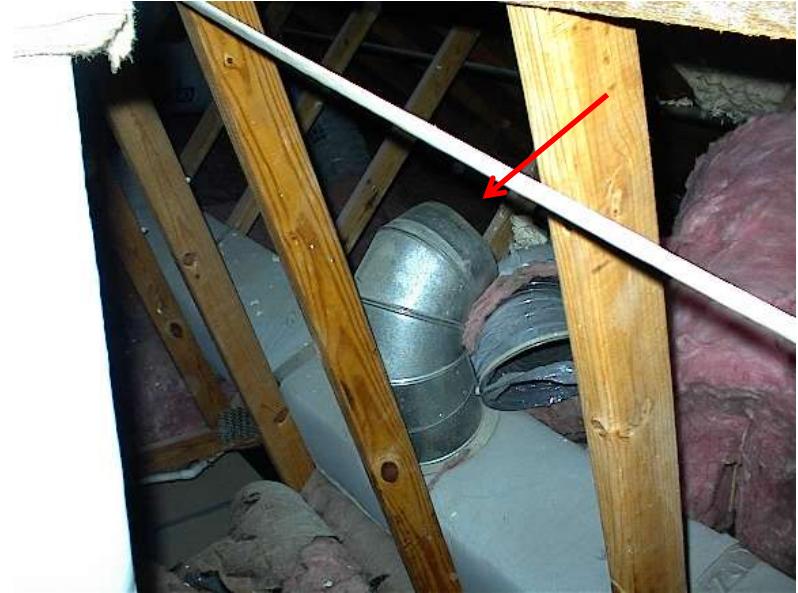
Mechanical systems leaks

Difficult access in attics can compromise the ducts. Move them inside the envelope!

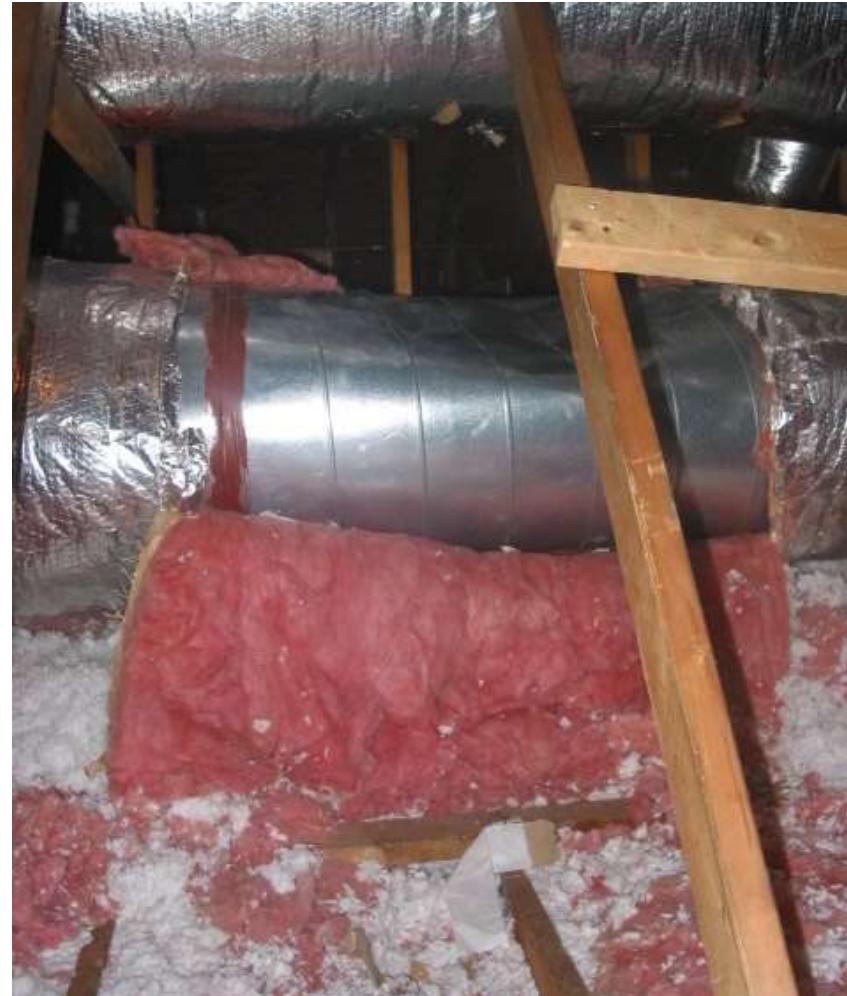
- Damaged or Missing Duct Insulation

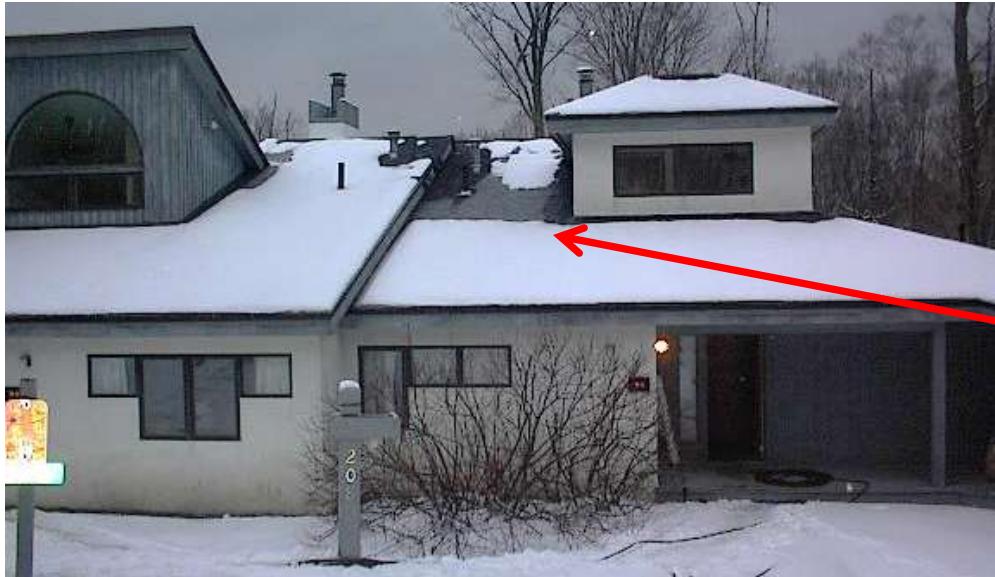
Missing or inadequate insulation

Snow melt over bathroom dropped ceiling

This bathroom has batt insulation, but no air barrier.

Note that the cathedral vented slopes are working!

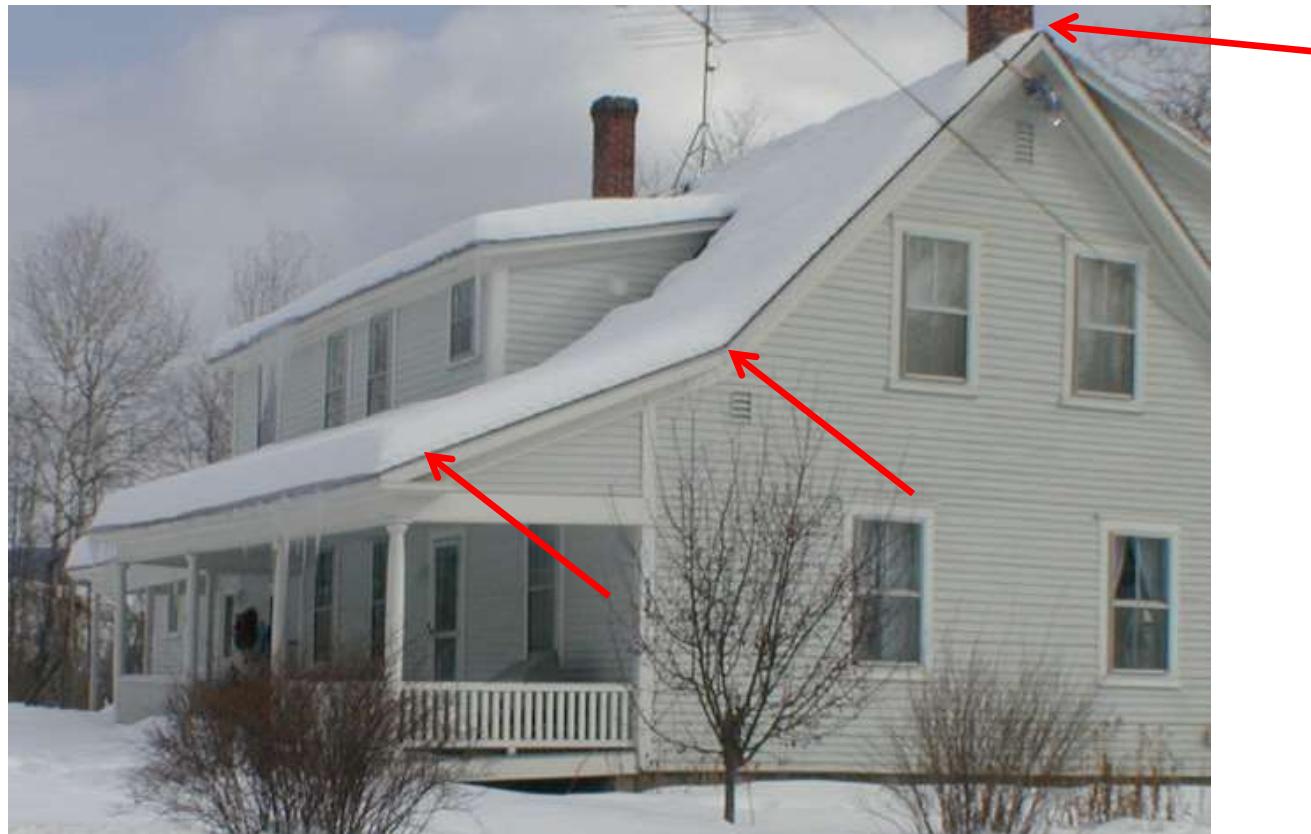
“Snowpack taper” indicates inadequate R-value and/or ventilation – warming increases as the flow progresses up the vent chute.

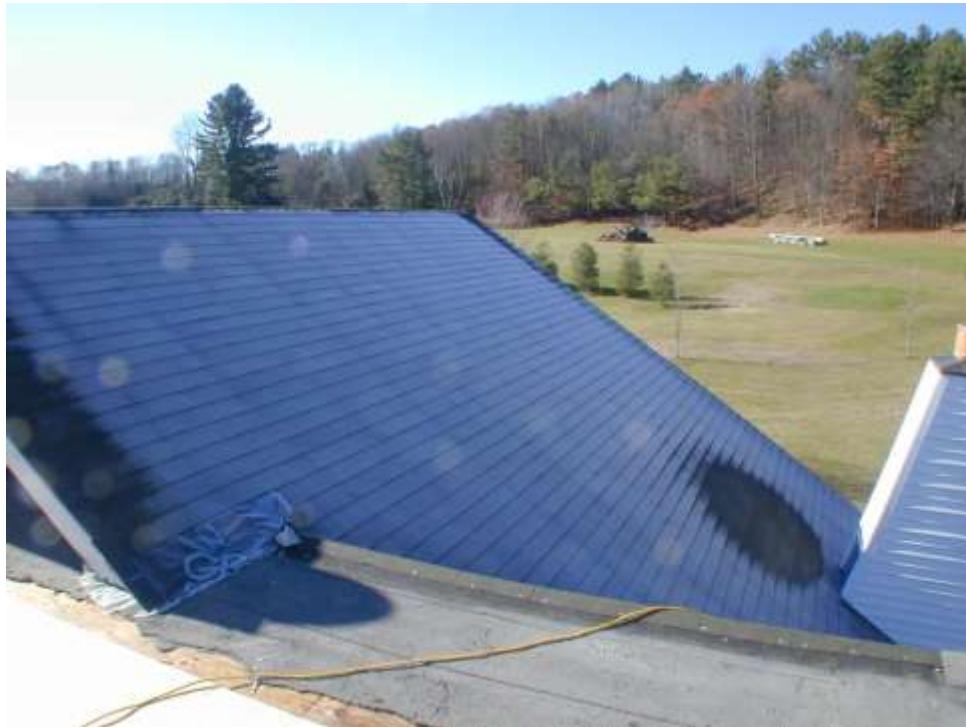
Frost melt pattern

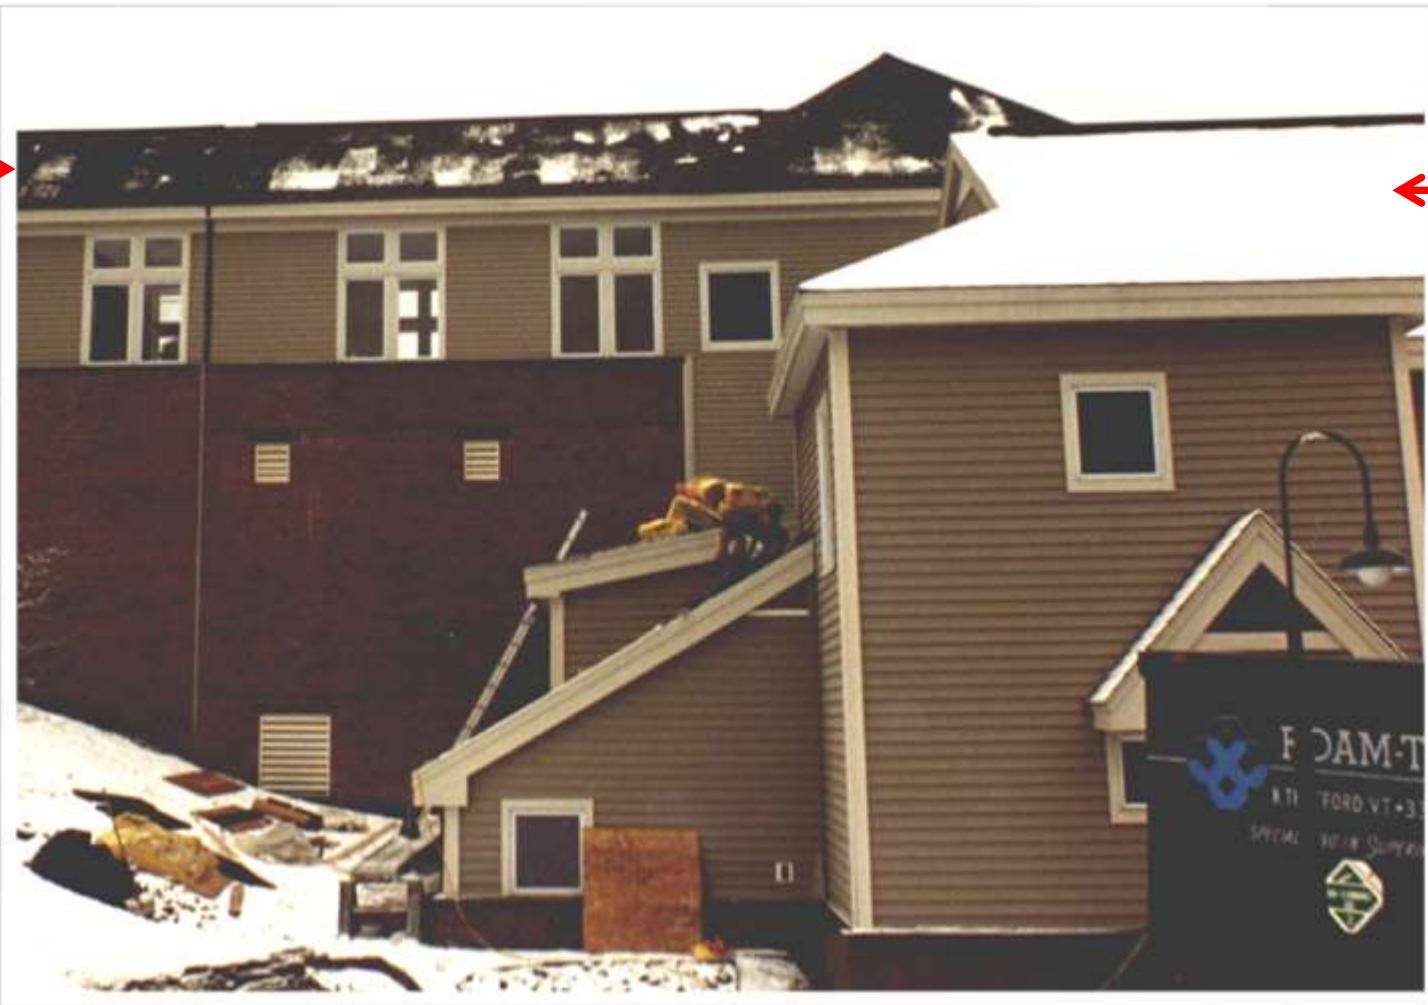
R=38 batts in both roofs. Photos of before (left) and after (right) repairing the existing air barrier

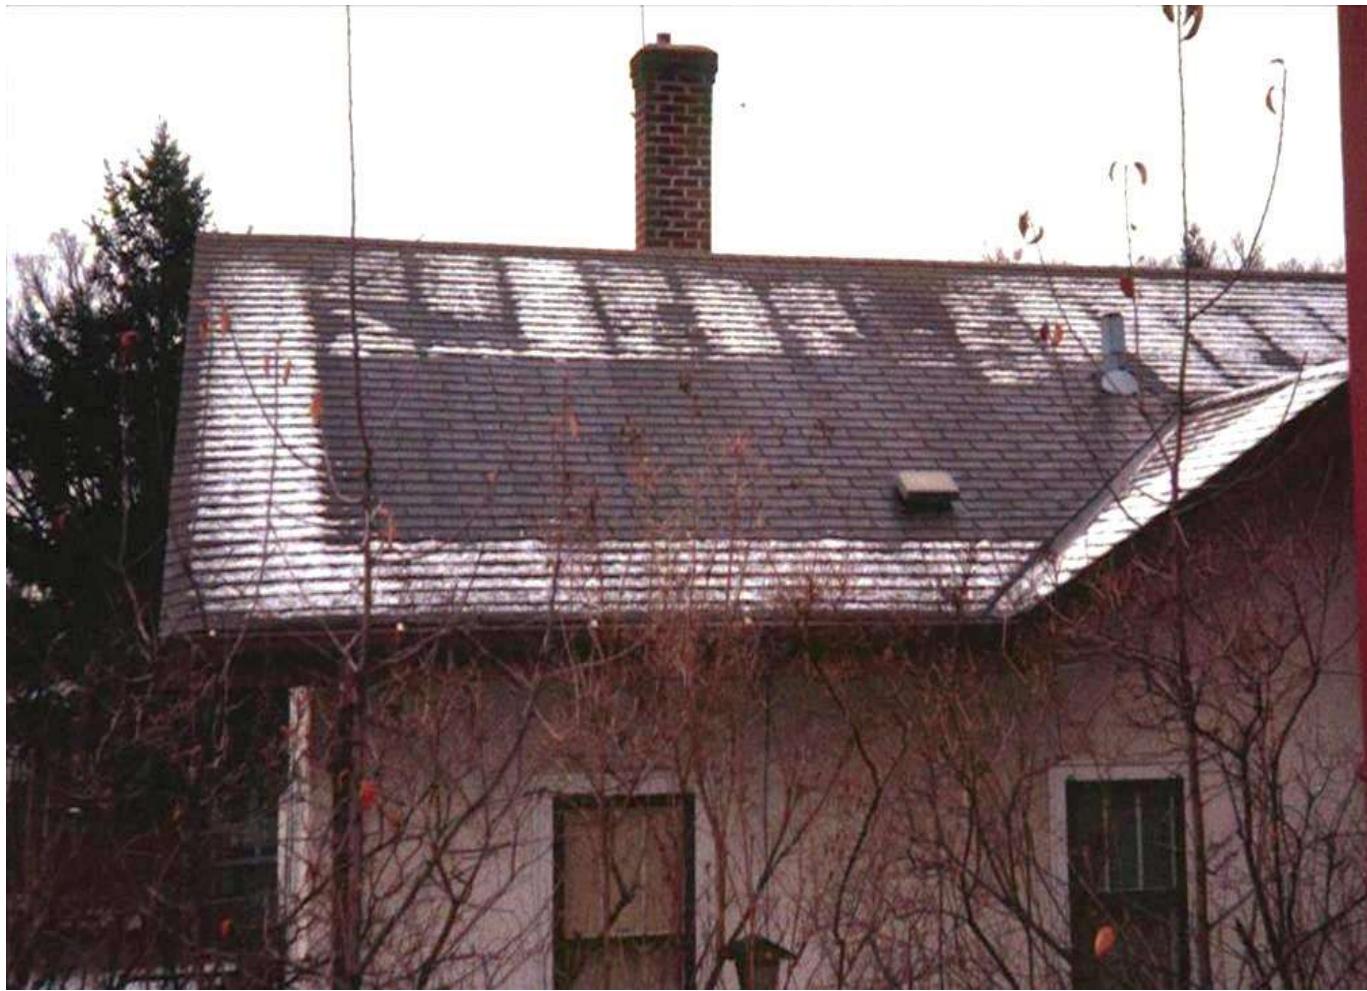
One air leak in an attic can melt the whole roof, defects in cathedral slope only affect the area where the defect is. Whole roof should look like the overhang.

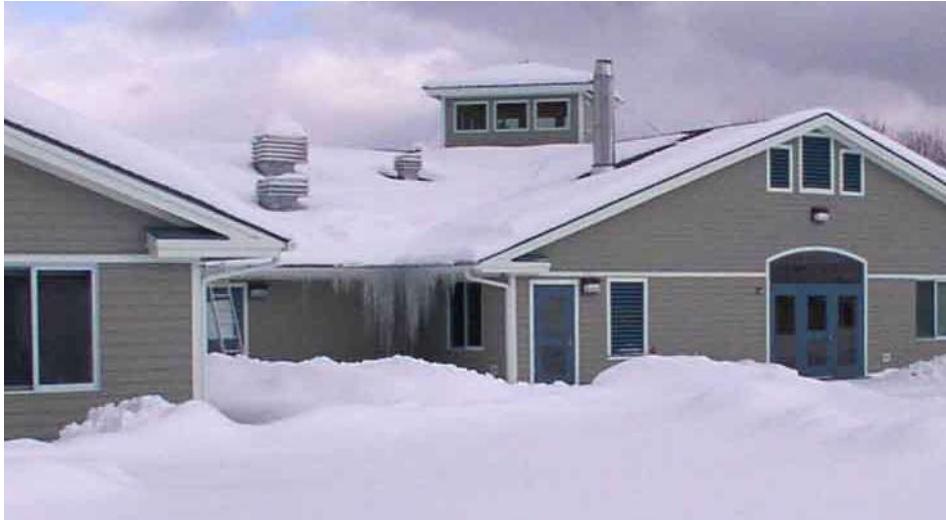
Where does the ice form?

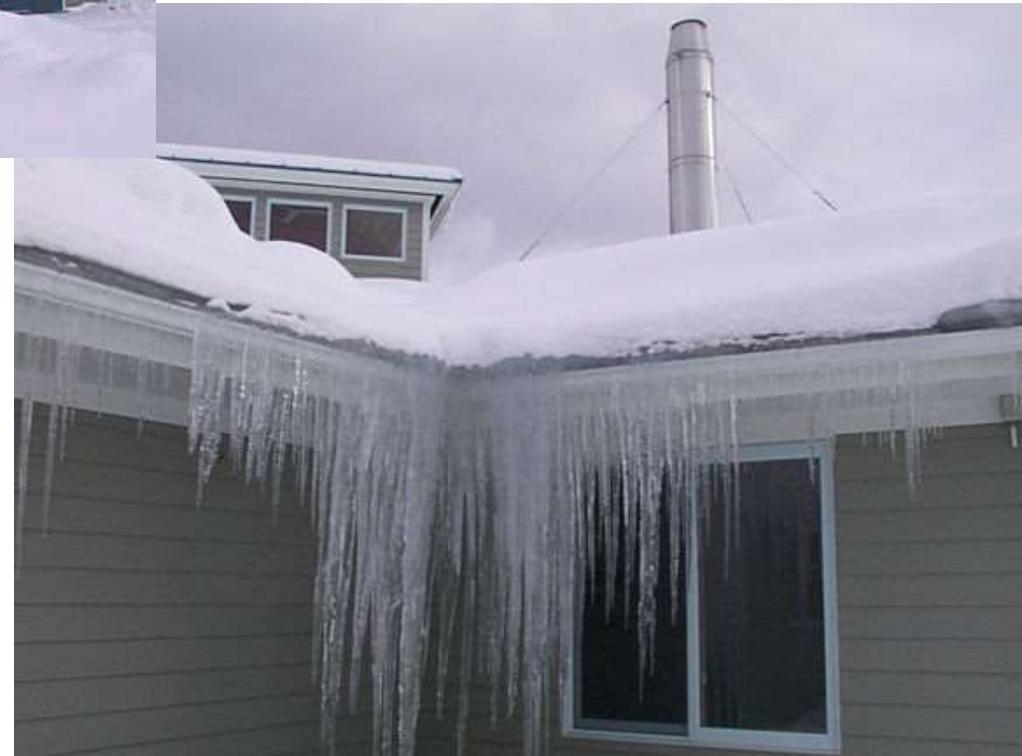
Cause(s) = ? Use a
heat tape to isolate the
two sides

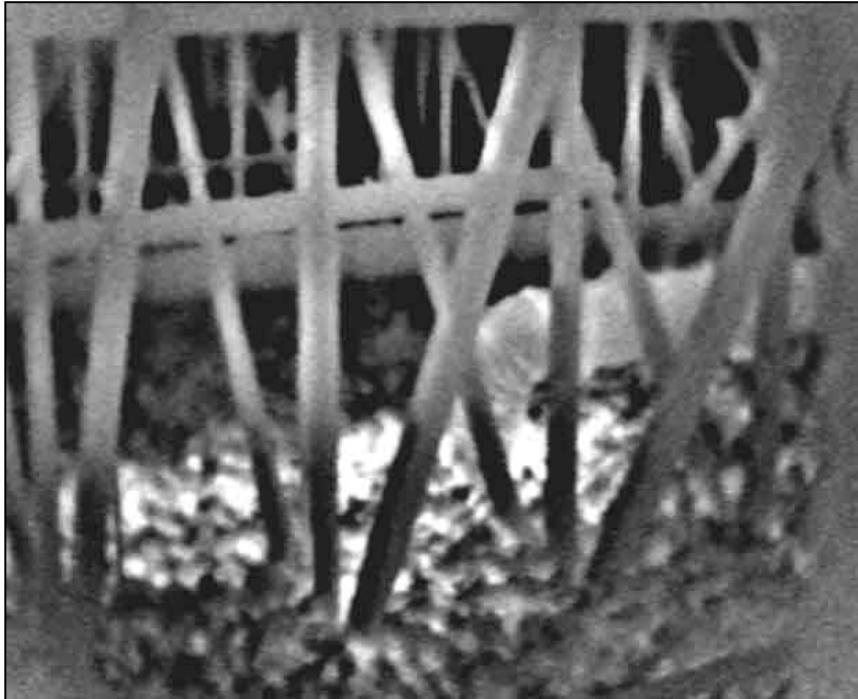
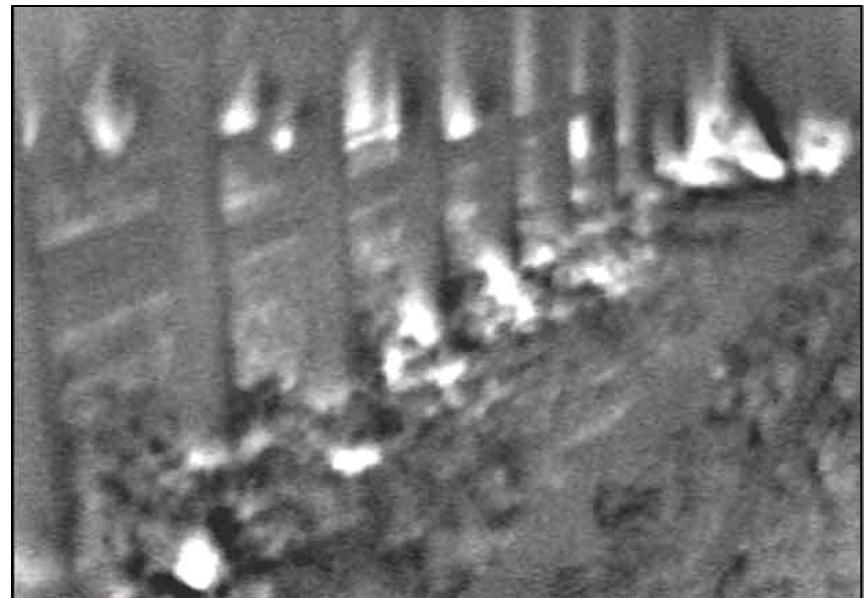
Locating hidden air leakage sites under the insulation is only visible when using infrared analysis (250,000 sq. ft. of attics)

Flagging and repair work
done in cycles until the attics
were below 20F

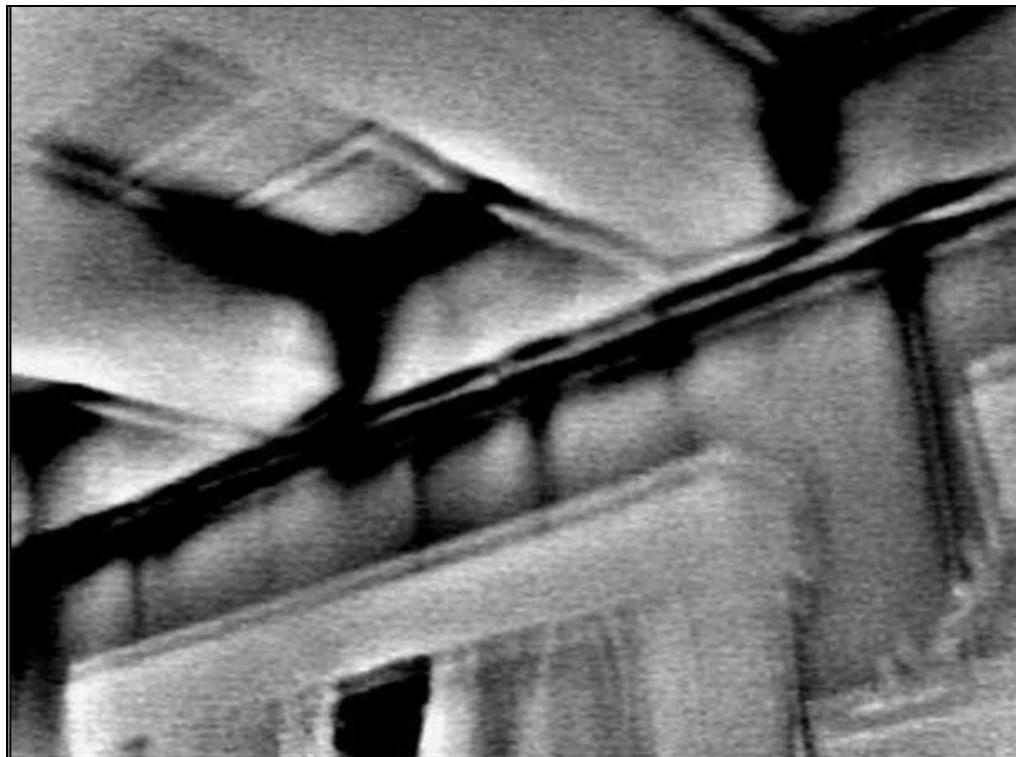
IR at ambient pressure – first floor of timber frame home

Hints: Measure temperatures at leakage sites to prioritize air sealing work

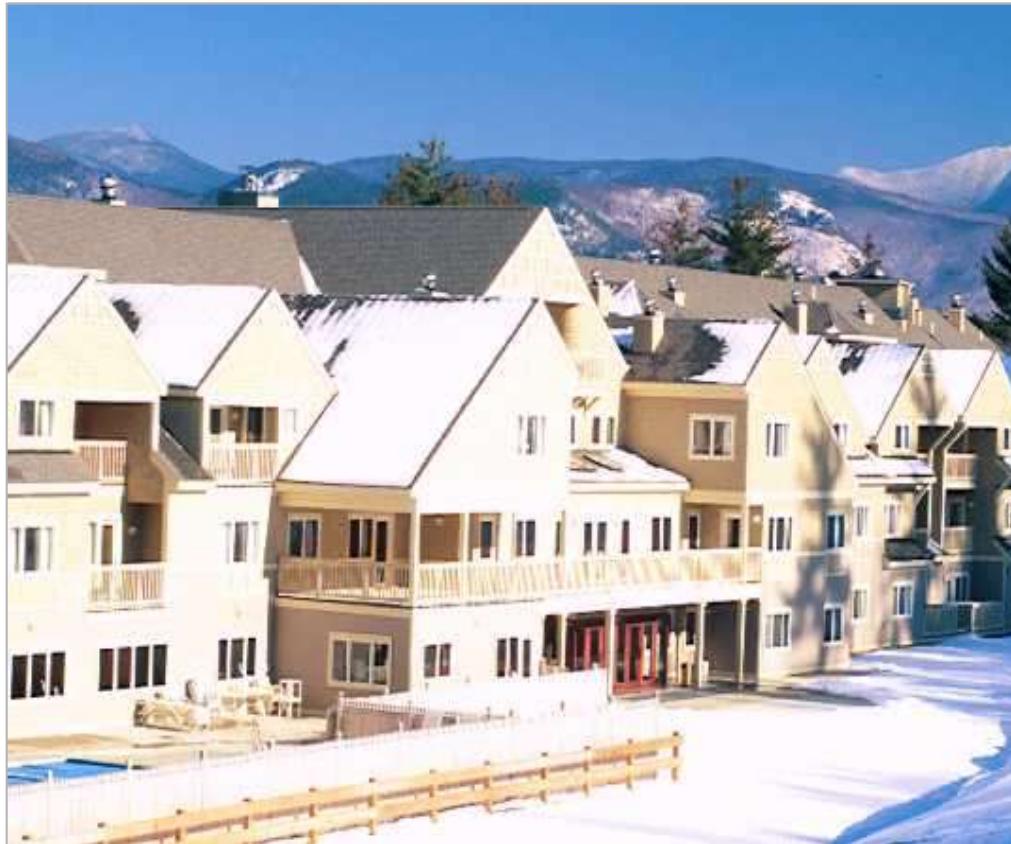
Temperature and RH Monitoring

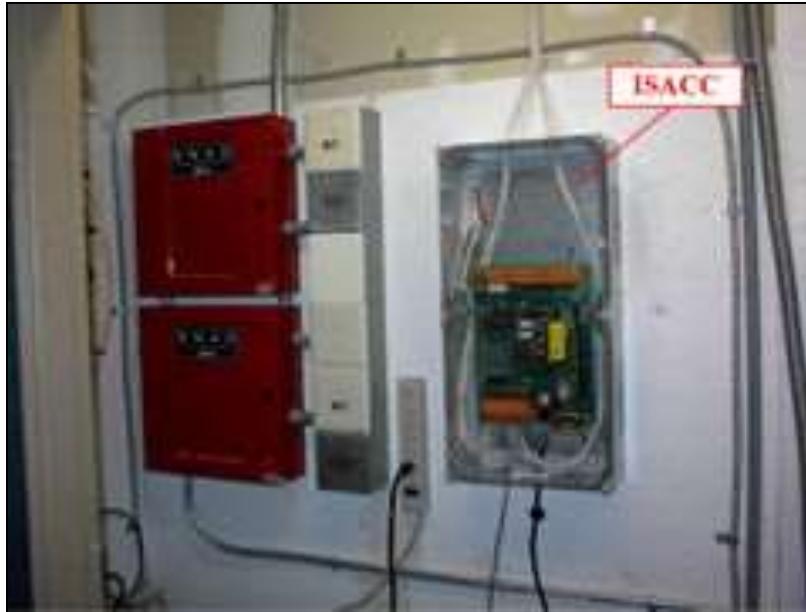
Temperature and RH Moisture Monitoring system

Monitoring and control systems with Wifi and Cellular access are now available. No sensor wiring and no land line is required.

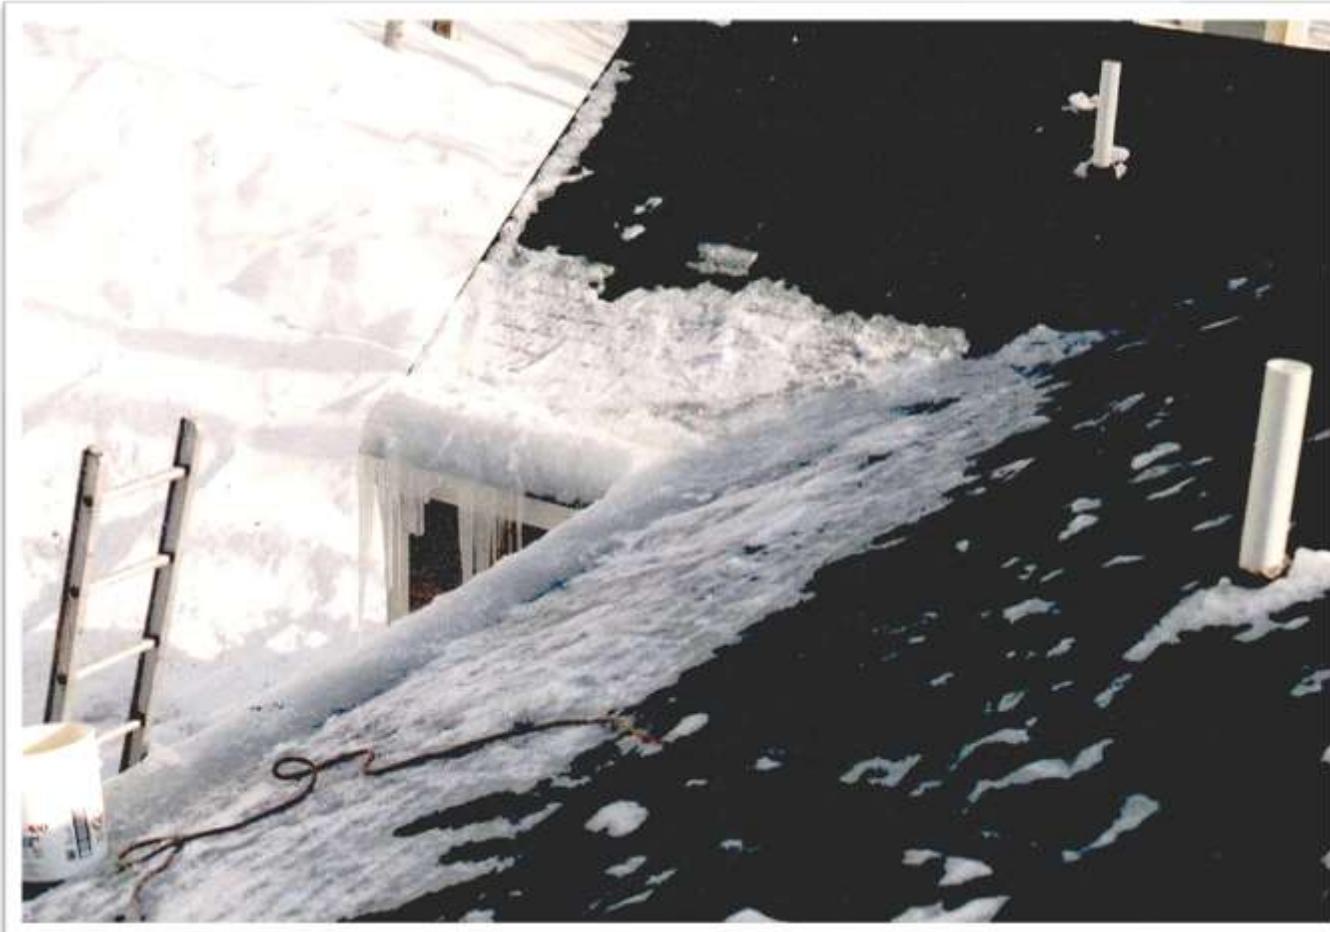
The heat loss is occurring where the ice is forming
and the leaks are occurring - Agree?

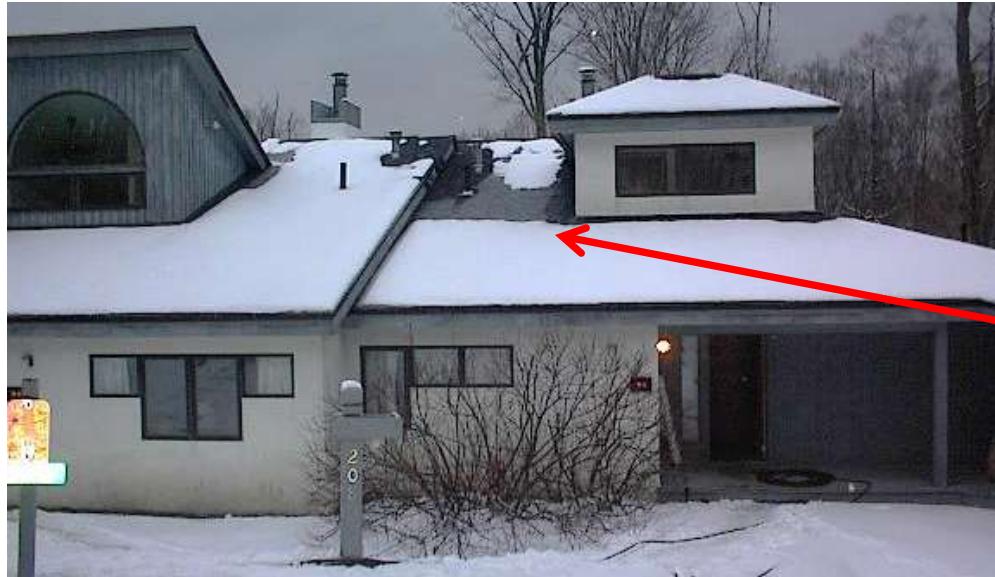
Missing or inadequate insulation

Snow melt over bathroom dropped ceiling

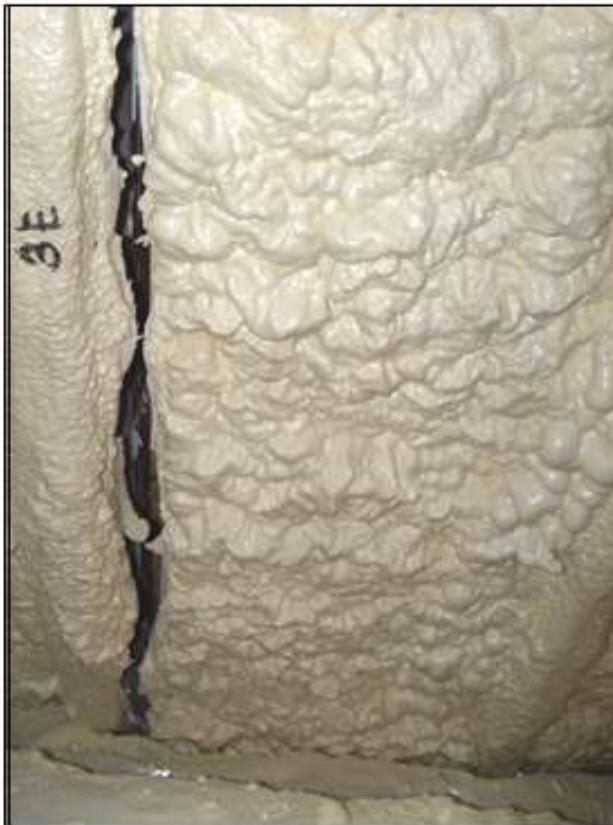
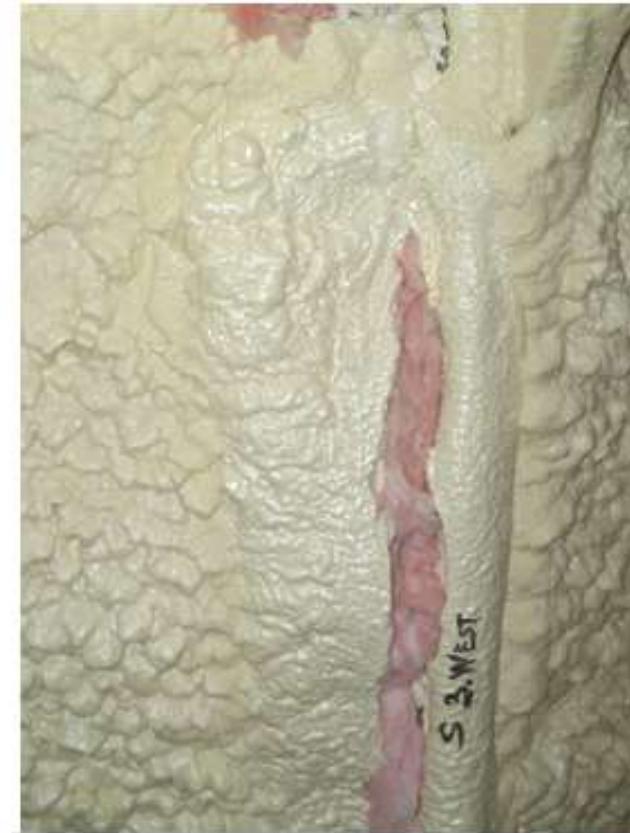
Photo DSCN1993.jpeg

Pictures of cracks along rafters in the House attics. The one on the right has been temporarily stuffed with batt insulation until the remediation work begins.

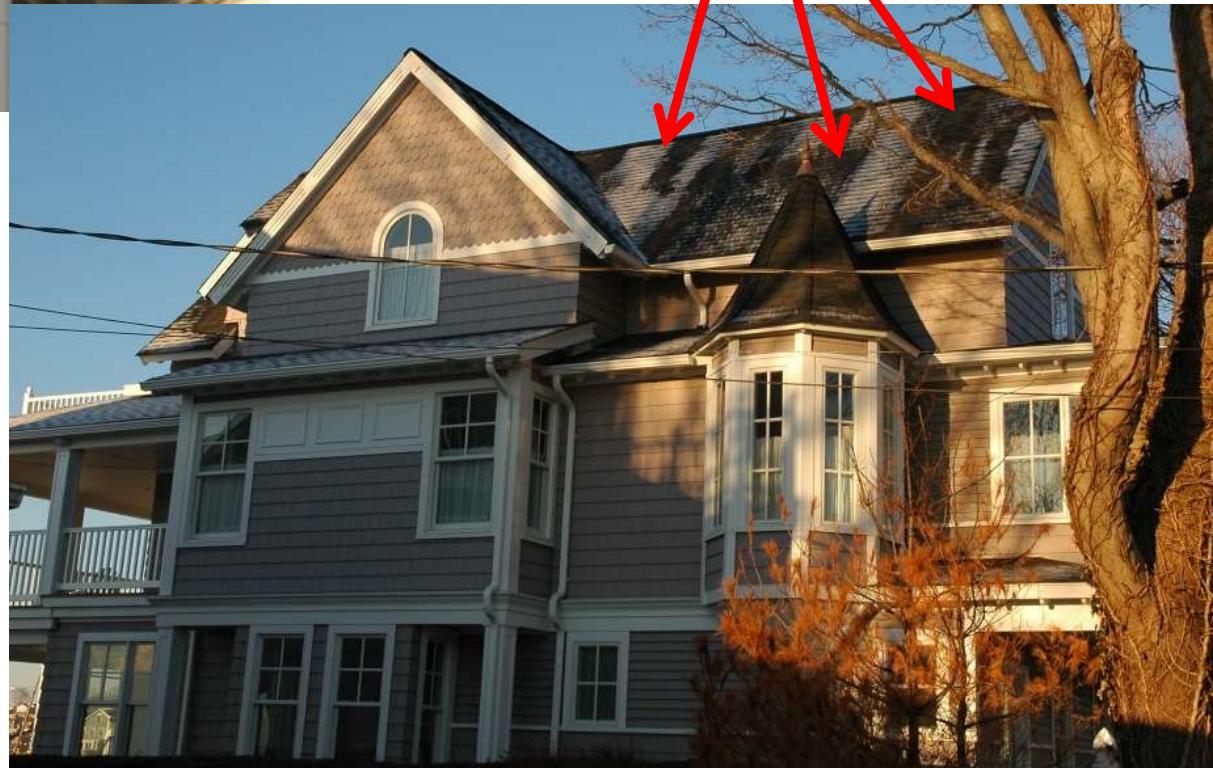
Melt patterns before the repair
of cracks in the SPF
