The First Frontier in Home Weatherization: Attics and Cathedral Roof Slopes

By: Henri Fennell, CSI/CDT

© H C Fennell Consulting, LLC 2025

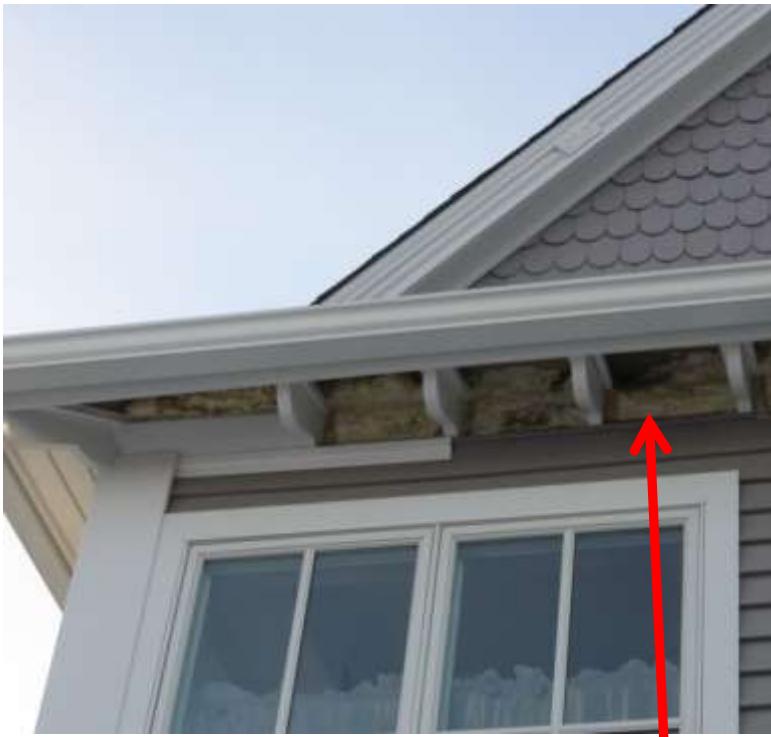
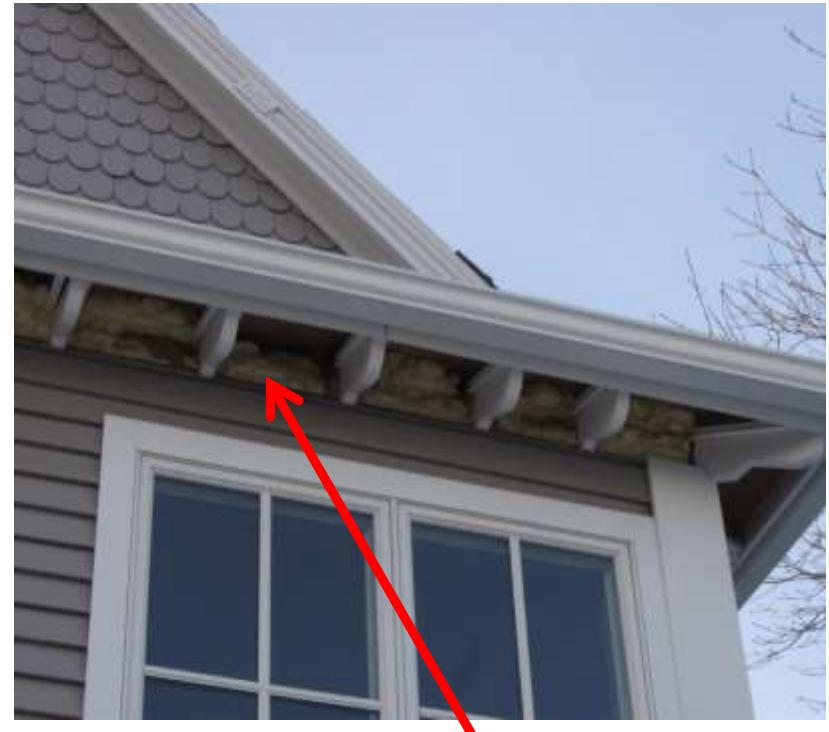
North side soffit areas

Holes in framing and missing foam sealant discovered in soffits using pressurized theatrical fog test method

0.54 CFM50/sf before remediation
