Jeffrey C. May

May Indoor Air Investigations LLC
Tyngsborough, MA

Moisture and Leak
Investigations

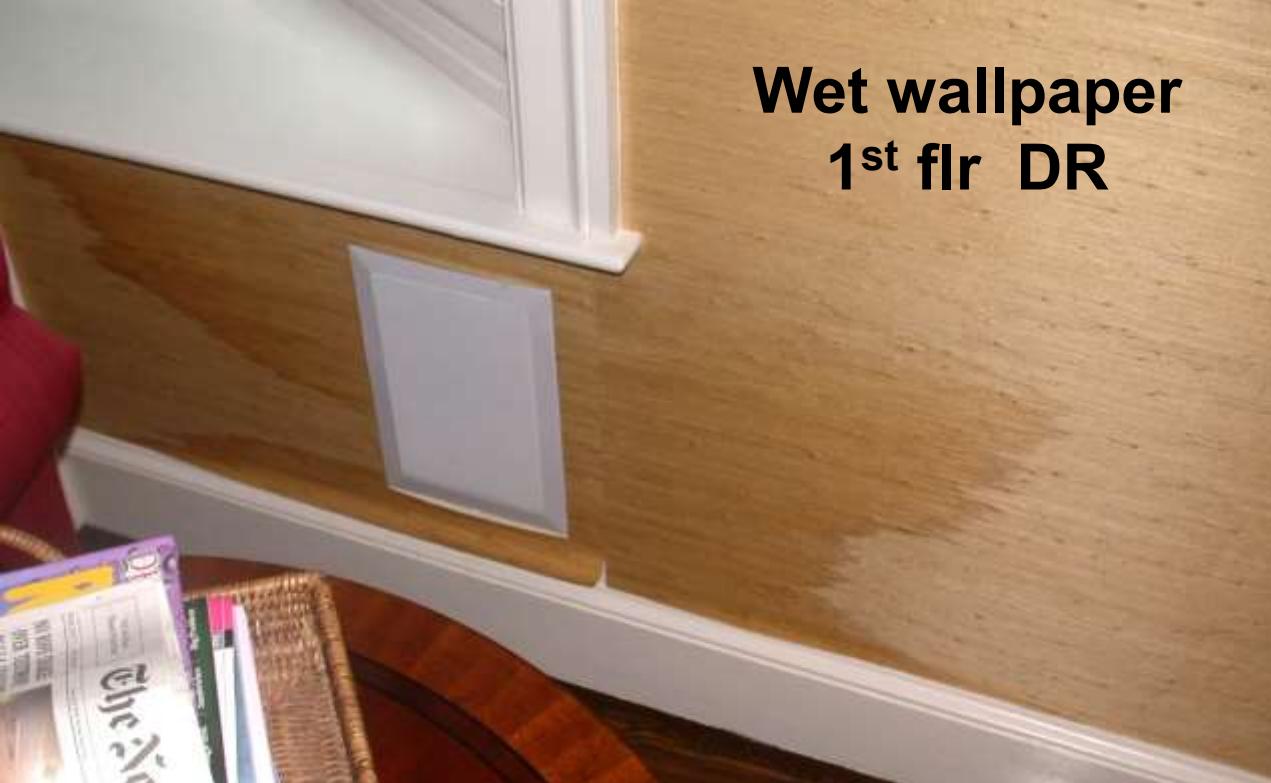
**Water on floor
2nd flr under window**

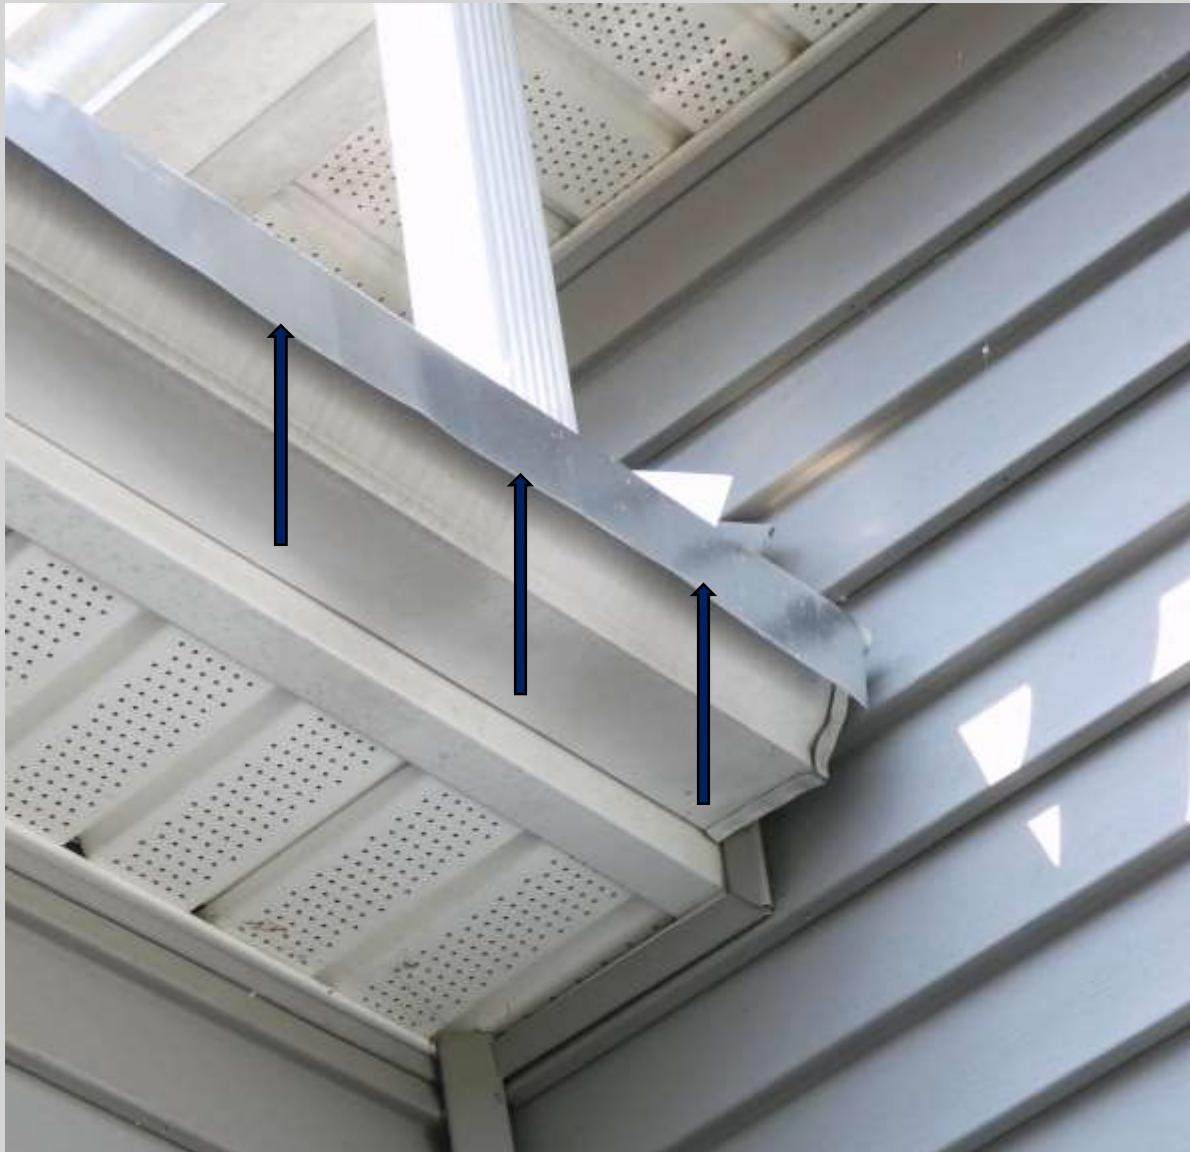
Clogged gutter

**Remind your clients to
keep their gutters and
downspouts clean.**

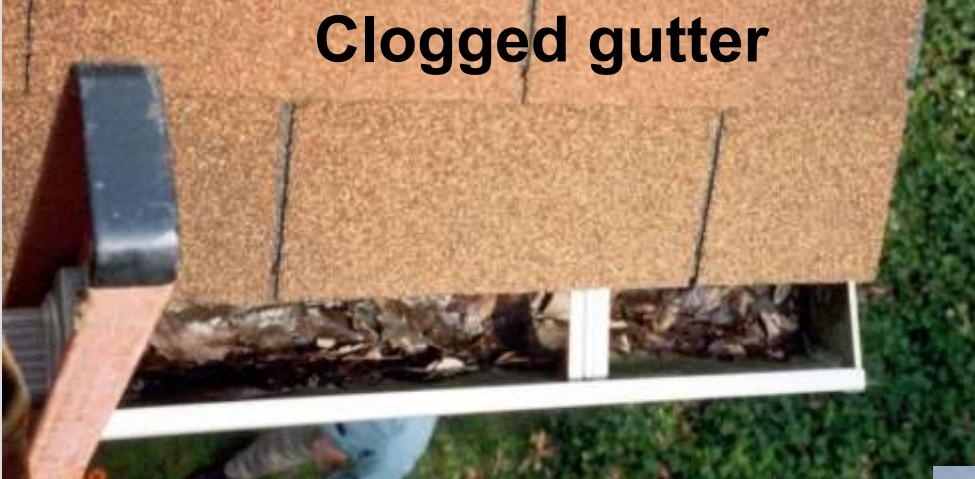
Fifteen years of Gutter Neglect in PA

Builder was sued in court

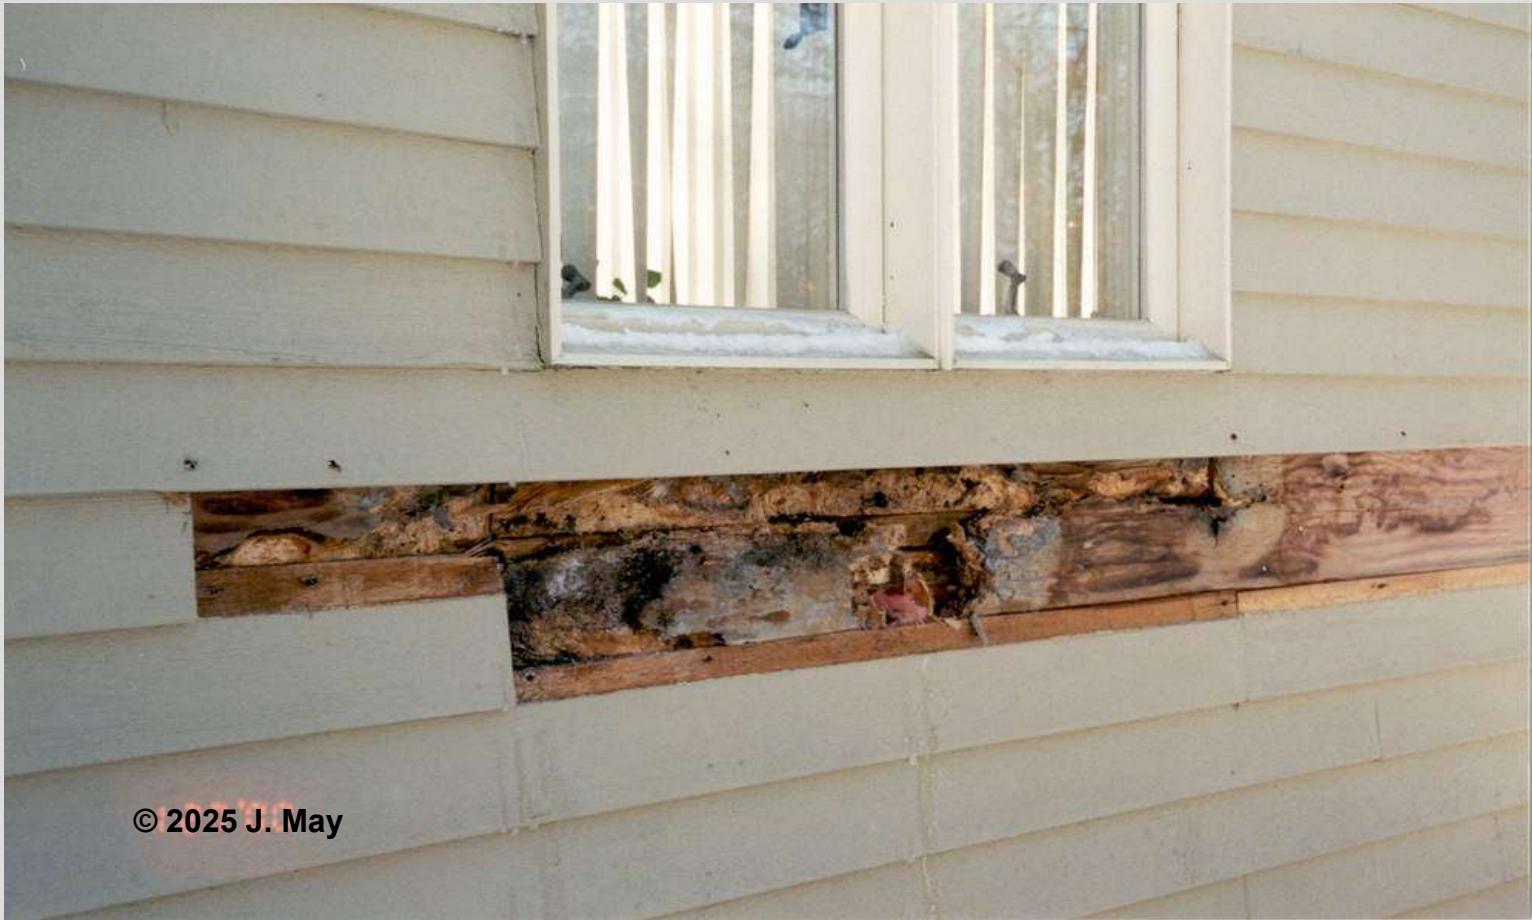
At the home above, pests and both insect and wood decay led to powerful, musty indoor odors. Water entered the wall between the separate window units.

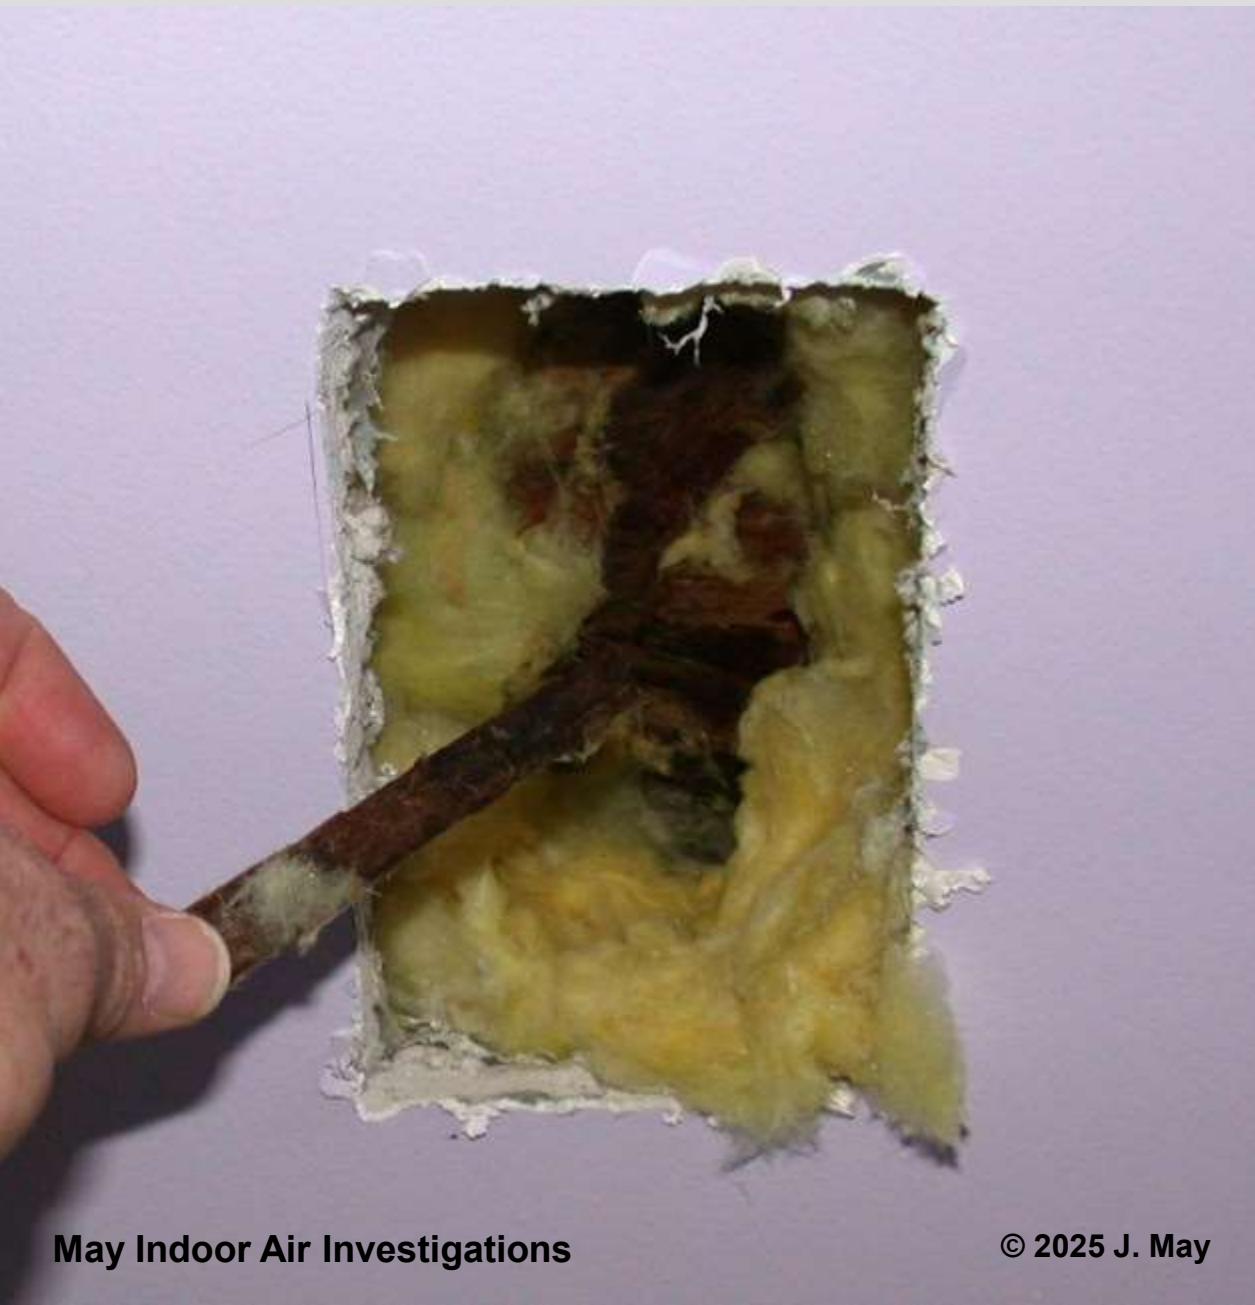
**Wet insulation
and OSB in
second-floor
baby's room in
corner of house**

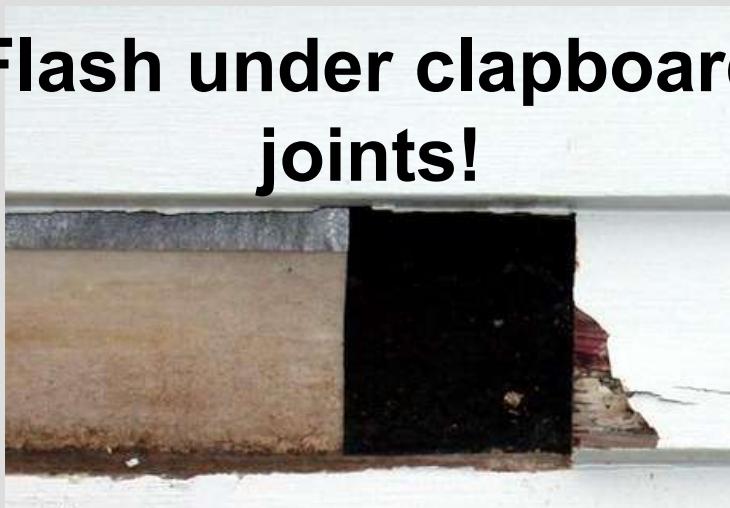
No flashing strips under clapboard joints

Nails driven in too far

Exposed wood grain at nail depressions not painted

Unfilled nail heads, too deeply set; fibers take in water also!

The resulted was wet sheathing. . .

Flash under clapboard joints!

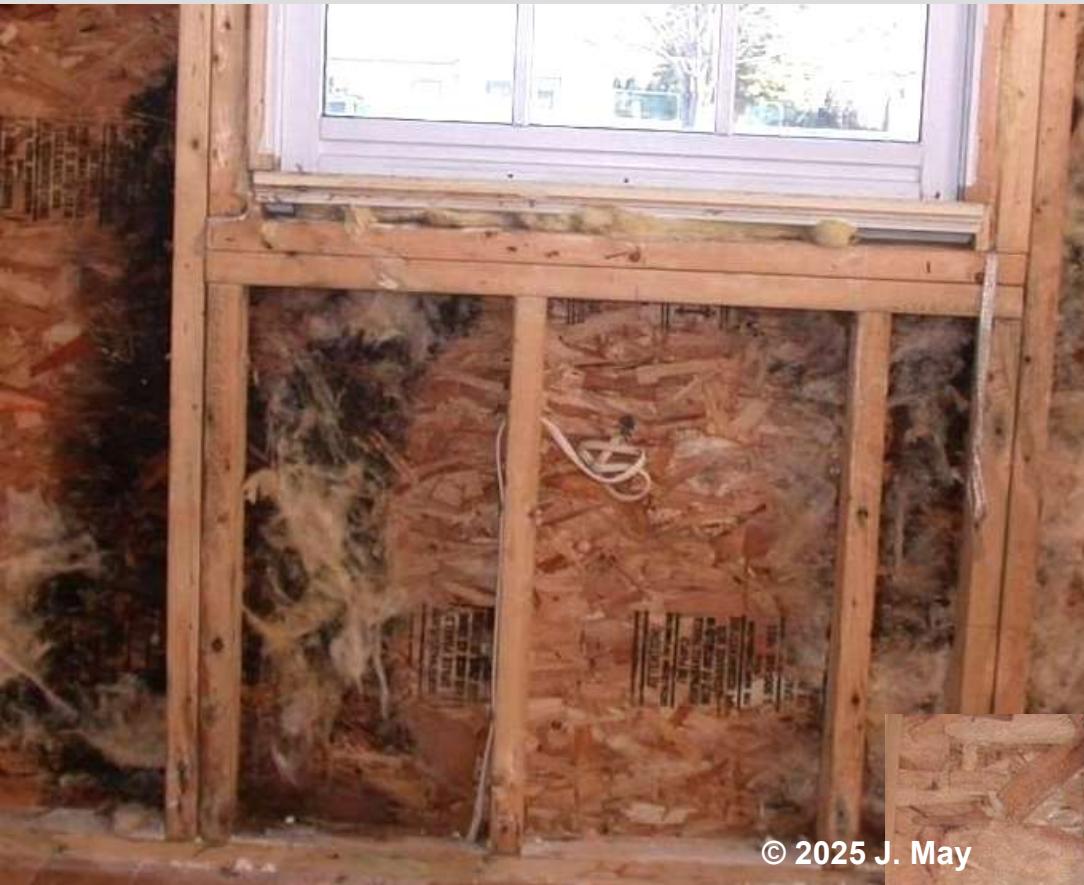
All the interior drywall was removed.

Both macrofungi and microfungi were growing on the OSB. The fungal growth-pattern suggests that water entered the wall from the exterior at the studs (nails and joints) and the window jamb joints.

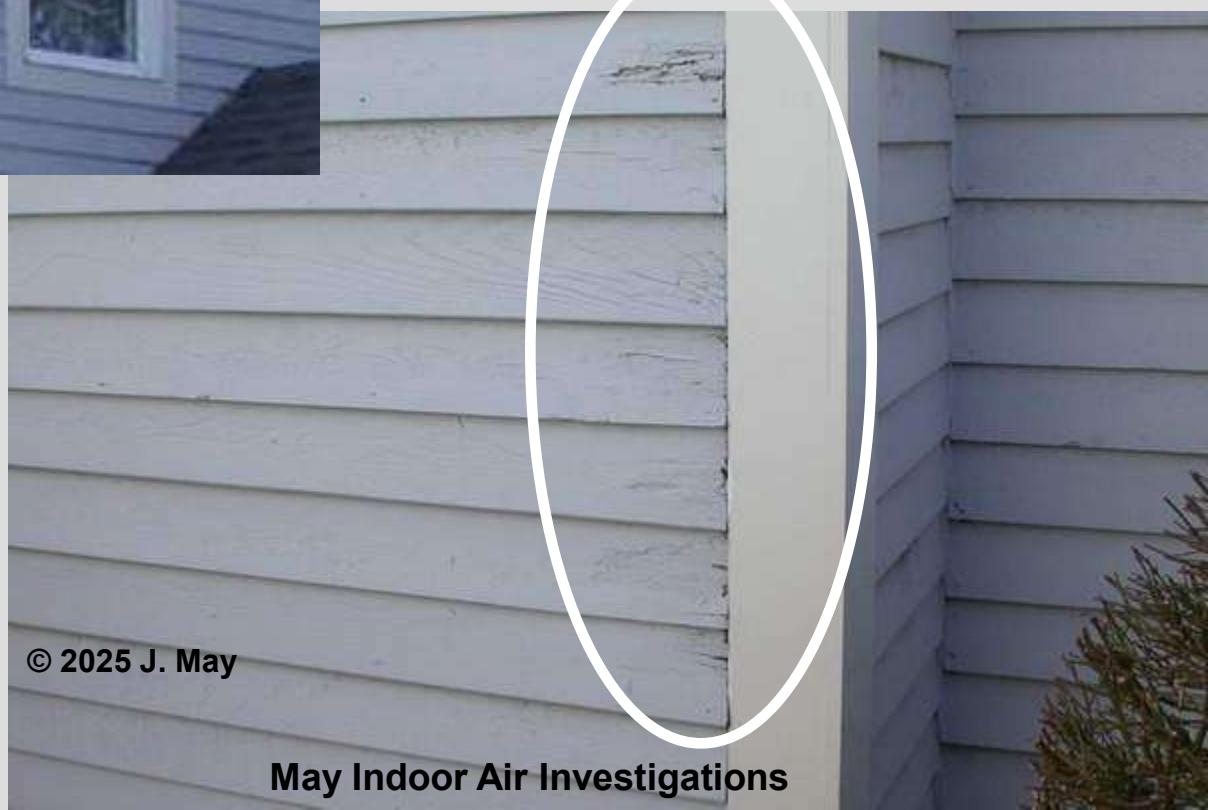
**Return sloped
improperly at
bottom edge**

**Visibly decayed
clapboards**

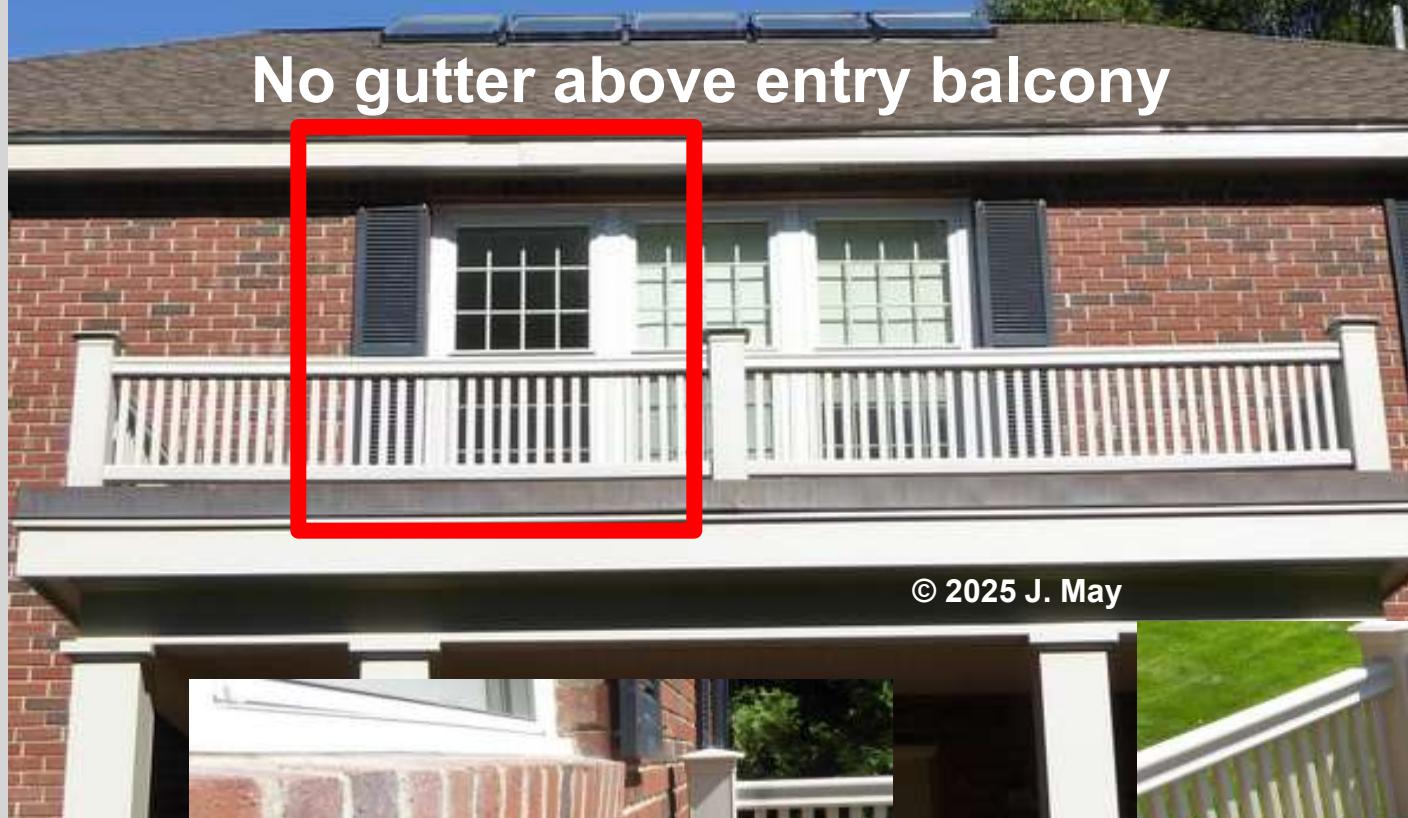
House with very musty entry hall but no visible mold

No gutter above entry balcony

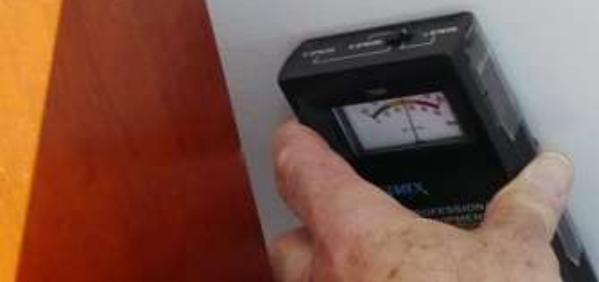
Elevated moisture content in drywall under 2nd floor window over entry

No odor at 2nd floor over entry!!

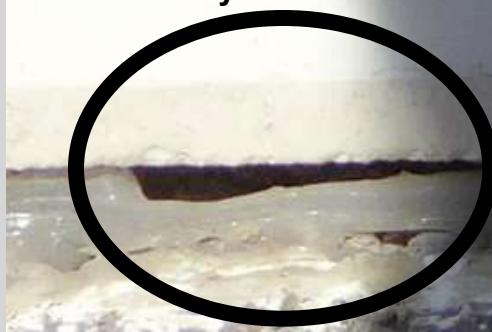
Small gap in caulk under window

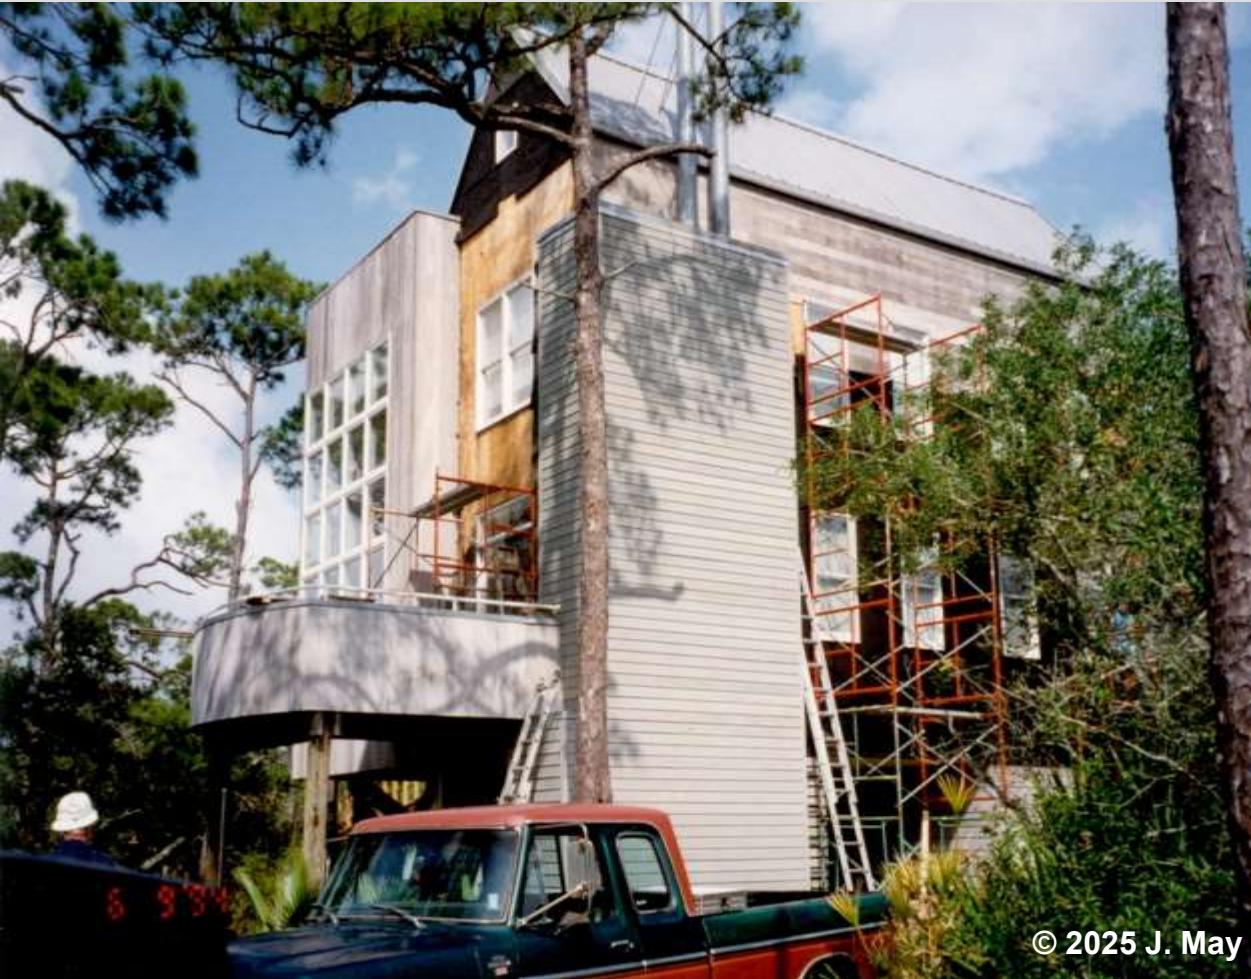
No roof overhang or gutters!

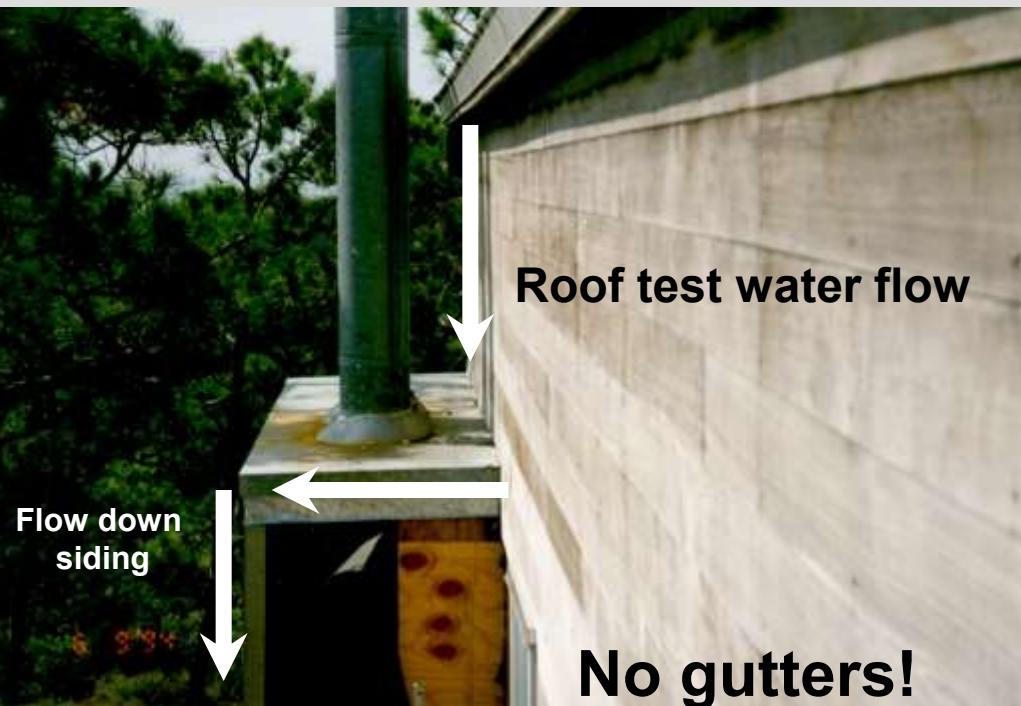
This house must have overhang or gutters!

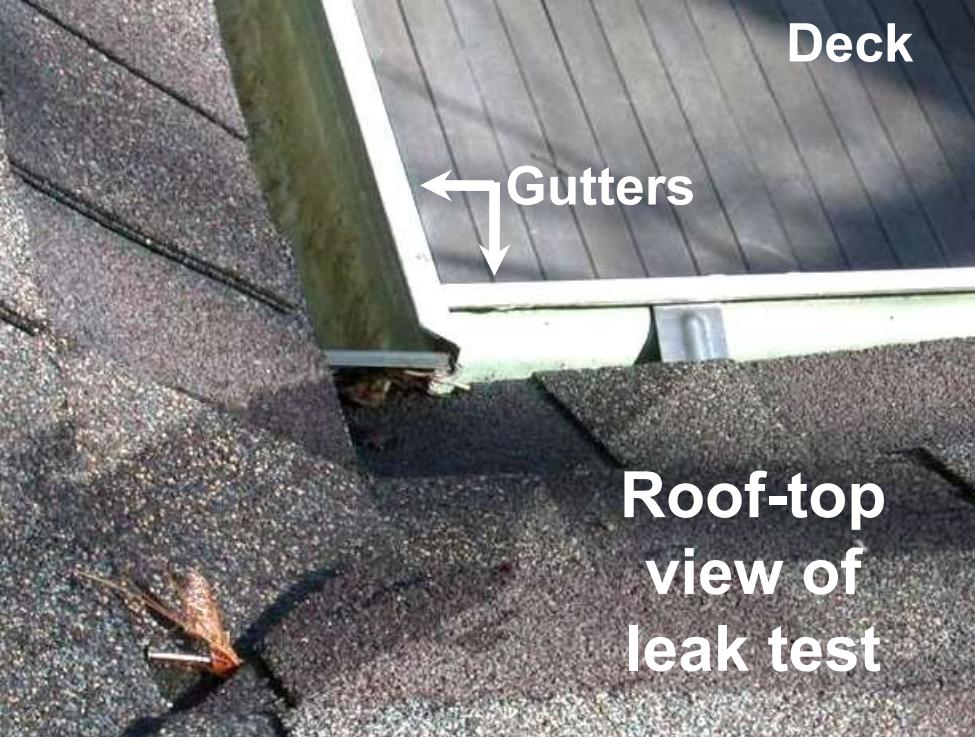
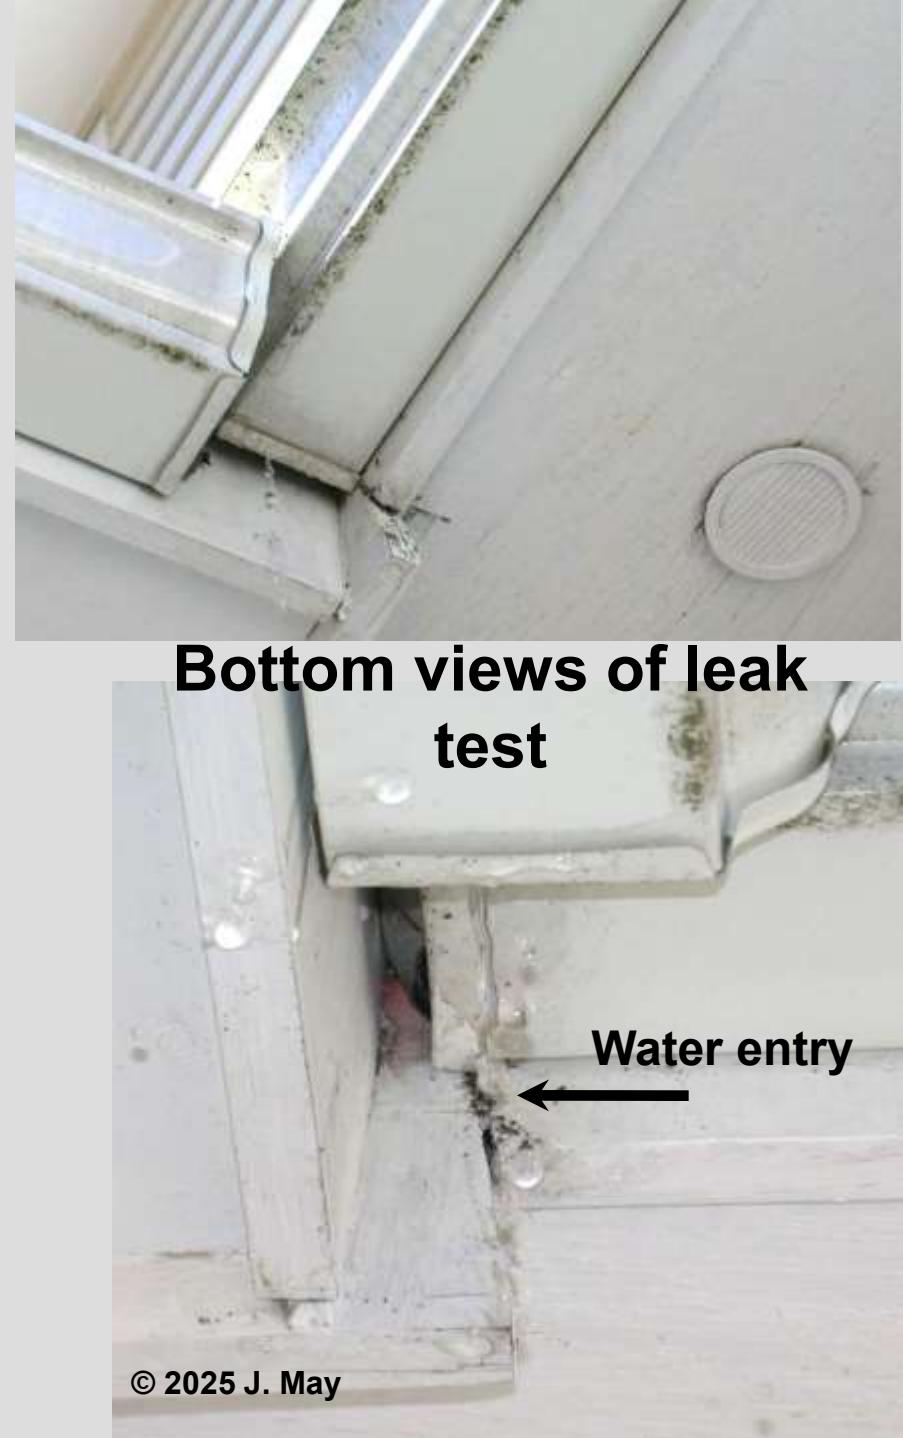
Great Design...
Gutters at different
levels met at a corner
under a roof valley.
Neither collected the
valley water.

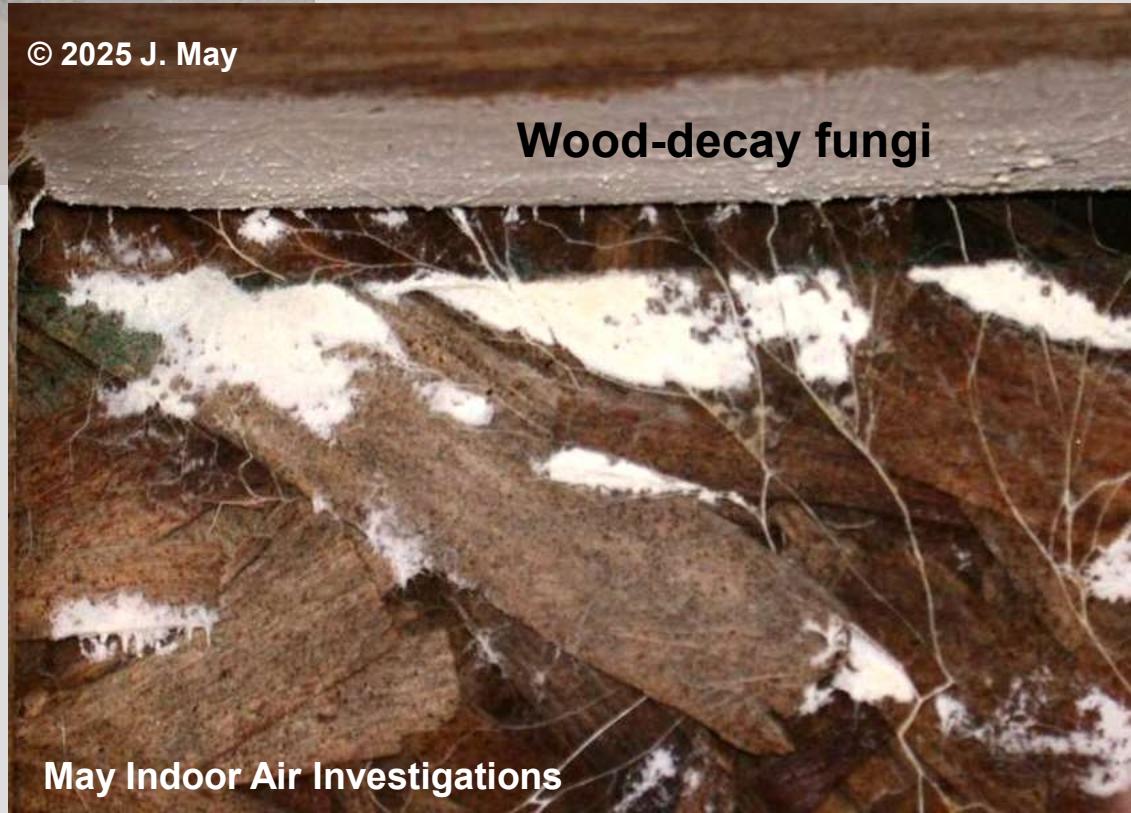
Wood-decay fungi

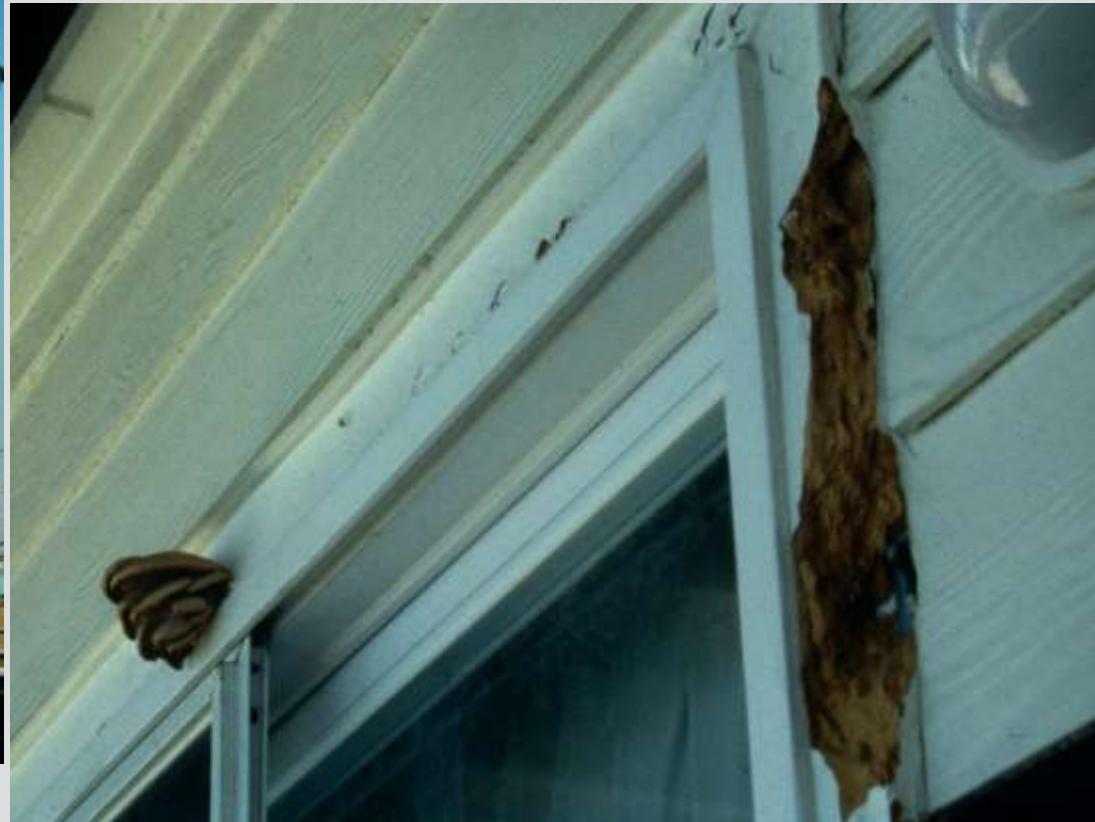
Mushroom at a three year-old building

The severe decay at the three year-old building was due to water penetration at a joint and a lack of flashing at the deck ledge.

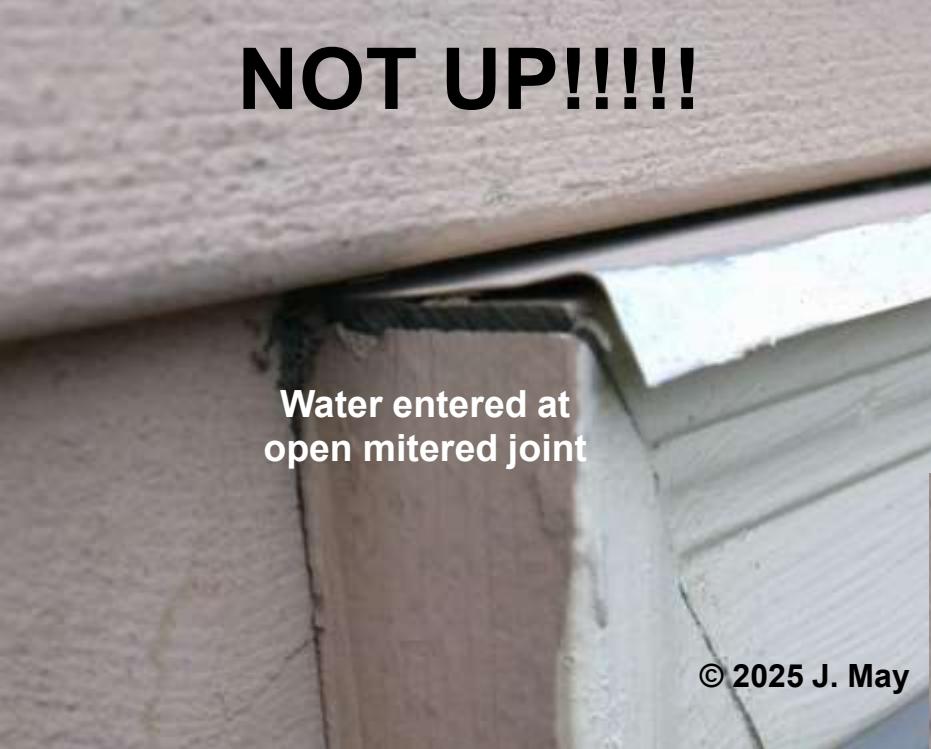
Water entered at open mitered joint

Water soaks up the back of the clapboard and runs to the ends of the flashing, and in this case, into the mitered joints, and down the wall behind the trim.

Drip Caps Should Be Bent Down!!!!

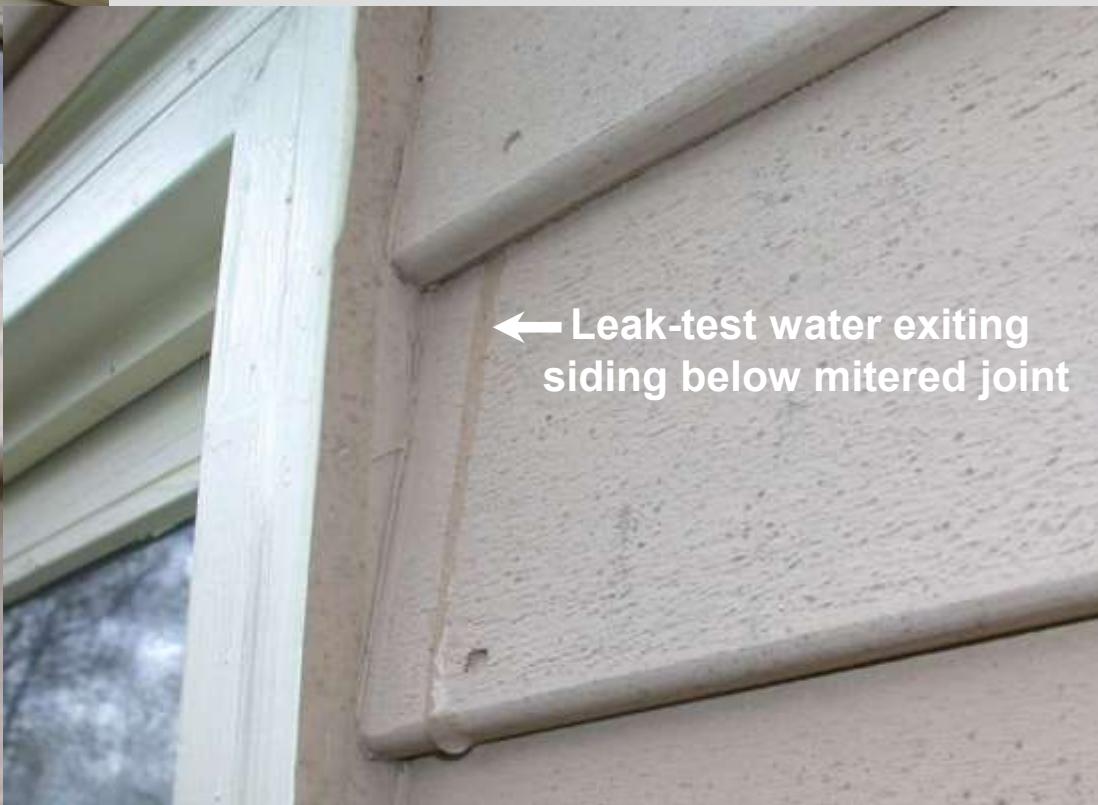
Casing

The decayed casing from the left side of the window was removed.

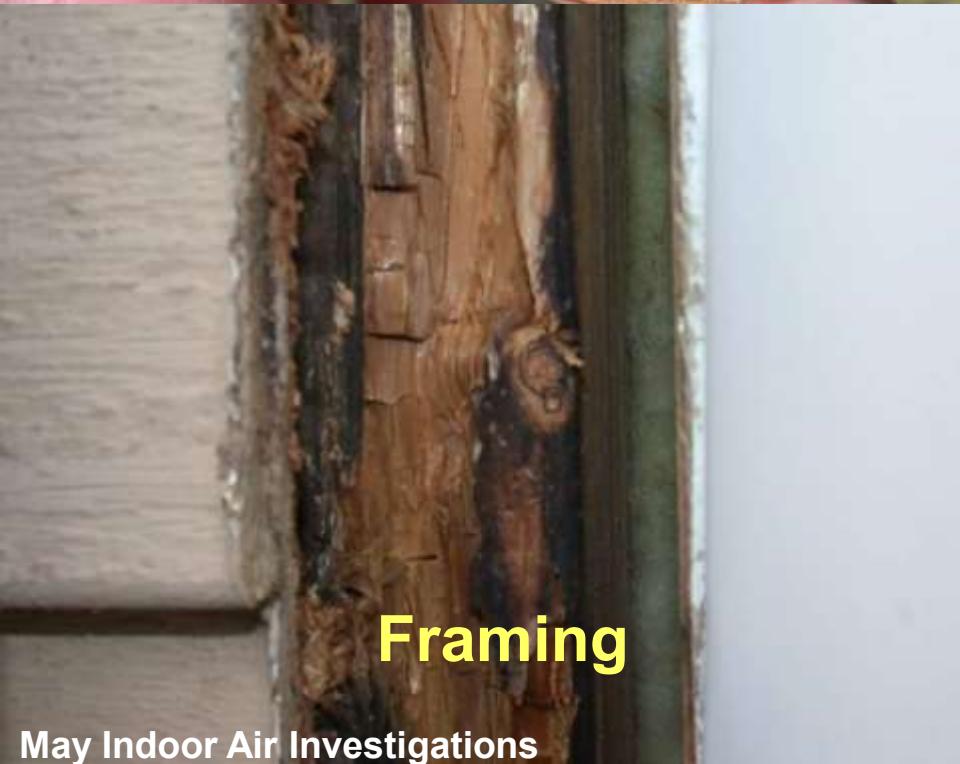
Framing

Even the framing lumber at the side of the window was rotted. The rough window opening was never flashed.

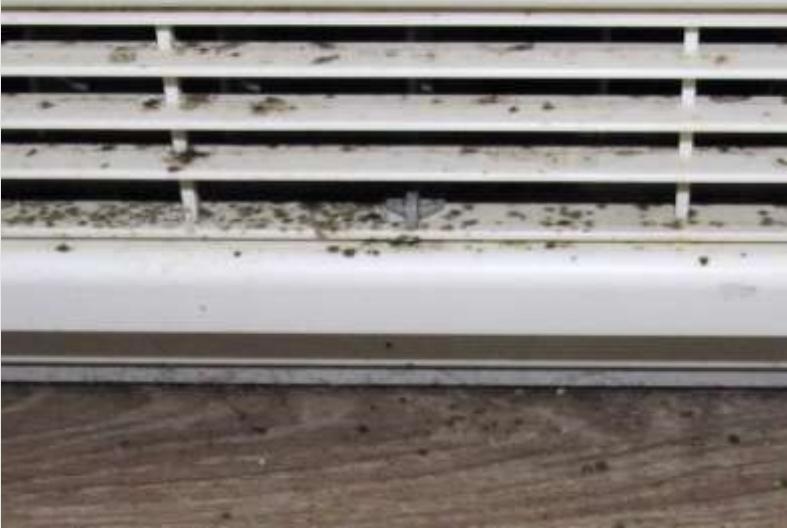
Moldy wall-mounted heat-pump return

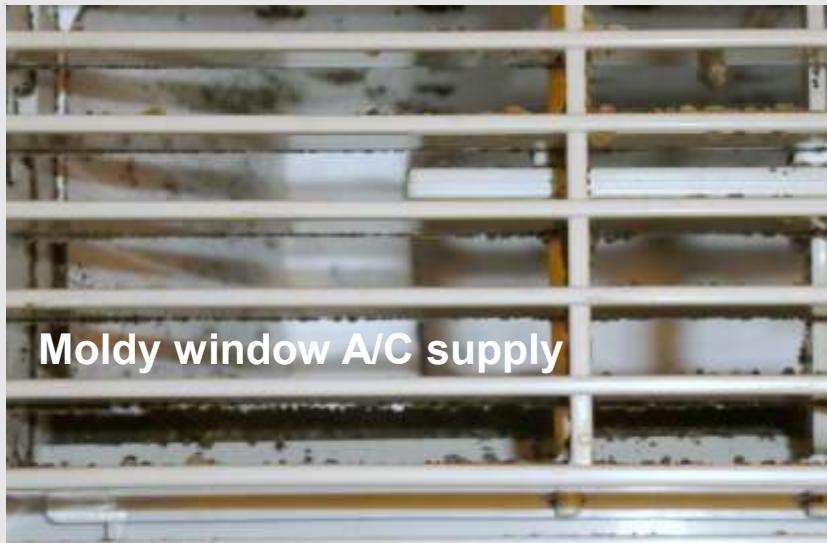
Moldy window A/C supply
